JAIPUR METRO Jaipur Metro Rail Corporation

Pre - Condition Building Survey for Construction of Underground Stations from Chandpole to Bari Chouper and reversal line

Shop No.18
Chandpole Bazaar
Jaipur
Unique ID:CP CC UP 0008/18

Report Number: AIMIL/ESG/JMCEC/CP CC UP 0008-18/01, Rev. 00, Dated: July 2014

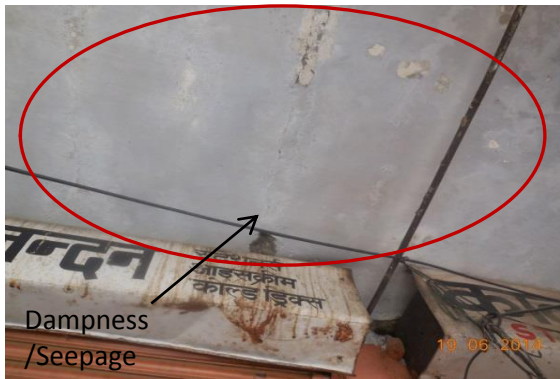
Photo 7

Dampness/Seepage on Roof of Varandah of Shop No.18, Ground Floor

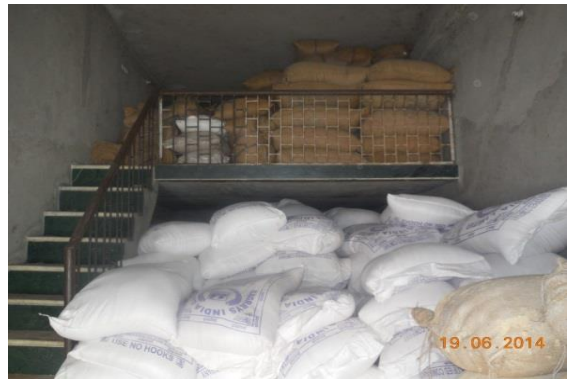
Photo 8

Covered with material, All Walls of Shop No.18, Ground Floor & Upper Ground Floor

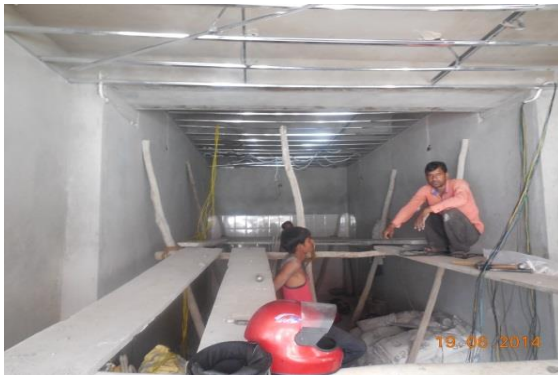
Photo 3

Under Repairing/ Renovation on All Walls of Shop No.30, Ground Floor

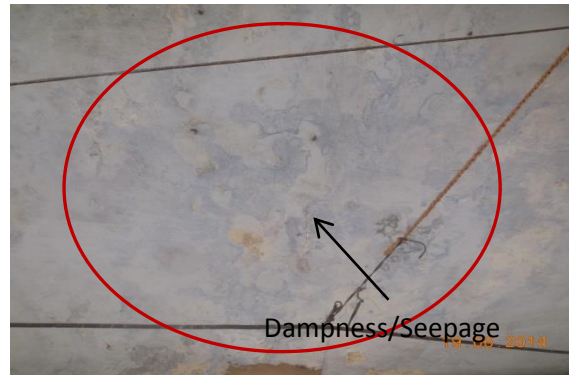
Photo 4

Dampness/Seepage on Roof of Varandah of Shop No.30, Ground Floor

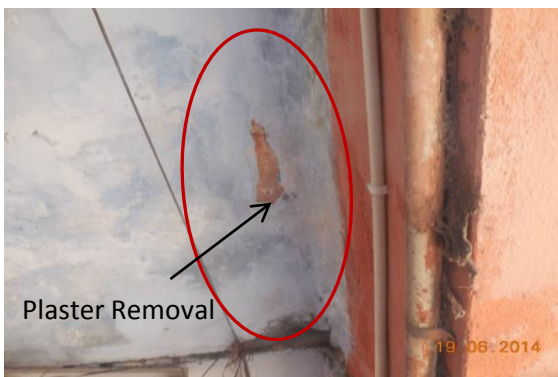
Photo 5

Plaster Removal on Roof of Varandah of Shop No.30, Ground Floor

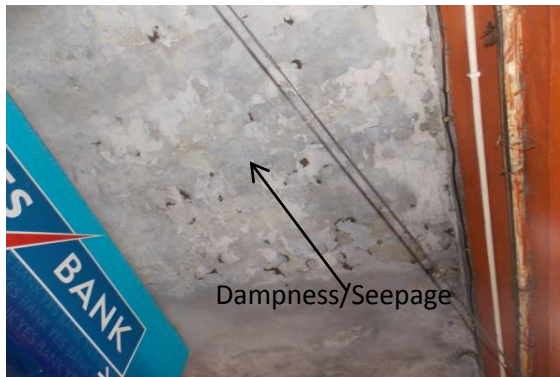
Photo 1

Dampness/ Seepage on Roof of Varandah of Shop No.55
Ground Floor

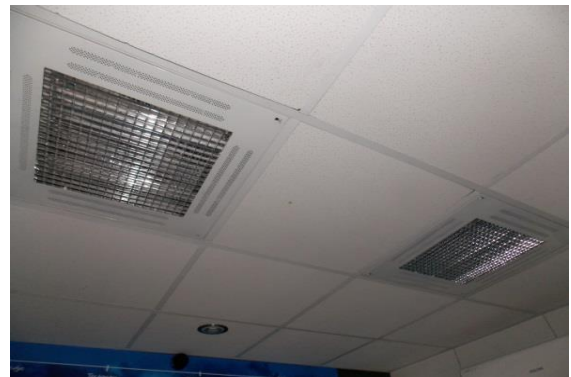
Photo 2

Covered with Wooden Ceiling, Roof of Shop No.55,
Ground Floor

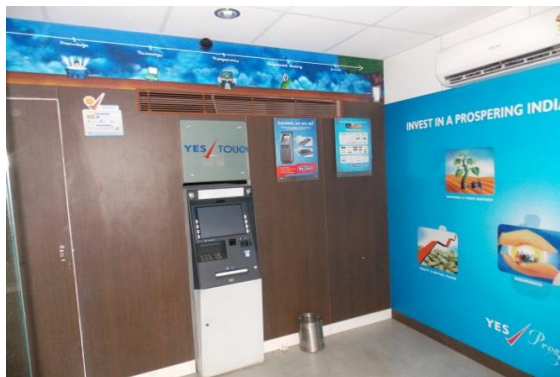
Photo 3

Covered with Wooden, All Walls of Shop No.55,
Ground Floor

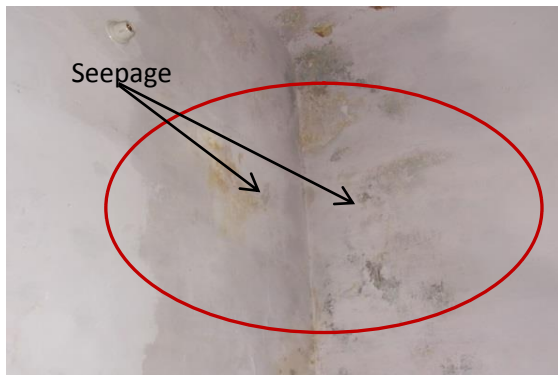
Photo 3
Seepage on Wall No.1 & 4 of Part-C of Shop No.72
Ground Floor

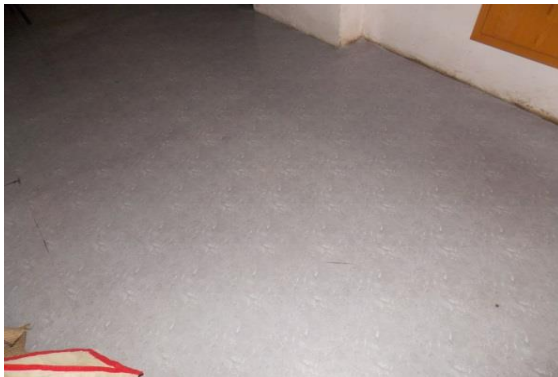
Photo 9
Covered with mat, Floor of Part-B of Shop No.72
Ground Floor

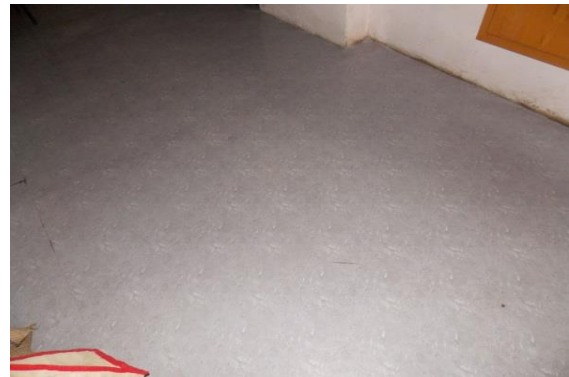
Photo 10
Covered with mat, Floor of Part-C of Shop No.72
Ground Floor

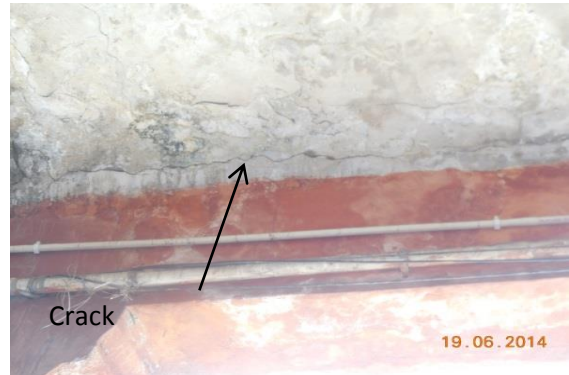
Photo 2

Horizontal Crack on Roof of Vrandah of Shop No. 76, Ground Floor, Approx. Width = 1.0mm, Approx. Length = 1.50m. Distance from Left Column = 1.0m, Height from Floor = 3.0m.

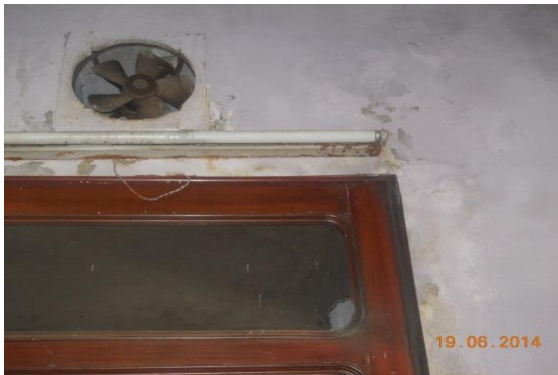
Photo 3

Dampness/Seepage on Wall No.4 of Part-B of Shop No.76, Ground Floor

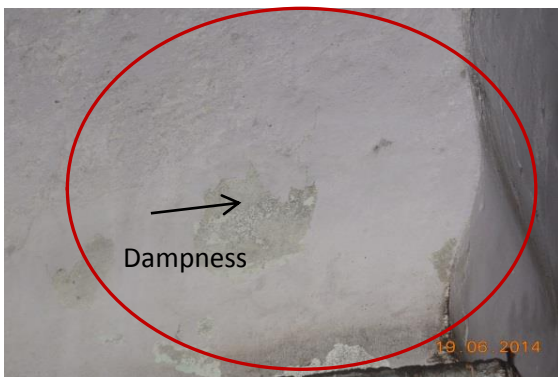
Photo 5

Dampness/Seepage on Roof of Part-B of Shop No.76, Ground Floor

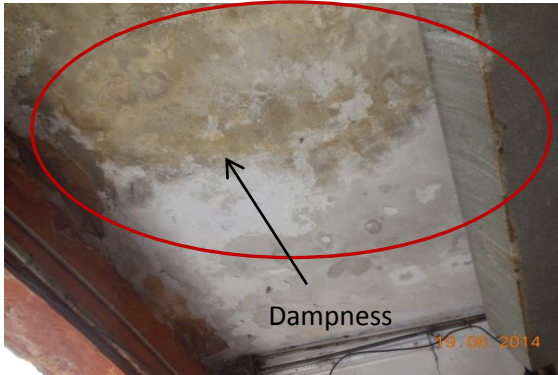
Photo 7

Dampness/Seepage on Roof of Varandah of Shop No.76, Ground Floor

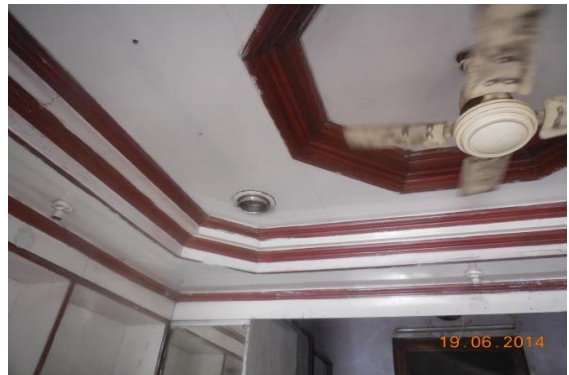
Photo 10

Covered with wooden Ceiling, Roof of Part-A of Shop No.76, Ground Floor

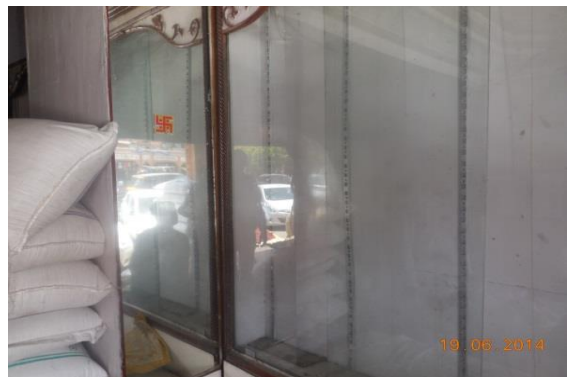
Photo 11

Covered with Wooden Work, Wall No.1 of Part-A of Shop No.76, Ground Floor

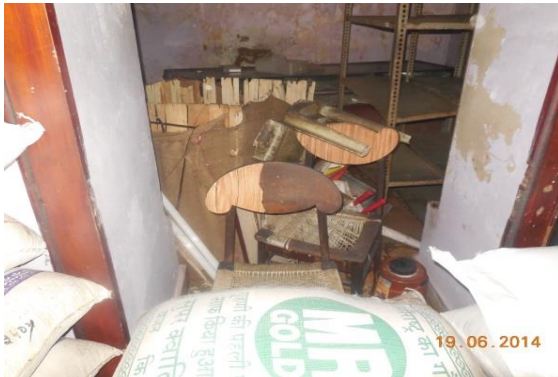
Photo 13

Covered with Material, Corridor of Part-C of Shop No.76, Ground Floor

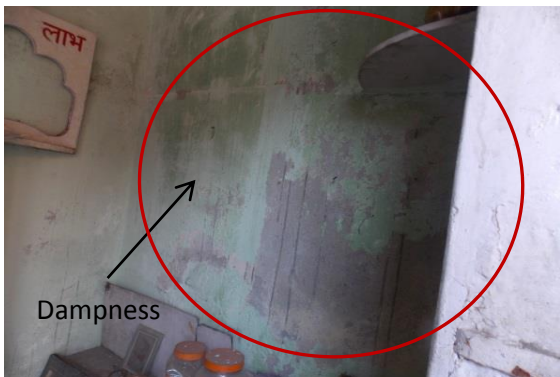
Photo 3

Dampness on Wall No. 2 of Lalit Crafts Palace, Ground Floor

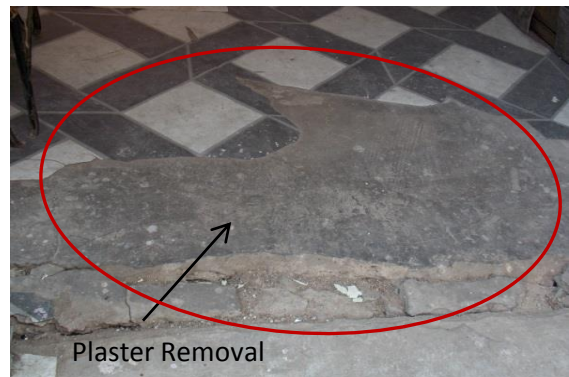
Photo 4

Plaster Removal on Floor of Lalit Crafts Palace, Ground Floor

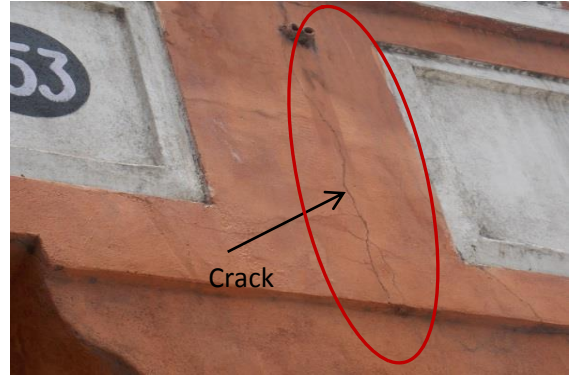
Photo 2

Inclined Crack on Varandah Right Side Column of Shop No. 153, Ground Floor, Approx. Width = 0.30mm, Approx. Length = 0.8m. Distance from Right Column = 0m, Height from Floor = 2.50m.

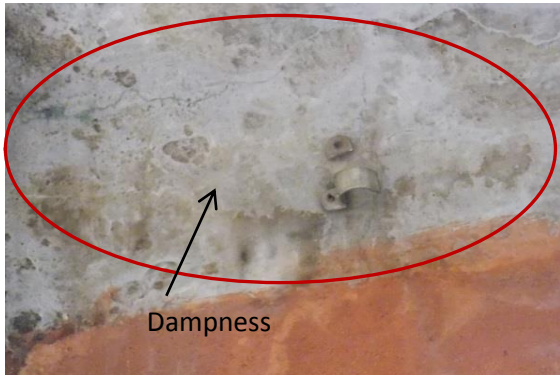
Photo 7

Dampness/Seepage on Beam of Varandah of Shop No. 153, Ground Floor

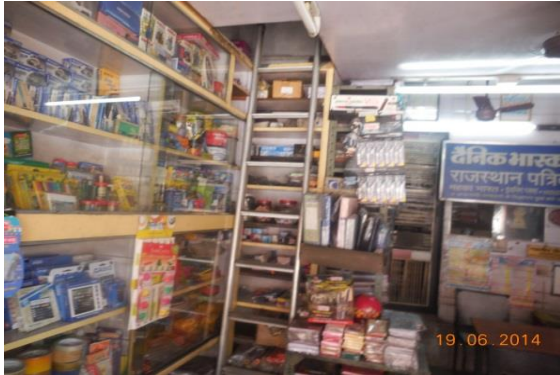
Photo 1

Covered With Material, Wall No. 4 of Part-A of Shop No. 159, Ground Floor

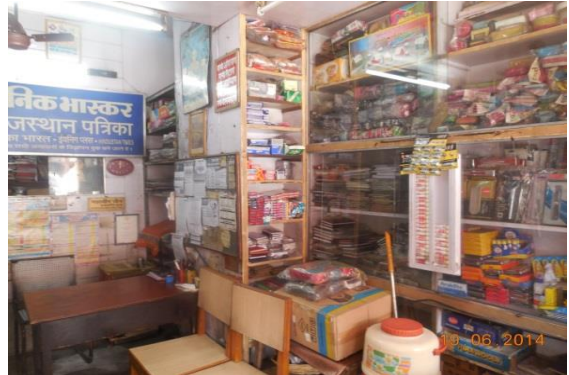
Photo 2

Covered With Material, Wall No. 2 of Part-A of Shop No. 159, Ground Floor

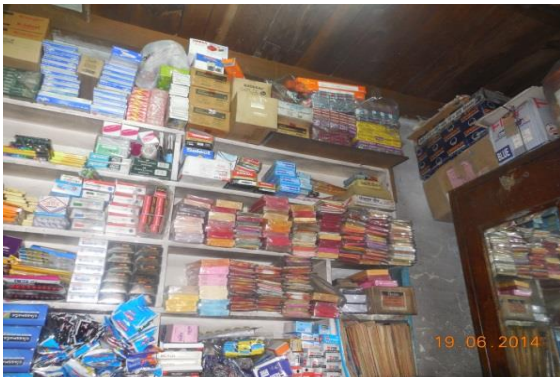
Photo 3

Covered With Material, All Walls of Part-B of Shop No. 159, Ground Floor

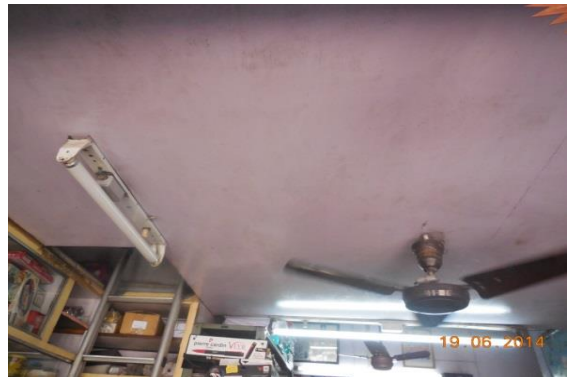
Photo 4

Covered With Wooden Ceiling, Roof of Part-A of Shop No. 159, Ground Floor

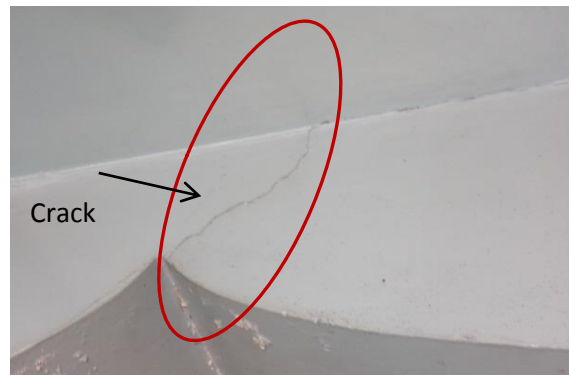
Photo 4

Inclined Crack on Wall No. 4 of Shop No. 163, Ground Floor, Approx. Width = 0.60mm, Approx. Length = 0.3m. Distance from Wall No. 1 = 2.0m, Height from Floor = 3.30m.

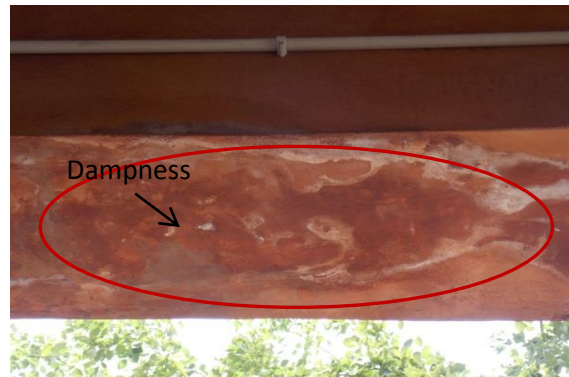
Photo 7

Dampness on Beam of Varandah of Shop No. 163, Ground Floor

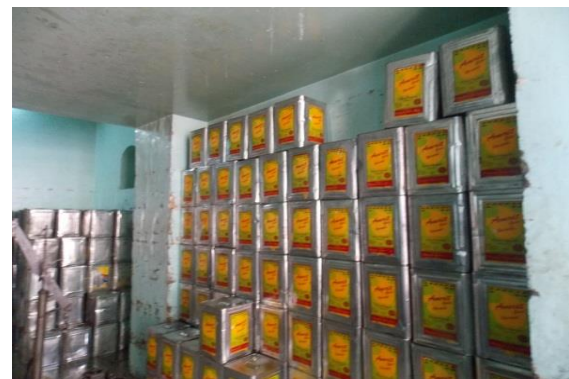
Photo 9

Covered With Materials, Wall No. 1 of Part B of Shop No. 163, Ground Floor

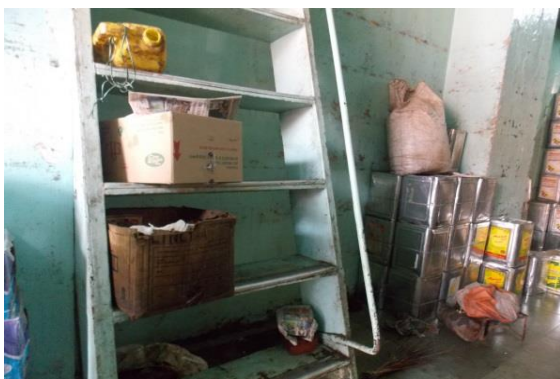
Photo 10

Covered With Materials, Wall No. 2 of Part B of Shop No. 163, Ground Floor

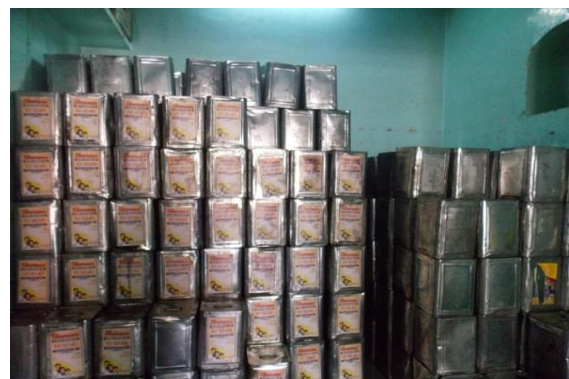
Photo 11

Covered With Materials, Wall No. 4 of Part C of Shop No. 163, Ground Floor

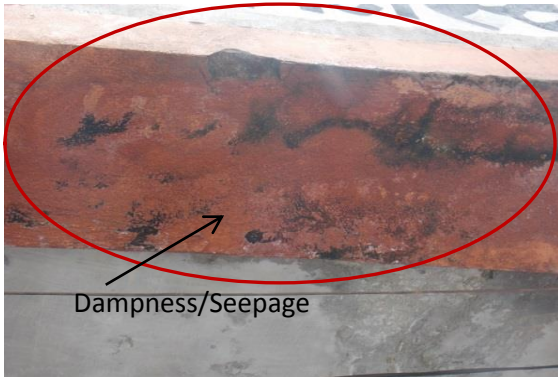
Photo 3

Dampness/Seepage on Beam of Varandah of Shop No. 177B, Ground Floor

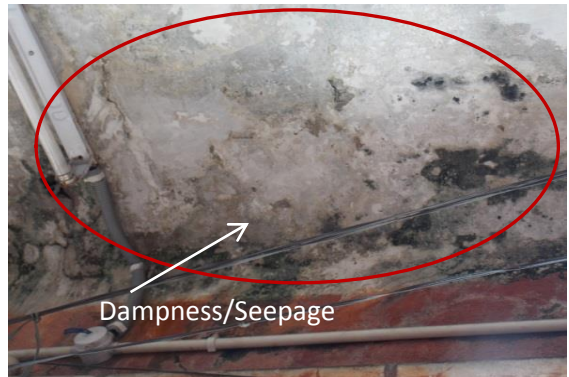
Photo 4

Dampness/Seepage on Roof of Varandah of Shop No. 177B, Ground Floor

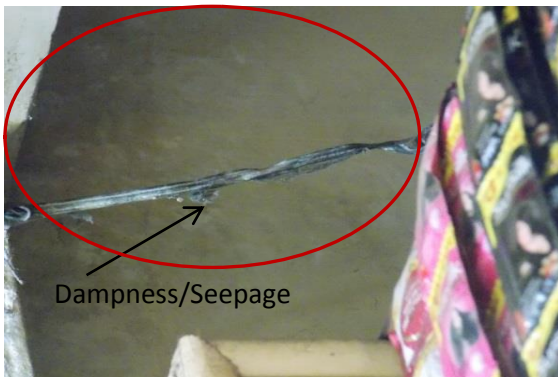
Photo 5

Dampness/Seepage on Wall No. 1 of Shop No. 177B, Ground Floor

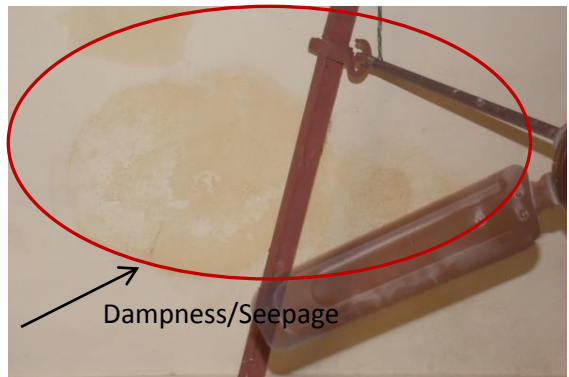
Photo 6

Dampness/Seepage on Roof of Shop No. 177B, Ground Floor

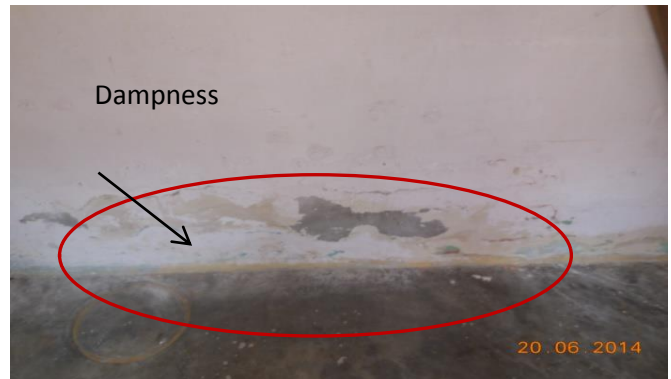
Photo 2
Dampness on Wall No. 4 of Shop No. 4, Ground Floor

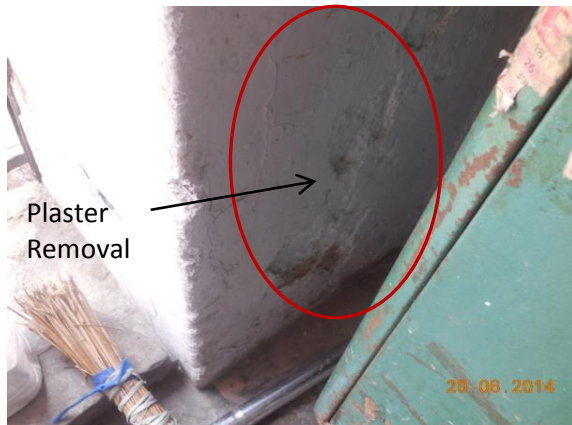
Photo 3
Plaster Removal of wall no.3, shop no.4, Ground Floor

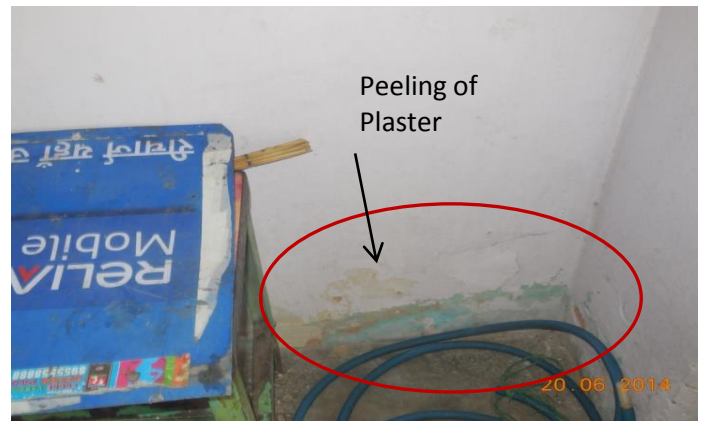
Photo 4
Peeling of plaster from wall no.2, shop no.4, Ground Floor

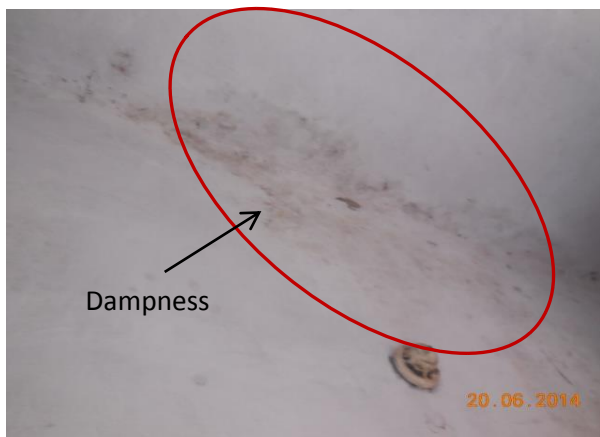
Photo 5
Dampness on roof, shop no.1, Ground Floor

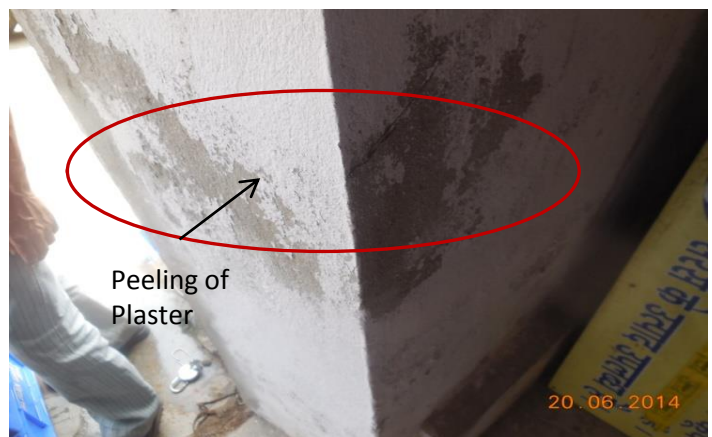
Photo 6
Peeling of plaster from wall no.3, shop no.1 Ground Floor

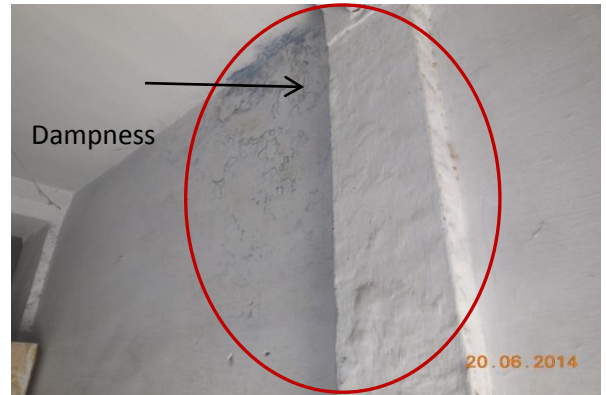
Summary of Defects Other Than Crack			
Defect ID	Location	Description	Photo No.
1	Wall No. 2 of Shop No. 325, Ground Floor	Dampness/Seepage	2

Photo 1
Dampness/Seepage on Wall No. 2 of Shop No. 325, Ground Floor

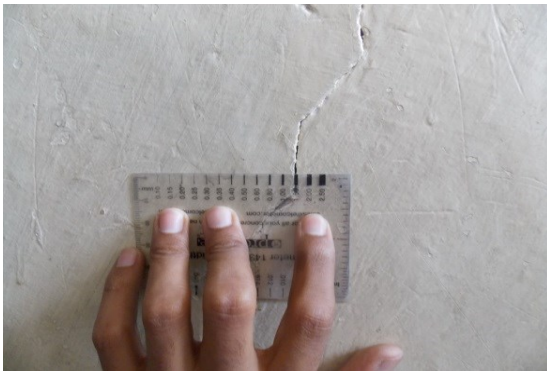
Photo 6B

Inclined Crack on Wall No.2 of Staircase of House above Shop No.59,(F.F.) Approx. Width=1.5mm, Approx.Length=3.0m. Distance from Wall No. 4 = 1.3m, Height from Floor = 0.5m.

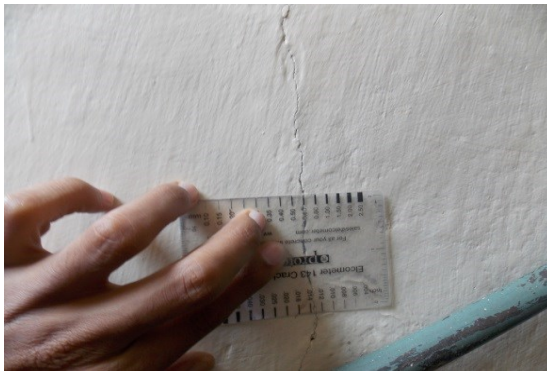
Photo 7B

Inclined Crack on Wall No.1 of Staircase of House above Shop No.59,(F.F.),Approx. Width=0.6mm, Approx.Length=3.0m. Distance from Wall No. 4 = 1.2m, Height from Floor = 0.0m.

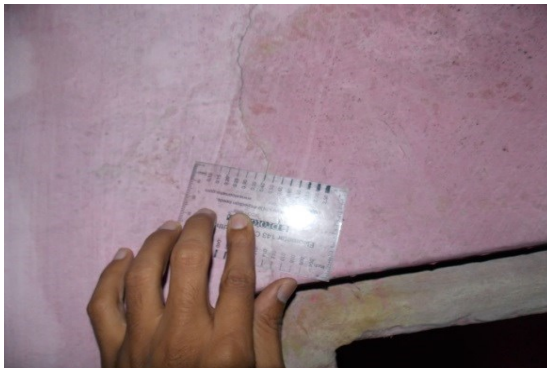
Photo 8B

Inclined Crack on Wall no. 4 of Lobby of House above Shop No.59, (F.F.),Approx. Width=0.4mm,Approx. Length=1.20m. Distance from Wall No.1= 0.6m, Height from Floor = 1.9m.

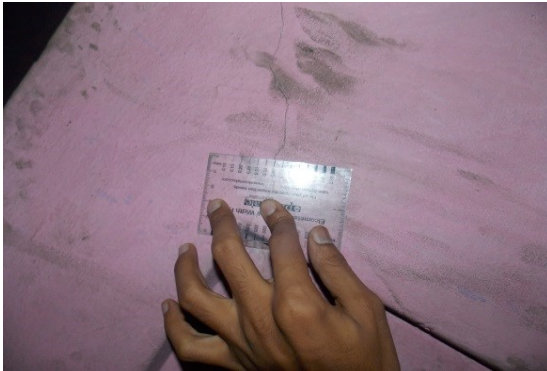
Photo 9B

Inclined Crack on Wall no. 3 of Lobby of House above Shop No.59, (F.F.), Approx. Width=0.4mm, Approx. Length=0.50m.
Distance from Wall No.1= 0.8m, Height from Floor = 1.95m.

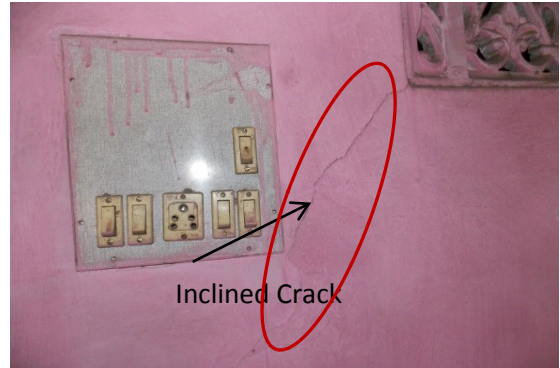
Photo 10A

Inclined Crack on Wall no. 3 of Room No. 1 of House above Shop No.59, (S.F.), Approx. Width=1.0mm, Approx. Length = 1.0m.
Distance from Wall No.1= 1.3m, Height from Floor = 1.5m.

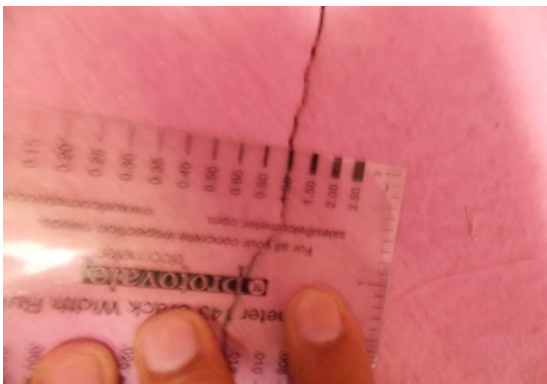
Photo 10B

Inclined Crack on Wall no. 3 of Room No. 1 of House above Shop No.59, (S.F.), Approx. Width=1.0mm, Approx. Length = 1.0m.
Distance from Wall No.1= 1.3m, Height from Floor = 1.5m.

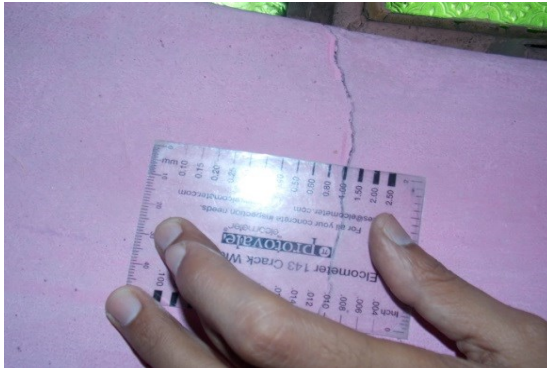
Photo 13B

Horizontal Crack on Wall no. 4 of Room No. 1 of House above Shop No.59, Second Floor, Approx. Width = 1.0mm, Approx. Length = 0.4m. Distance from Wall No.1= 1.3m, Height from Floor = 1.6m.

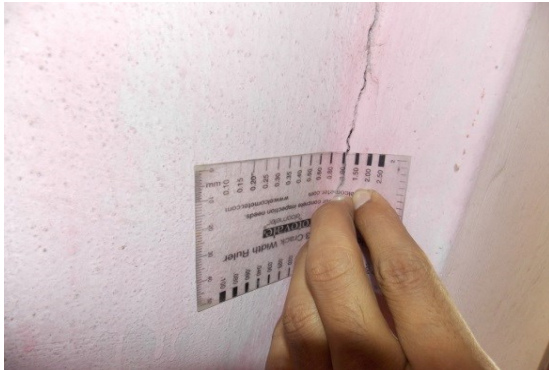
Photo 15B

Vertical Crack Between Wall no. 1 & Column of Room No. 2 of House above Shop No.59, Second First Floor, Approx. Width = 0.6mm, Approx. Length = 0.4m. Distance from Wall No.2= 1.0m, Height from Floor = 1.7m

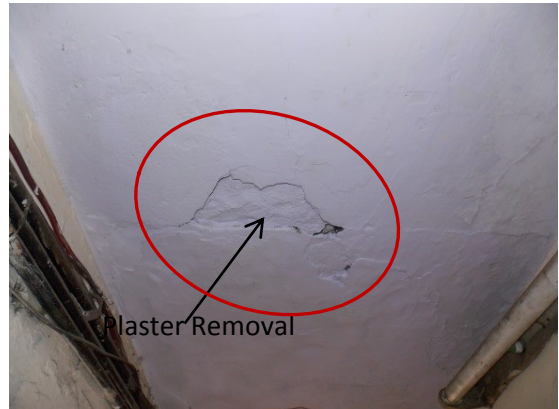
Photo 21
Plaster Removal on Roof of Stair of House above Shop No.59,
First floor

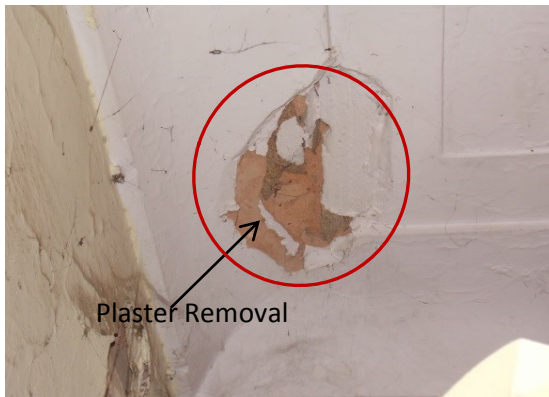
Photo 22A
Plaster Removal on Roof of Gallery of House above Shop No.59,
First floor

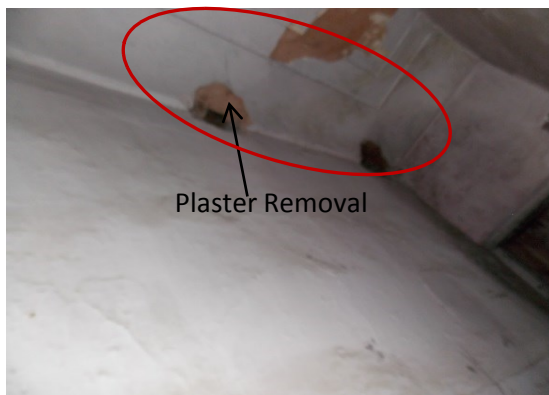
Photo 23A
Plaster Removal on Wall No.1 of Gallery of above Shop No.59,
First floor

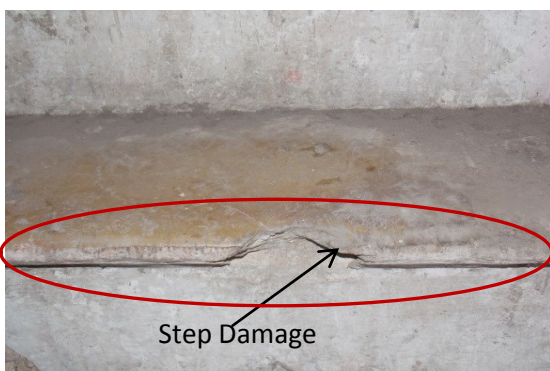
Photo 27
 Step Damage of Stair Case of House above Shop No.59, Part A, First
 floor

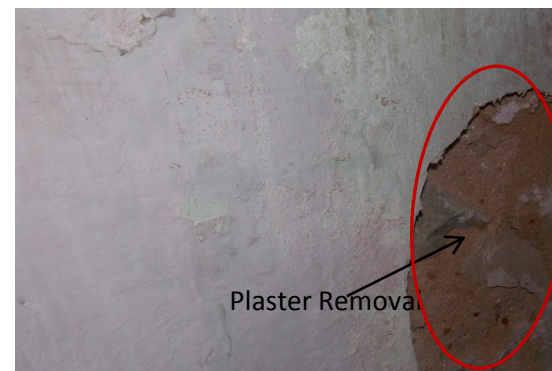
Photo 28
 Plaster Removal on Wall No. 4 of Staircase of above Shop No.59,
 First floor

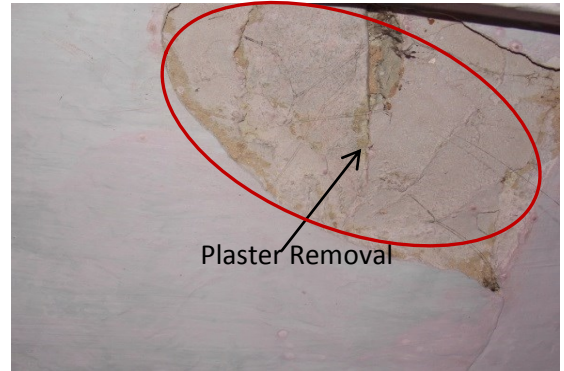
Photo 30
 Plaster Removal on Roof of Staircase of above Shop No.59,
 First floor

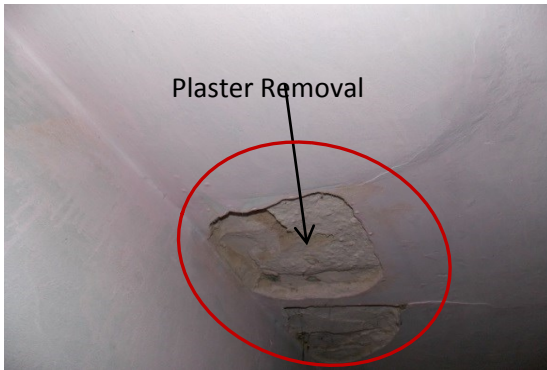
Photo 31
 Plaster Removal on Roof of Passage of above Shop No.59,
 Second floor

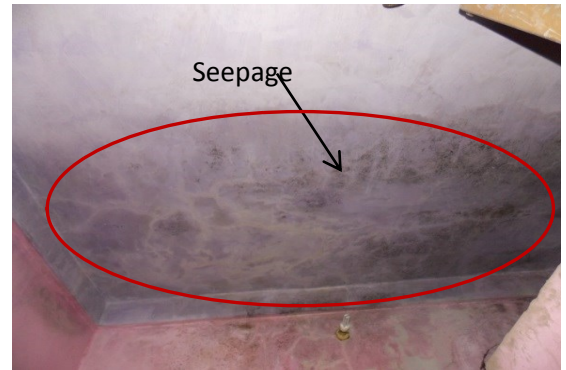
Photo 32
 Seepage on Roof of Lobby of House above Shop No.59,
 Second floor

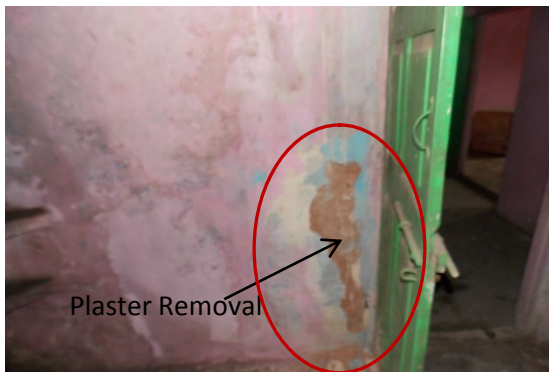
Photo 37A

Plaster Removal on Wall No.3 of Kitchen of House above Shop No.59, Second floor

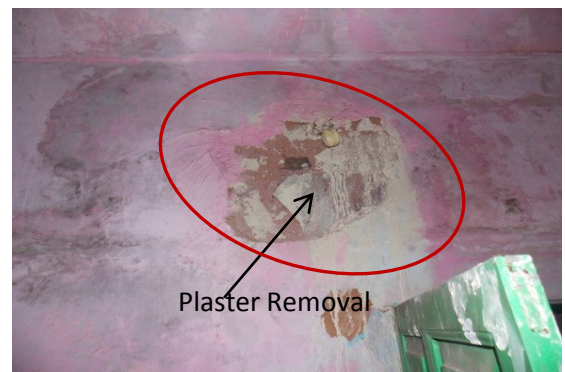
Photo 37B

Plaster Removal on Wall No.3 of Kitchen of House above Shop No.59, Second floor

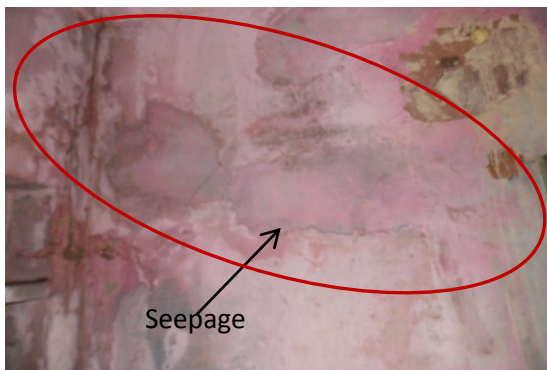
Photo 38

Seepage on Wall No.3 of Kitchen of House above Shop No.59, Second floor

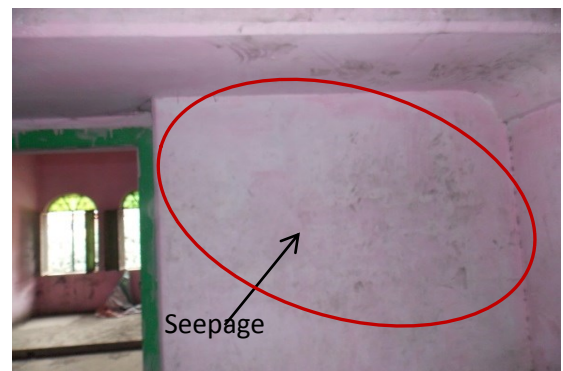
Photo 39

Seepage on Wall No.1 of Kitchen of House above Shop No.59, Second floor

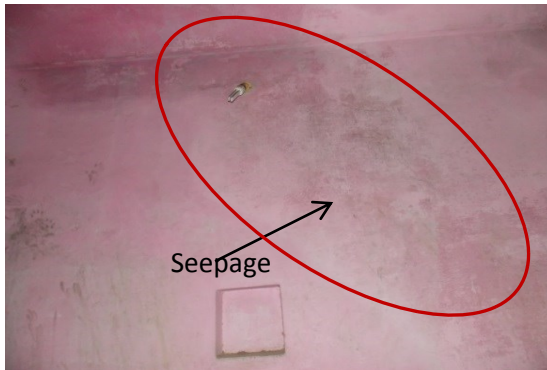
Photo 40

Seepage on Wall No.4 of Kitchen of House above Shop No.59, Second floor

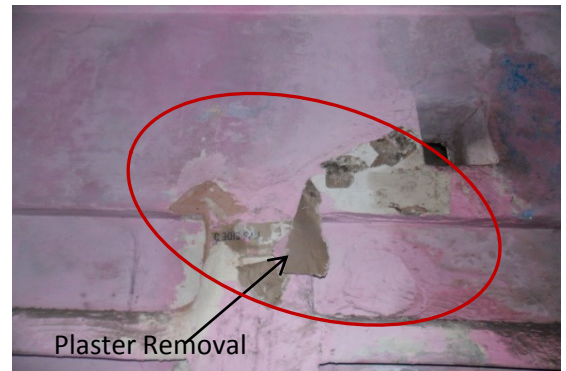
Photo 41

Plaster Removal on Wall No. 2 of Kitchen of House above Shop No.59, Second floor

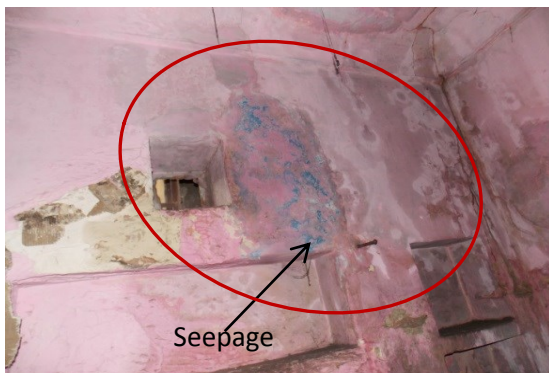
Photo 42

Seepage on Wall No. 2 of Kitchen of House above Shop No.59, Second floor

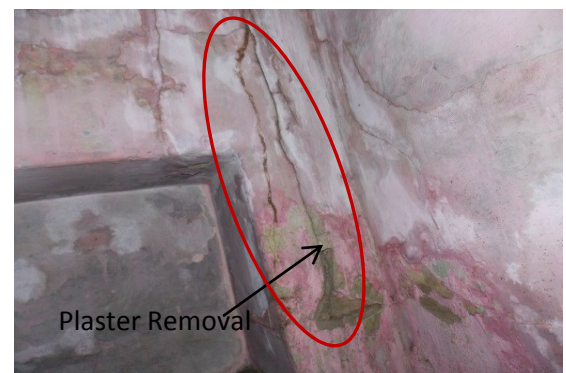
Photo 43

Plaster Removal on Wall No.2 of Kitchen of House above Shop No.59, Second Floor

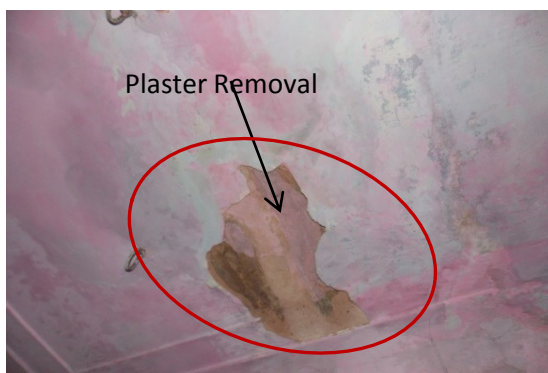
Photo 44A

Plaster Removal on Roof of Kitchen of House above Shop No.59, Second Floor

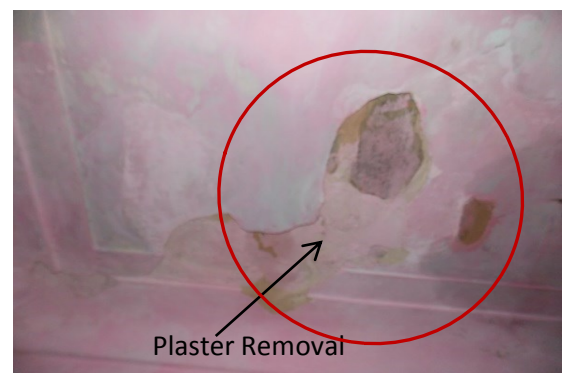
Photo 44B

Plaster Removal on Roof of Kitchen of House above Shop No.59, Second floor

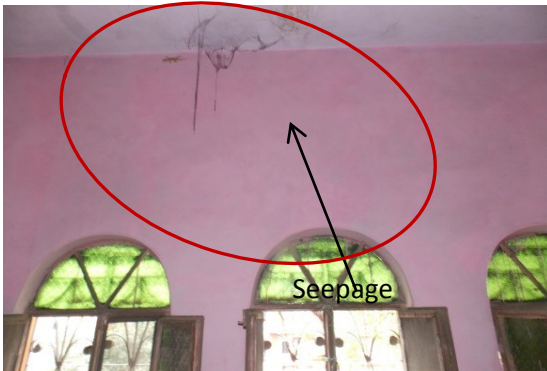
Photo 50

Seepage on Wall No. 4 of Room No.2 of House above Shop No.59, Second floor

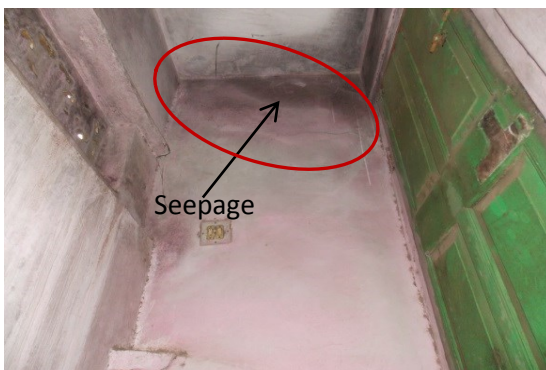
Photo 54

Seepage on Wall No.2 of Staircase SF to Terrace, Second Floor

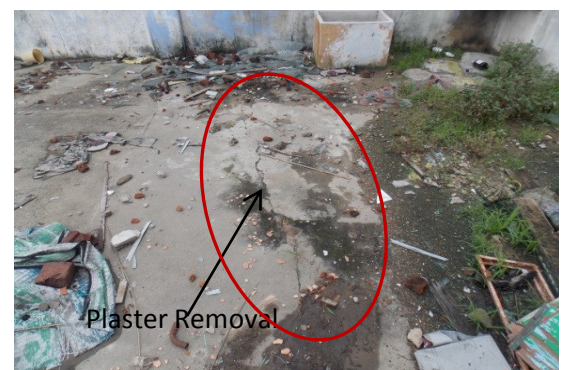
Photo 55

Plaster Removal on Floor of Terrace, Terrace

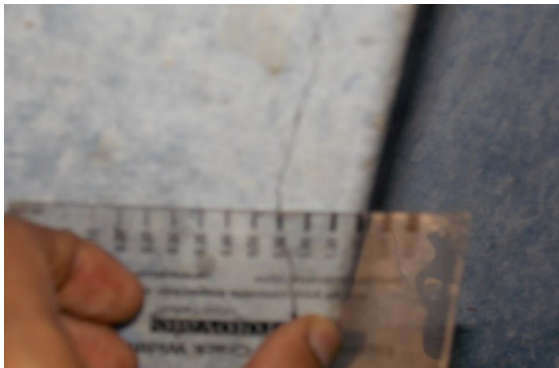
Photo 2B

Inclined Crack on Wall No.4 of Bathroom No. 1 of House No.558 Ground floor, Approx. Width=0.6mm, Approx.Length=0.3m. Distance from Wall No.1=.3m, Height from Floor=1.2m.

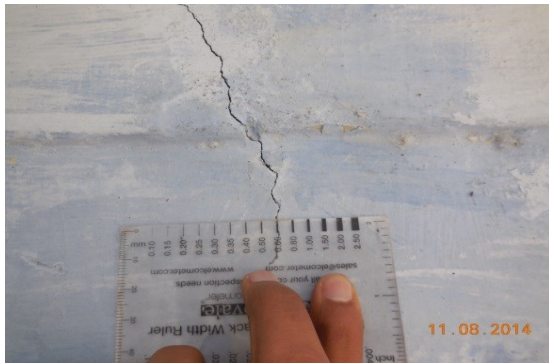
Photo 5B

Inclined Crack on Wall No.2 of Coatyrd of House No.558 Ground floor, Approx. Width=0.6mm, Approx.Length=1.3m. Distance from Wall No.4=1.2m, Height from Floor=1.9m.

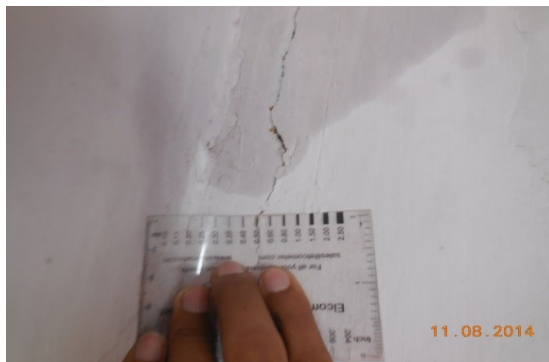
Photo 6B

Inclined Crack on Wall No.2 of Room No. 8, Part A of House No.558 First floor, Approx. Width=0.5mm, Approx.Length=2.7m. Distance from Wall No.4=0.1m, Height from Floor=0.0m.

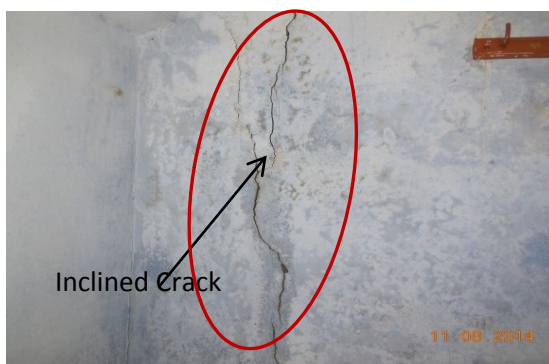
Photo 8A

Inclined Crack on Wall No.4 of Room No. 11, Part A of House No.558 First floor, Approx. Width=2.5mm, Approx.Length=1.5m. Distance from Wall No.1=0.3m, Height from Floor=0.7m.

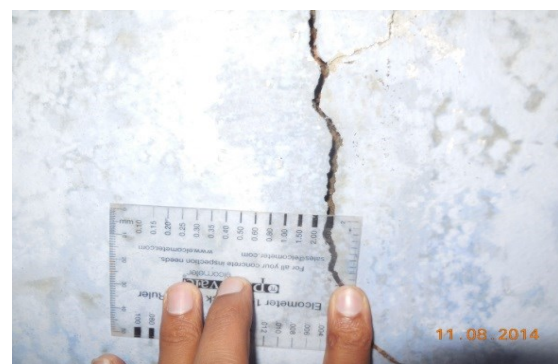
Photo 8B

Inclined Crack on Wall No.4 of Room No. 11, Part A of House No.558 First floor, Approx. Width=2.5mm, Approx.Length=1.5m. Distance from Wall No.1=0.3m, Height from Floor=0.7m.

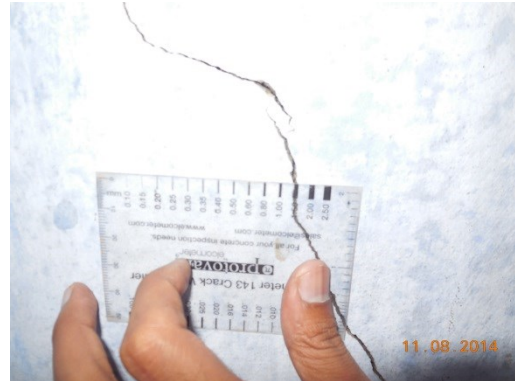
Photo 9B

Inclined Crack on Wall No.4 of Room No. 11, Part A of House No.558 First floor, Approx. Width=1.5mm, Approx.Length=1.0m. Distance from Wall No.1=0.35m, Height from Floor=0.0m.

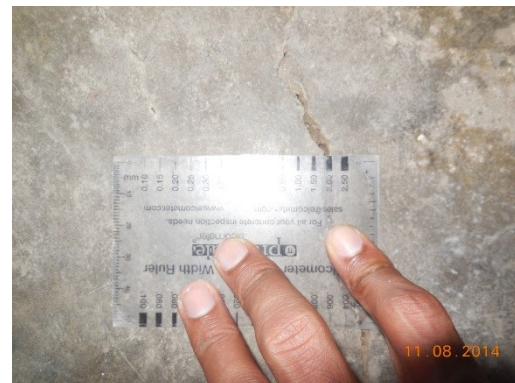
Photo 10B

Inclined Crack on Floor of Room No. 11, Part A of House No.558 First floor, Approx. Width=2.0mm, Approx.Length=2.5m. Distance from Wall No.4=0.0m, Height from Floor=0.0m.

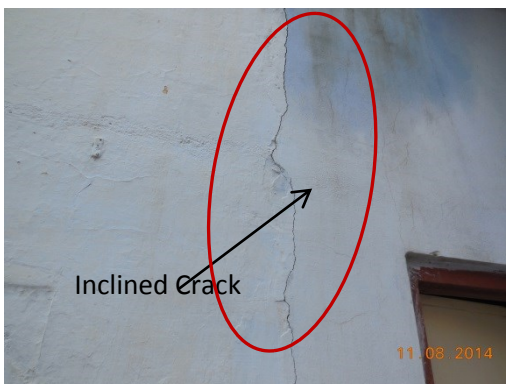
Photo 11A

Inclined Crack on Wall No. 3 of Corridor of House No.558 First floor, Approx. Width=1.5mm, Approx.Length=3.5m. Distance from Wall No.1=1.5m, Height from Floor=0.0m.

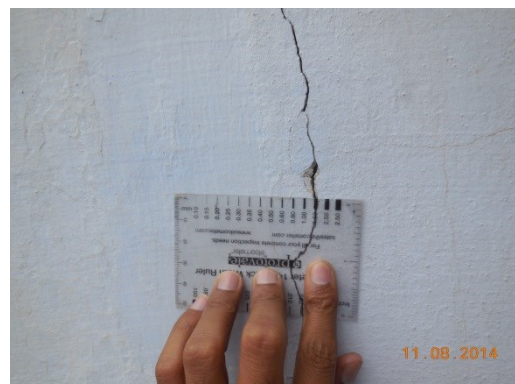
Photo 11B

Inclined Crack on Wall No. 3 of Corridor of House No.558 First floor, Approx. Width=1.5mm, Approx.Length=3.5m. Distance from Wall No.1=1.5m, Height from Floor=0.0m.

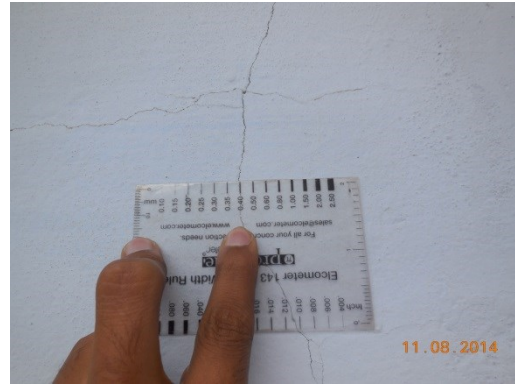
Photo 12B

Inclined Crack on Wall No. 2 of Corridor of House No.558 First floor, Approx. Width=0.4mm, Approx.Length=2.0m. Distance from Wall No.3=1.6m, Height from Floor=1.8m.

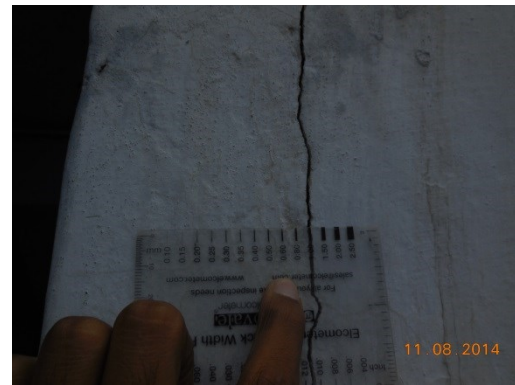
Photo 13B

Inclined Crack on Wall No. 3 of Corridor of House No.558 First floor, Approx. Width=1.0mm, Approx.Length=3.0m. Distance from Wall No.2=1.3m, Height from Floor=0.0m.

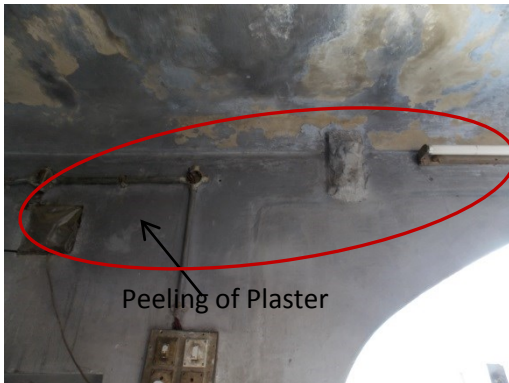
Photo 18

Peeling of Plaster on Wall No. 4 of Passage of House No.558, Ground floor

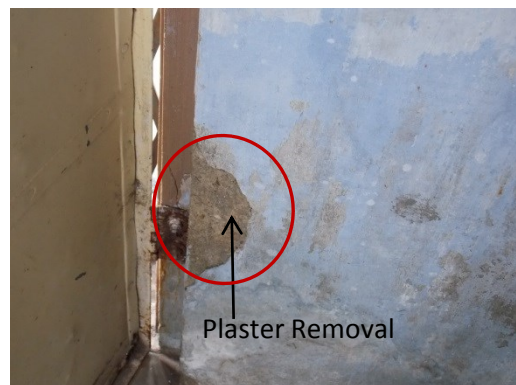
Photo 21

Plaster Removal on Wall No. 3 of Passage of House No.558, Ground floor

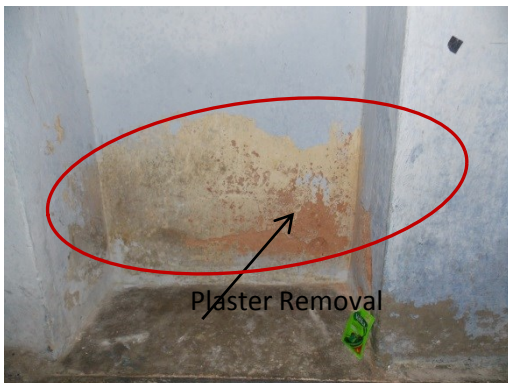
Photo 26

Plaster Removal on Wall No. 4 of Bathroom No. 2 of House No.558, Ground floor

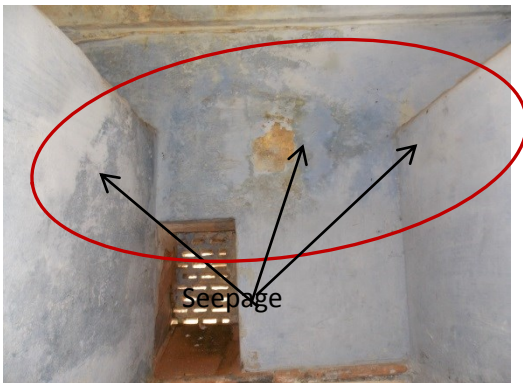
Photo 34

Seepage on All Walls of Toilet No. 2 of Lobby No.2 of H.No.558, Ground floor

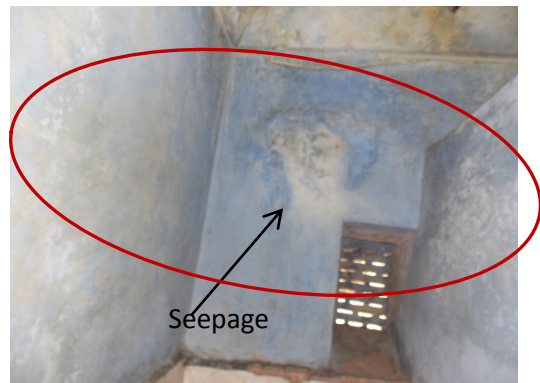
Photo 35

Seepage on All Walls of Toilet No. 3 of Lobby No. 2 of H.No.558, Ground floor

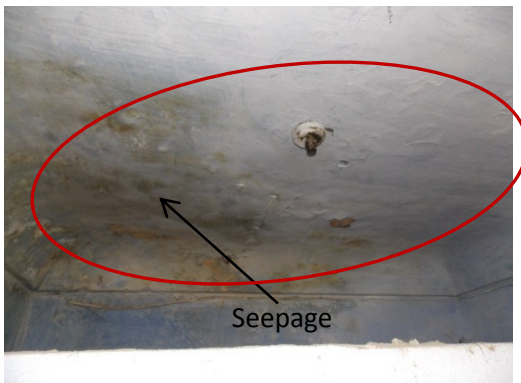
Photo 36

Seepage on Roof of Toilet No. 1, 2 & 3 of Lobby No.2 of H.No.558, Ground floor

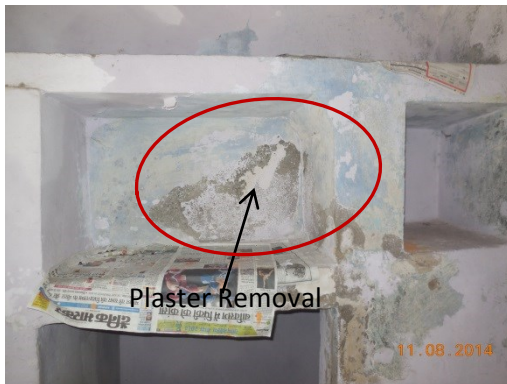
Photo 40

Plaster Removal on Wall No. 1 of Room No. 7 of House No.558, Ground floor

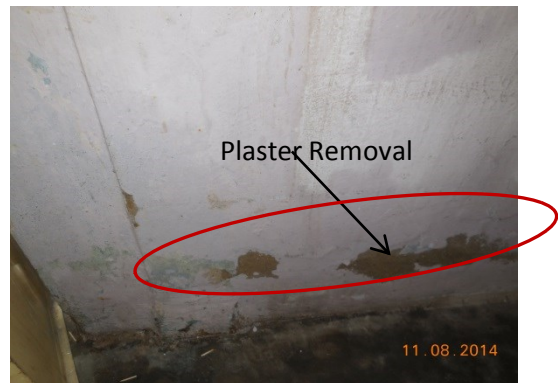
Photo 41

Plaster Removal on Wall No. 3 of Room No. 7 of House No.558, Ground floor

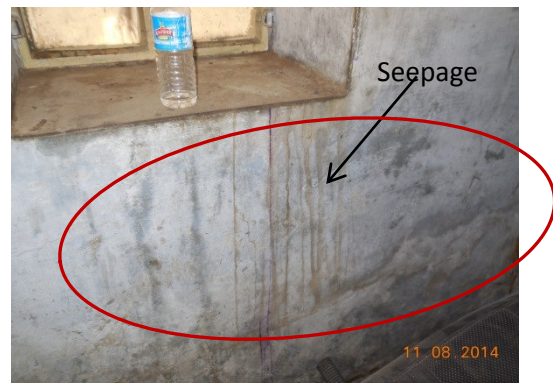
Photo 45

Seepage on Wall No.1 of Part B of Room No.1 of House No.558, Ground floor

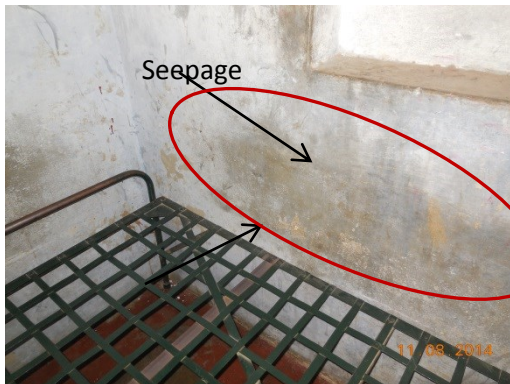
Photo 46

Seepage on Wall No. 2 of Part B of Room No. 1 of H.No.558, Ground floor

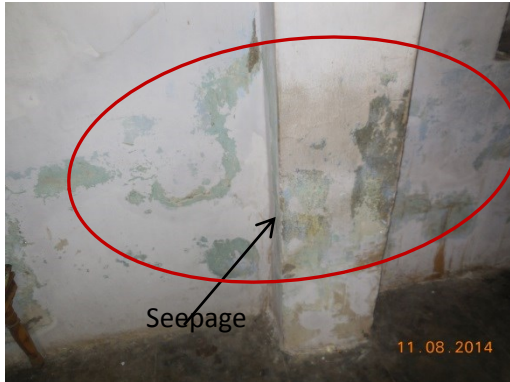
Photo 52

Seepage on Wall No. 4 of Room No. 6 of H.No.558, Ground floor

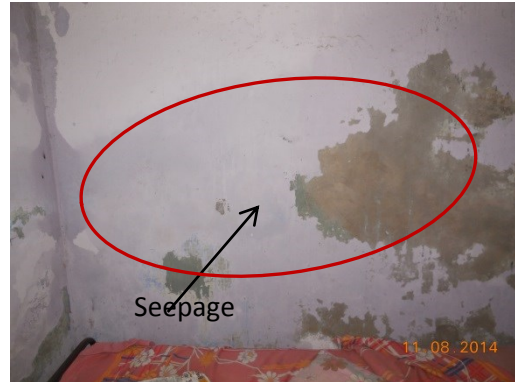
Photo 53

Seepage on Wall No.2 of Room No. 6 of H.No.558, Ground Floor

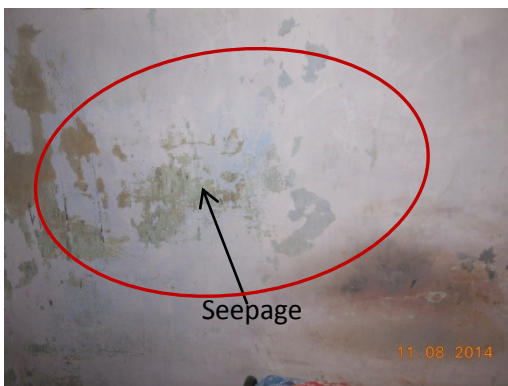
Photo 54

Seepage on Wall No.3 of Room No.6 of H.No.558, Ground floor

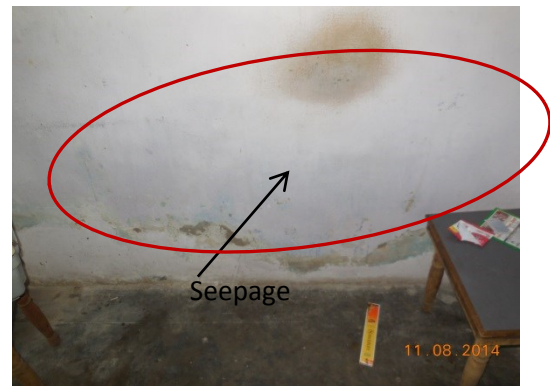
Photo 55

Seepage on Wall No.1 of Room No.6 of H.No.558, Ground floor

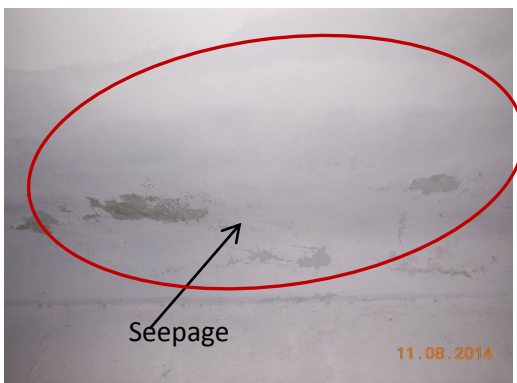
Photo 56

Seepage on Roof of Room No. 6 of House No.558, Ground floor
