JAIPUR METRO Jaipur Metro Rail Corporation

Pre - Condition Building Survey for Construction of Underground Stations from Chandpole to Bari Chouper and reversal line

Shop No.18
Chandpole Bazaar
Jaipur
Unique ID:CP CC UP 0008/18

Report Number: AIMIL/ESG/JMCEC/CP CC UP 0008-18/01, Rev. 00, Dated: July 2014

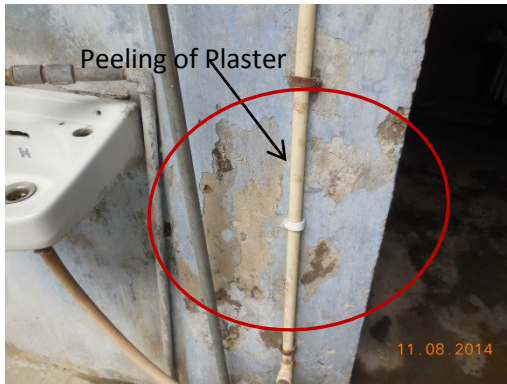
Photo 58

Peeling of Plaster on Wall No. 2 of Courtyard of House No.558, Ground floor

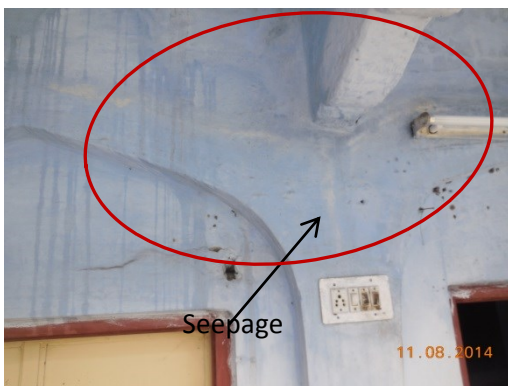
Photo 60

Seepage on Wall No.4 of Courtyard of H.No.558, Ground floor

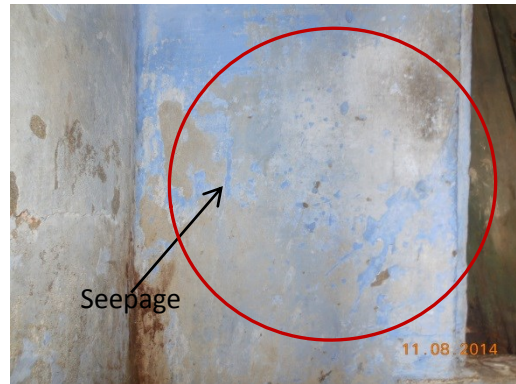
Photo 65

Seepage on Wall No.2 Stair GF to FF of H.No.558, Ground Floor

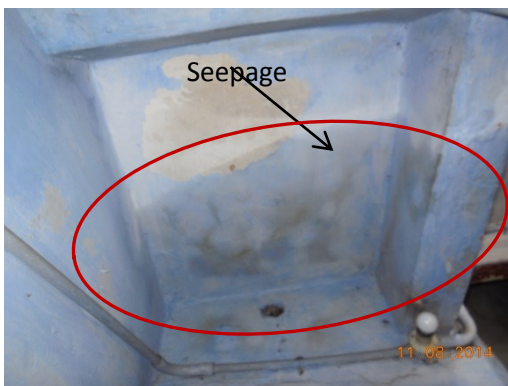
Photo 66

Seepage on Roof of Stair GF to FF of H.No.558, Ground Floor

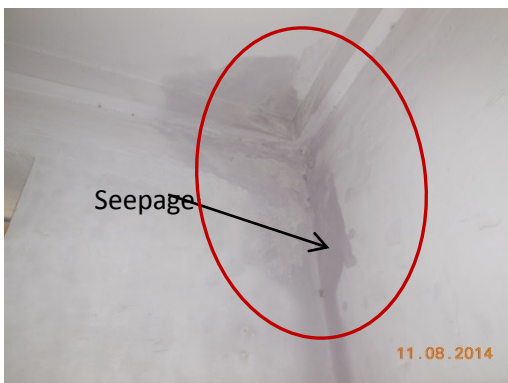
Photo 68

Seepage on Wall No.1,3 &Roof of Part A of Room No. 8, First floor

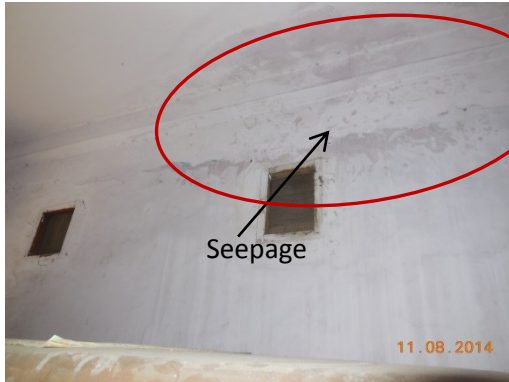
Photo 70

Seepage on Wall No.2 & Roof of Part B of Room No.8, First floor

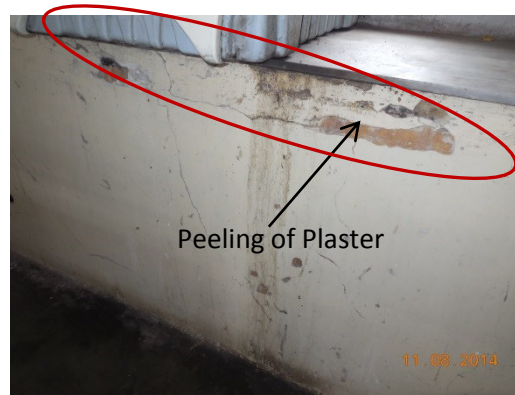
Photo 71

Peeling of Plaster on Wall No.4 of Part B of Room No.8, First floor

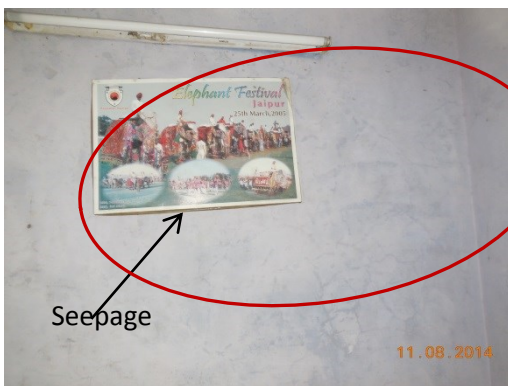
Photo 72

Seepage on Wall No.4 of Room No.14 of H.No.558, First floor

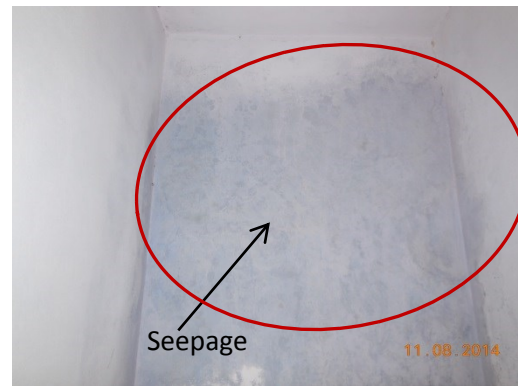
Photo 73

Seepage on Wall No.2 of Toilet & Bath No.1 of H.No.558, First floor

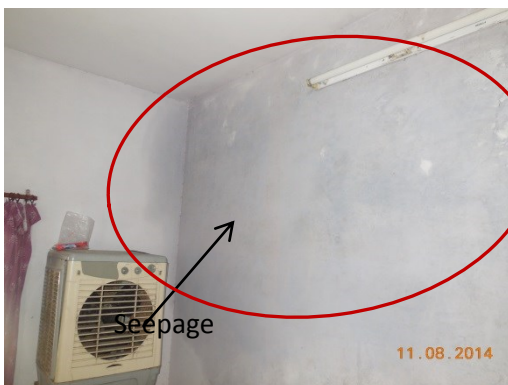
Photo 74

Seepage on Wall No.1 & 4 of Room No.13 of H. No.558, First floor

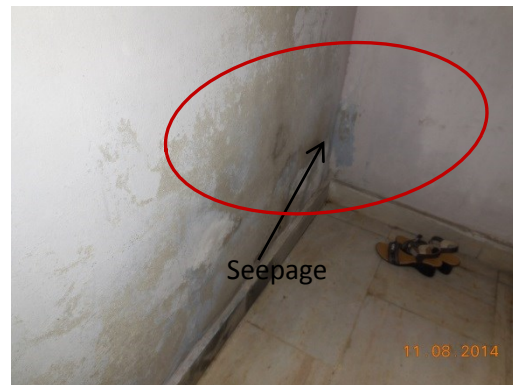
Photo 75

Seepage on Wall No.1 & 3 of Room No.13 of H. No.558, First floor

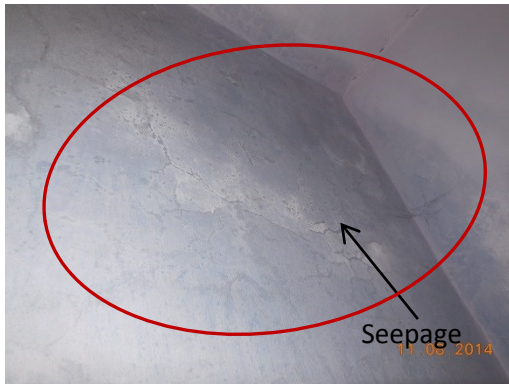
Photo 76

Seepage on Wall No. 1 & 4 & Roof of Toilet No. 4 of Room No.13 of H.No.558, First floor

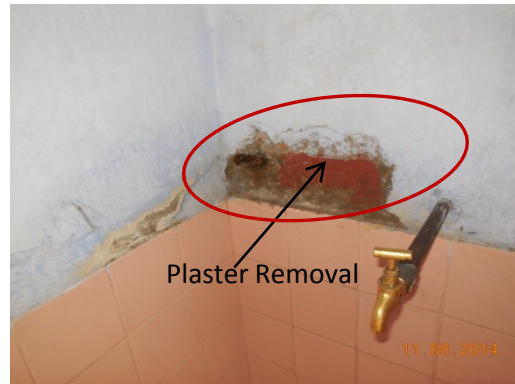
Photo 77

Plaster Removal on Wall No.2 & 4 of Bathroom No.1 of H.No.558, First floor

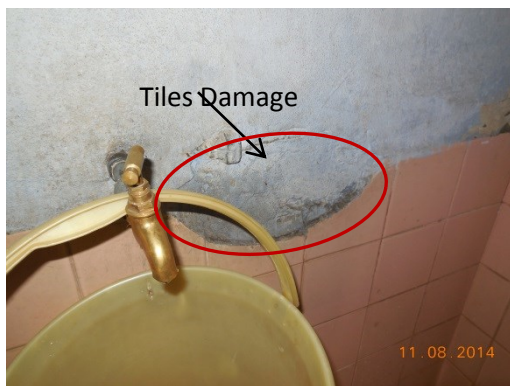
Photo 78

Tiles Damage on Wall No. 1 of Bathroom No. 2 of H.No.558, First Floor

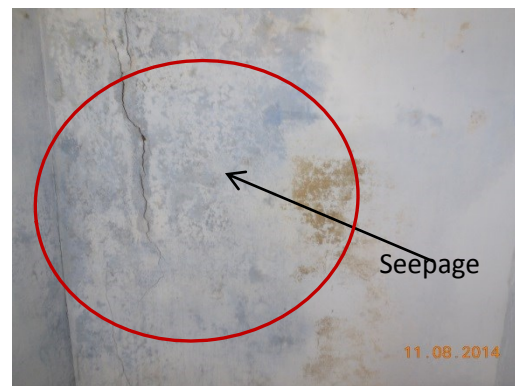
Photo 79

Seepage on Wall No.4 of Part A of Room No.11 of H. No.558, First Floor

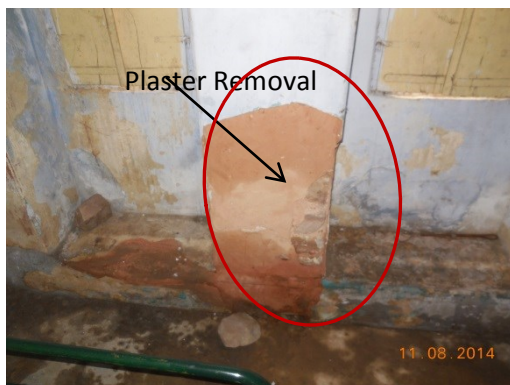
Photo 80

Plaster Removal on Wall No. 4 of Part B of Room No.11 of H.No.558, First floor

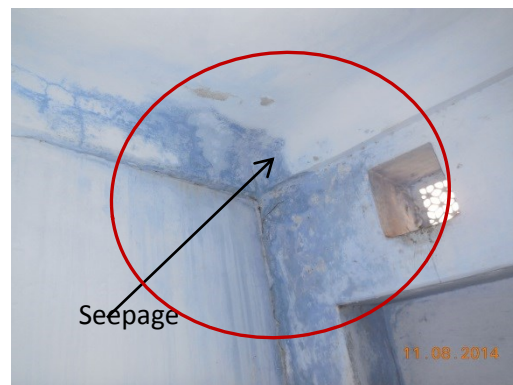
Photo 81

Seepage on Wall No.4 & Roof of Part B of Room No.11 of H.No.558, First floor

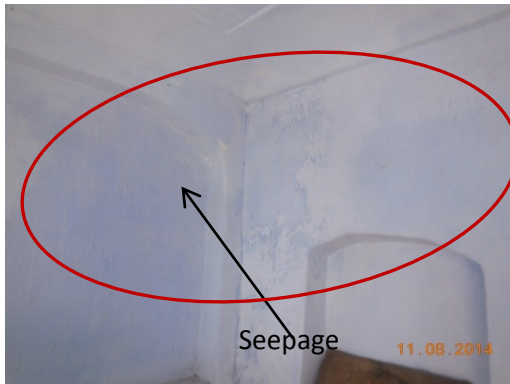
Photo 82

Seepage on Wall No. 1, 4 & Roof of Room No.10 of H.No.558, First floor

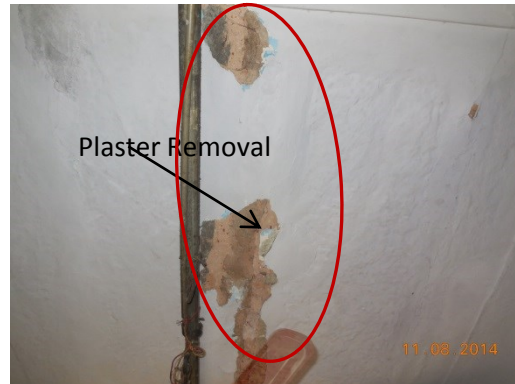
Photo 83

Plaster Removal on Roof of Room No. 15, Part B of House No.558, First floor

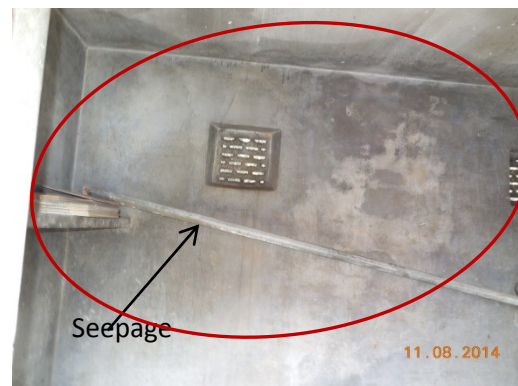
Photo 85

Seepage on All Walls of Store of House No.558, First floor

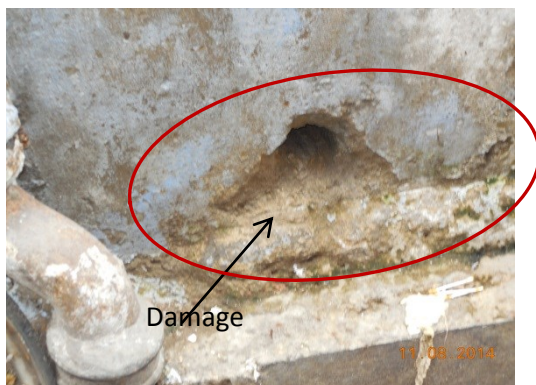
Photo 86

Damage on External Façade of House No.558, Ground floor

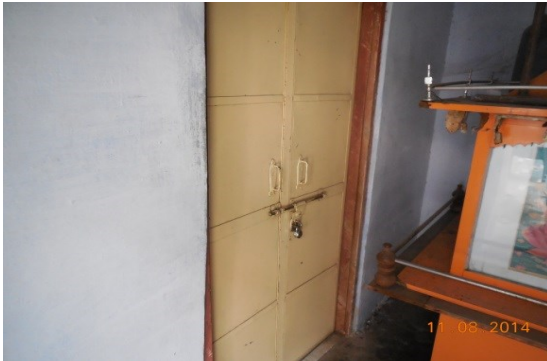
Photo 88

Locked Room No. 4 of House No. 558, Ground floor

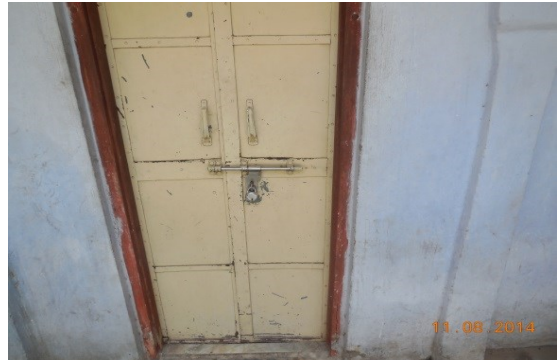
Photo 89

Locked Room No. 3 of House No. 558, Ground floor

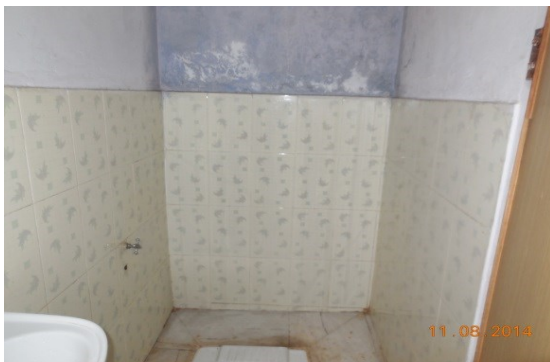
Photo 90

All Walls Covered With Tils (Partially Y) of Toilet & Bathroom No. 1 of House No. 558, First floor

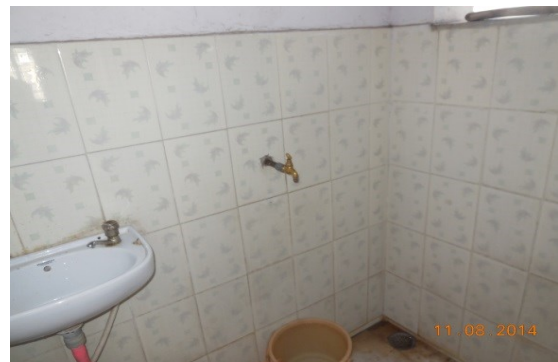
Photo 91

All Walls Covered With Tils of Bathroom of Room No. 13 of House No. 558, First floor

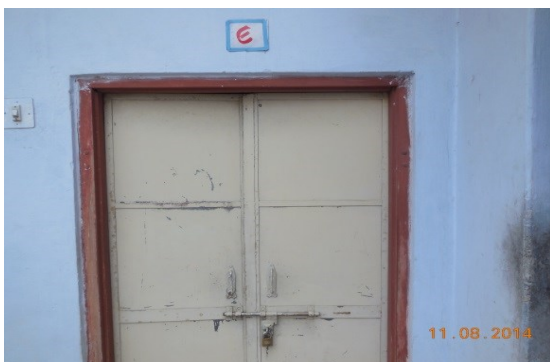
Photo 92

Locked Room No. 9 of House No. 558, First floor

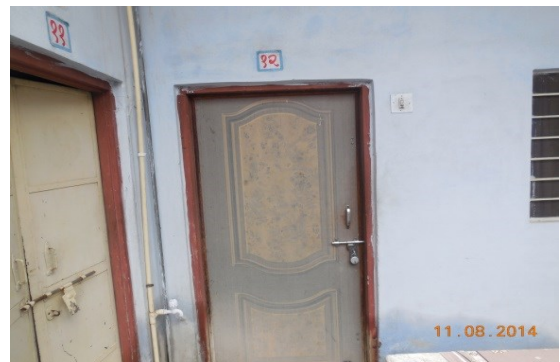
Photo 93

Locked Room No. 12 of House No. 558, First floor

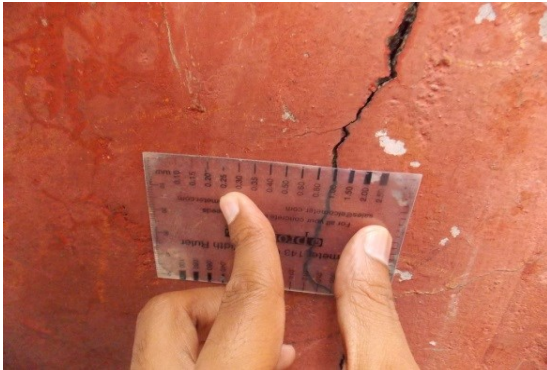
Photo 6A

Inclined Crack on Wall No.1 of Stair GF to FF, (First Floor)
Approx. Width = 1.0mm, Approx. Length = 1.20m.
Distance from Wall No. 3 = 0.30m, Height from Floor = 0m.

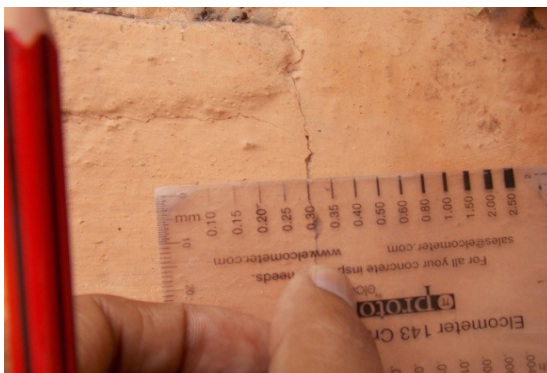
Photo 9A

Inclined Crack on Outerwall of Muthoot Finance (First Floor)
Approx. Width = 0.30mm, Approx. Length = 1.0m.
Distance from R.H.S.Wall= 2.90m, Height from Floor = 0.90m.

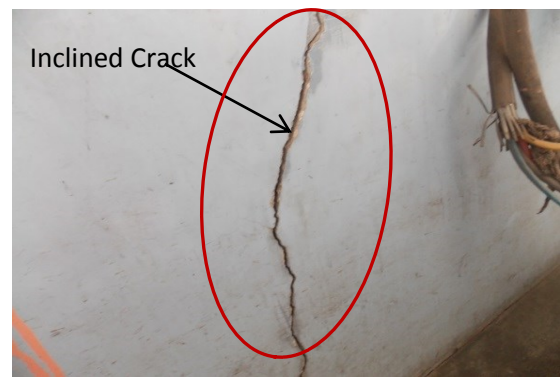
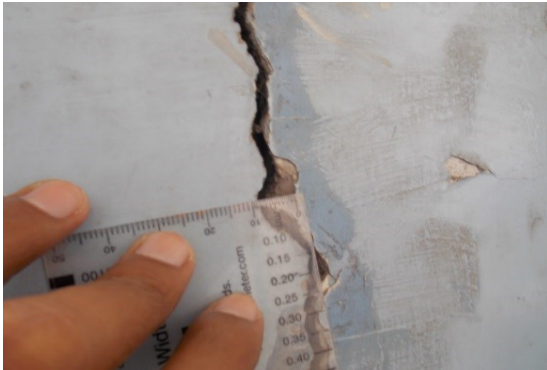
Photo 10A

Inclined Crack on Wall No. 4 of Gallery (Second Floor),
Approx. Width = 9.0mm, Approx. Length = 0.9m.
Distance from Wall No.1= 7.0m, Height from Floor = 0m.

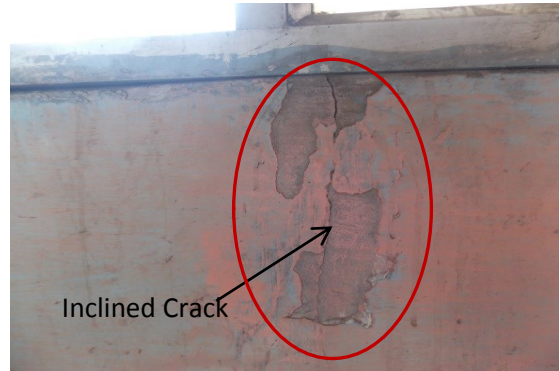
Photo 11A

Inclined Crack on Wall No. 4 of Gallery (Second Floor),
Approx. Width = 1.0mm, Approx. Length = 1.0m.
Distance from Wall No.1= 5.0m, Height from Floor = 0m.

Inclined Crack on Wall No. 4 of Gallery (Second Floor)
Approx. Width = 1.0mm, Approx. Length = 1.0m.
Distance from Wall No.1= 5.0m, Height from Floor = 0m.

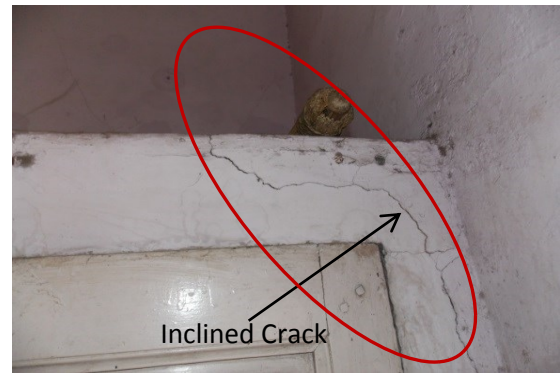
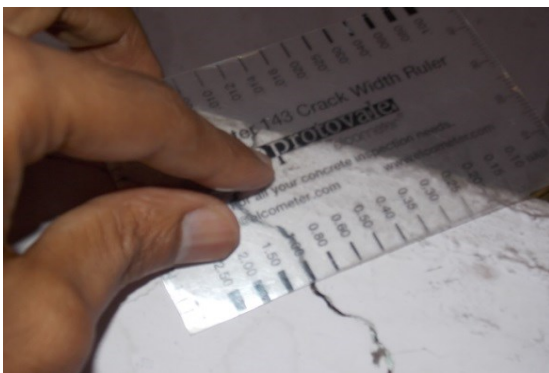
Photo 12A

Inclined Crack on Wall No. 4 of Hall No.1 (Second Floor)
Approx. Width = 1.0mm, Approx. Length = 1.70m.
Distance from Wall No.2= 0.1m, Height from Floor = 0m.

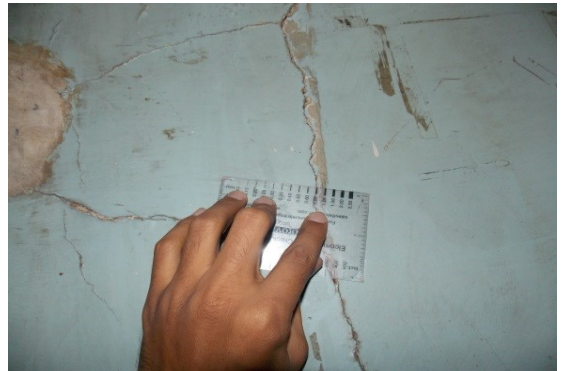
Photo 17A

Inclined Crack on Wall No.4 of Stair T.F. to 4th F.(Fourth Floor)
Approx. Width = 0.8mm, Approx. Length = 1.0m.
Distance from Wall No.1= 2.40m, Height from Floor = 2.0m.

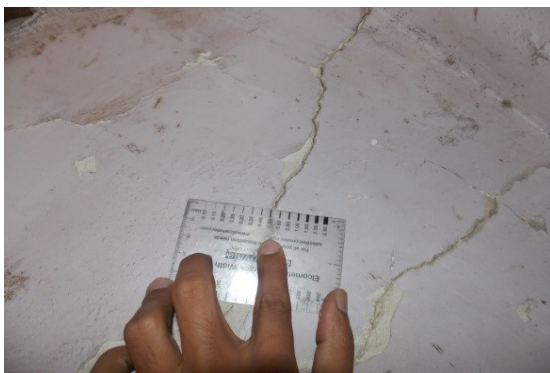
Photo 19A

Inclined Crack on Wall No.1 of Teenshade Room (Fourth Floor)
Approx. Width = 0.5mm, Approx. Length = 0.80m.
Distance from Wall No.4 = 0.5m, Height from Floor = 2.0m.

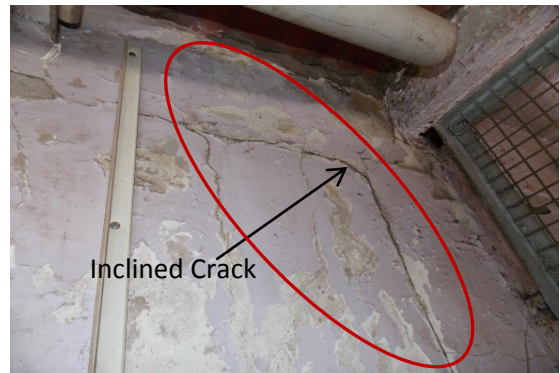
Photo 20A

Inclined Crack on Wall No.2 of Teenshade Room (Fourth Floor)
Approx. Width = 0.8mm, Approx. Length = 2.0m.
Distance from Wall No.3 = 2.0m, Height from Floor = 0.60m.

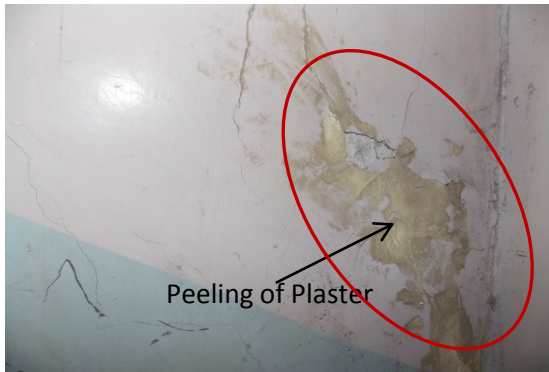
Photo 31A

Peeling of Plaster on Wall No.4 of FF to MSN Floor, First Floor

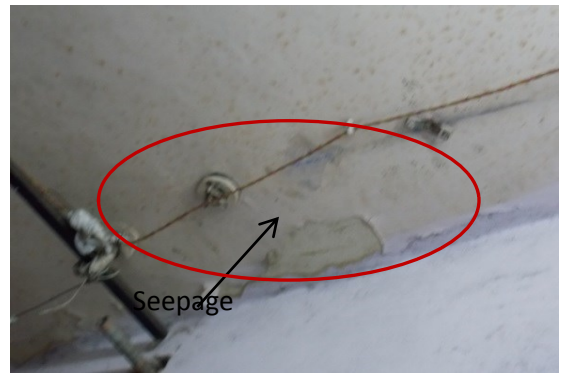
Photo 33

Seepage on Roof of Room No.4, Second Floor

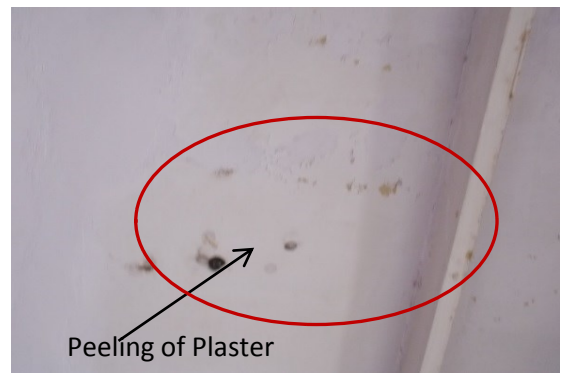
Photo 35

Peeling of Plaster on Wall No.2 of Room No.5, Second Floor

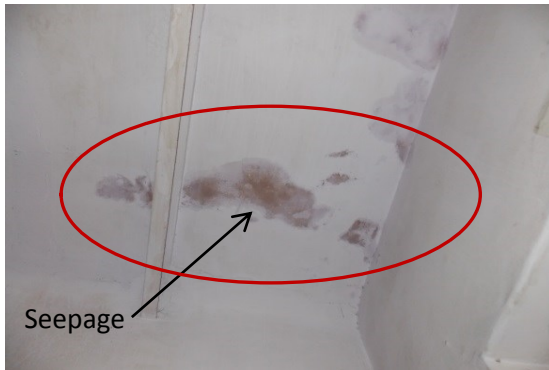
Photo 37
Seepage on Roof of Hall No.2, Second Floor

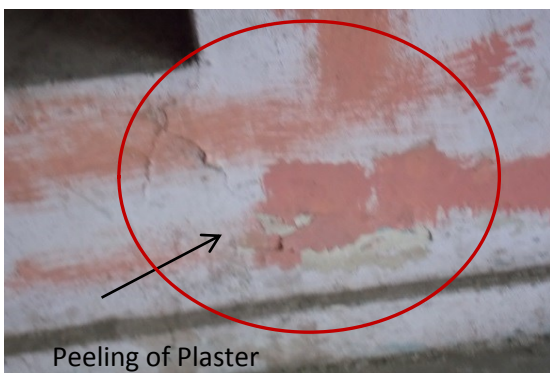
Photo 41
Peeling of Plaster on Wall No.4 of Hall No.1 (Second Floor)

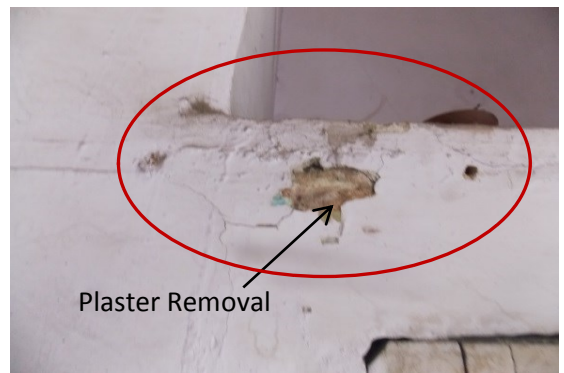
Photo 42
Plaster Removal on Wall No.4 of Hall No.1 (Second Floor)

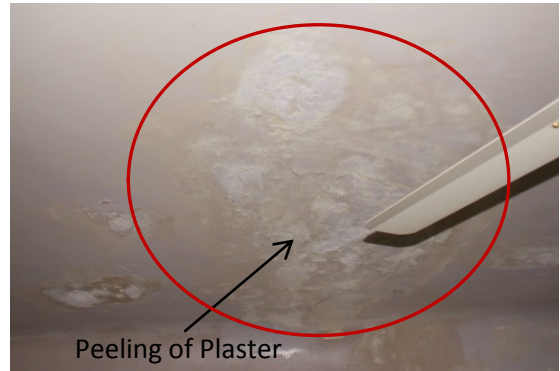
Photo 44

Peeling of Plaster on Roof of Room No.1 (Third Floor)

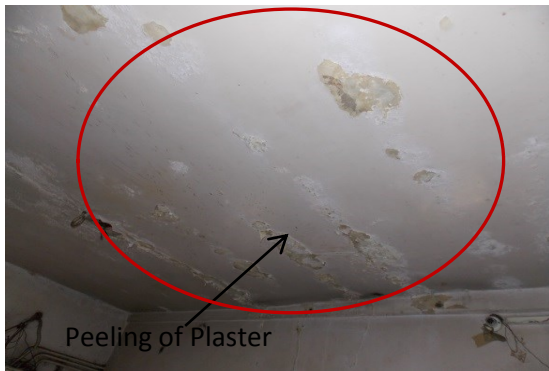
Photo 49
Peeling of Plaster on Roof of Kitchen No.1 (Third Floor)

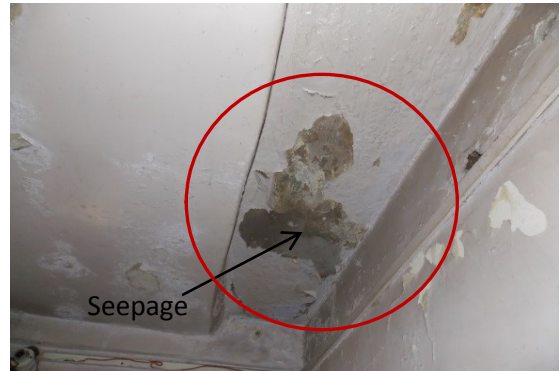
Photo 50
Seepage on Roof of Kitchen No.1 (Third Floor)

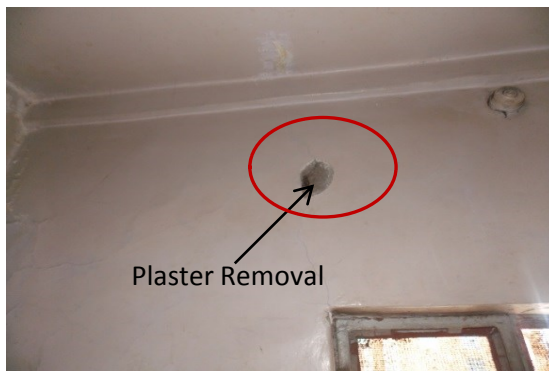
Photo 53
Plaster Removal on Wall No.4 of Kitchen No.1 (Third Floor)

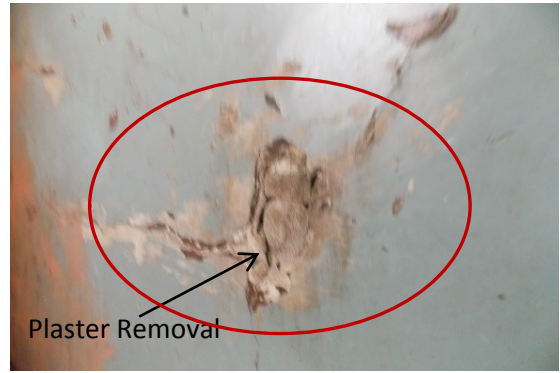
Photo 56
Plaster Removal on Wall No.4 of Stair T.F. to 4th F. (4th Floor)

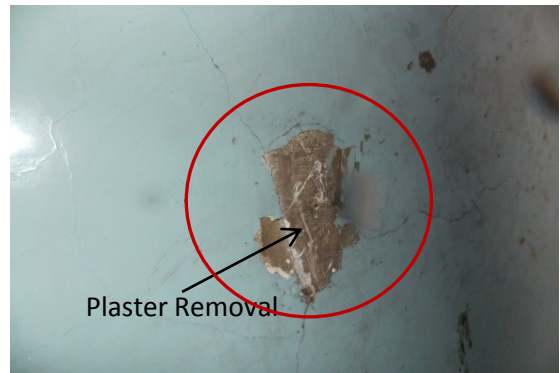
Photo 58
Plaster Removal on Wall No.4 of Stair T.F. to 4th F. (4th Floor)

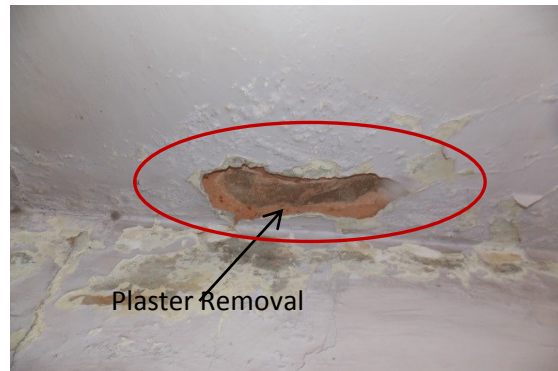
Photo 62
Plaster Removal on Roof of Lobby (4th Floor)

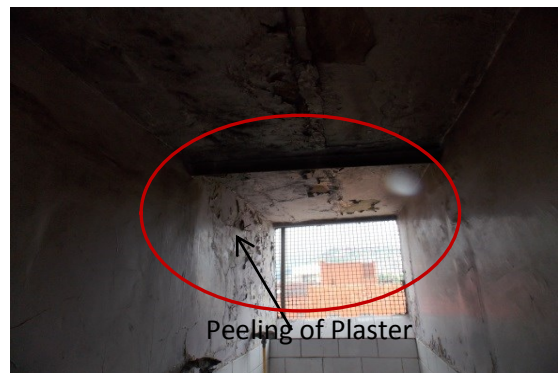
Photo 64
Peeling of Plaster on All Walls of Toilet No.1 (4th Floor)

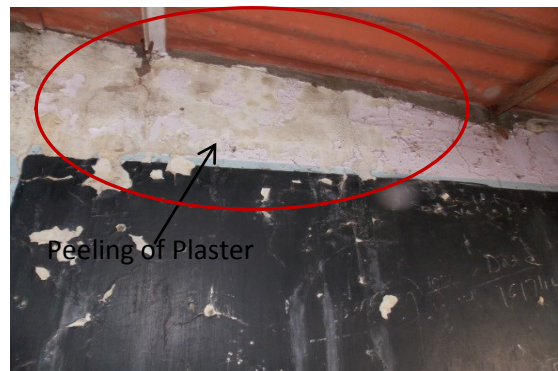
Photo 66
Peeling of Plaster on Wall No.3 of Tinshade Room (4th Floor)

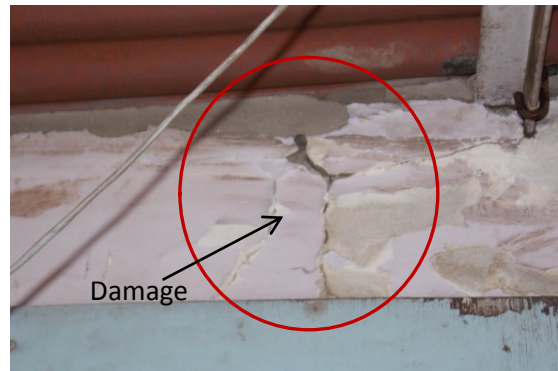
Photo 68

Damage on Wall No.4 of Tinshade Room (4th Floor)

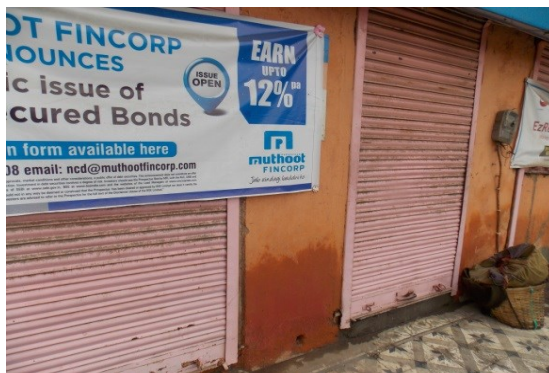
Photo 69

Locked, Room No.4, First Floor

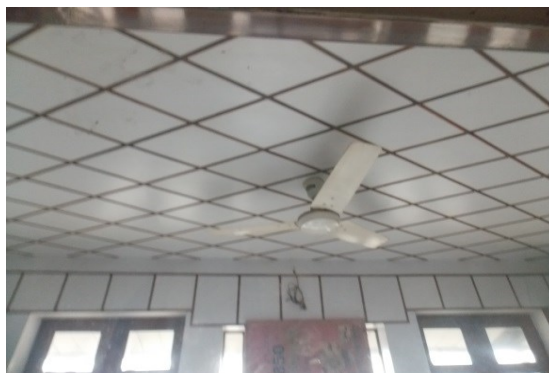
Photo 71

Covered with wooden Ceiling, Roof of Office Room, Second Floor

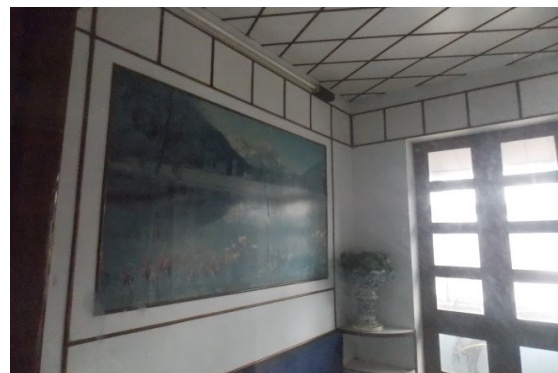
Photo 72

Covered with wooden Work, Wall No.1 of Office Room, Second Floor

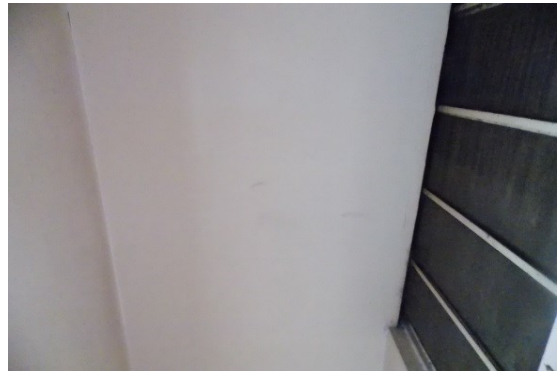
Photo 74

Covered with wooden Work, Roof of Lobby, Second Floor

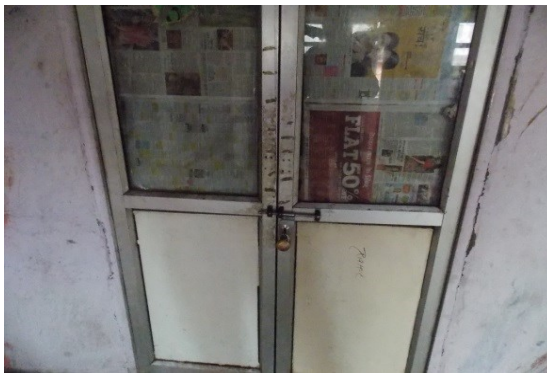
Photo 75

Locked, Room No.6, Second Floor

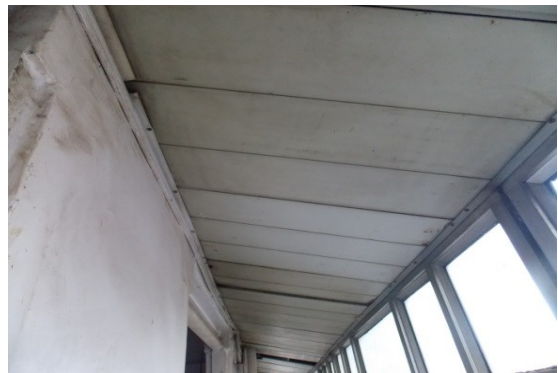
Photo 76

Covered with wooden Ceiling, Roof of Gallery, Second Floor

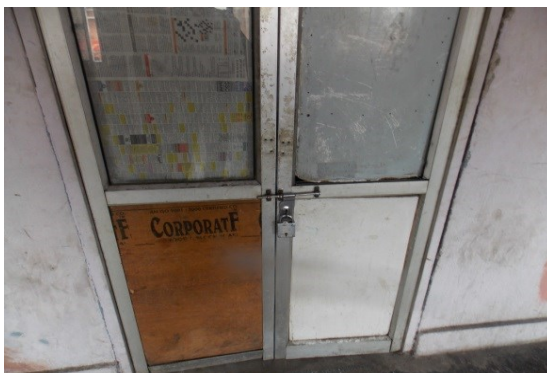
Photo 77

Locked, Room No.2, Second Floor

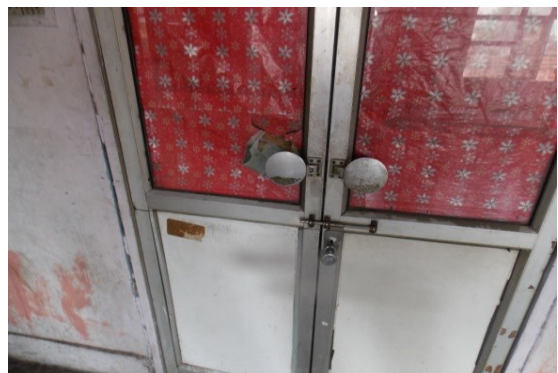
Photo 78

Locked, Room No.1, Second Floor

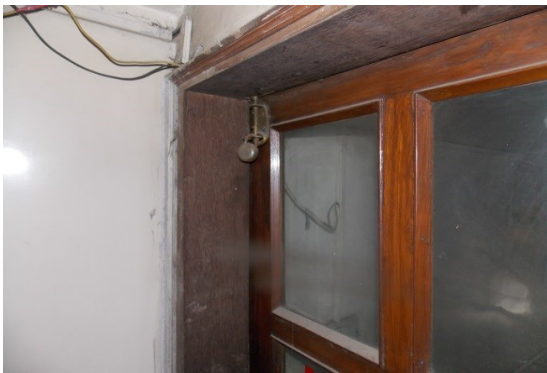
Photo 79
Locked, Room, Second Mezzanine Floor

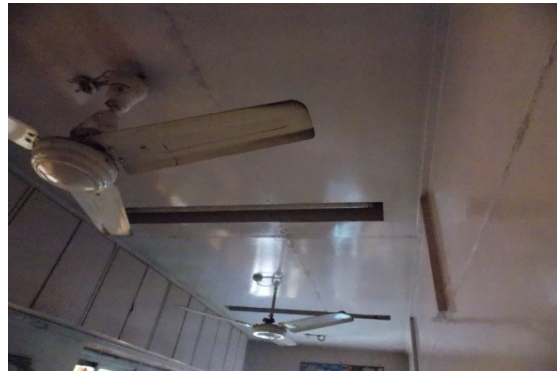
Photo 80
Covered with wooden Ceiling, Roof of Room No.2, Third Floor

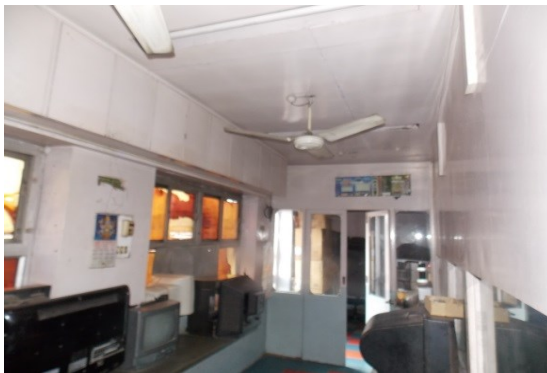
Photo 81
Covered with wooden Work, All Walls of Room No.2, Third Floor

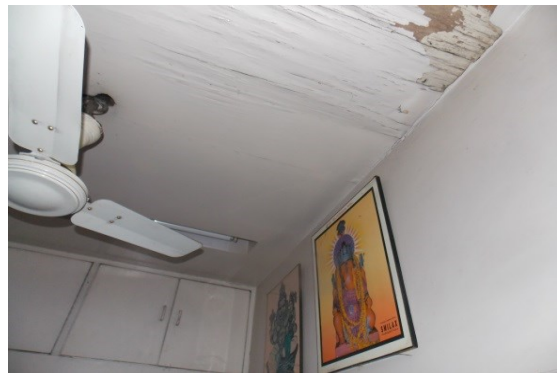
Photo 82
Covered with wooden Ceiling, Roof of Room No.4, Third Floor

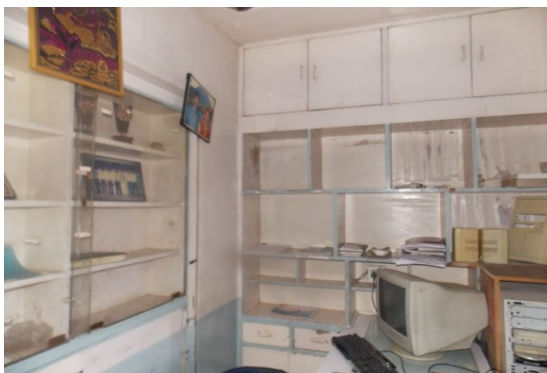
Photo 83
Covered with wooden Work, Wall No. 1 & 4 of Room No.2, Third Floor

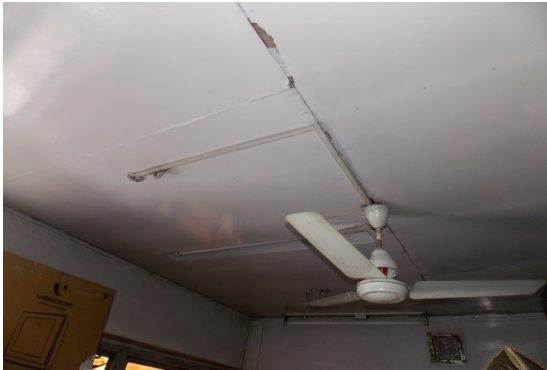
Photo 85

Covered with wooden Ceiling, Roof of Room No.3, Third Floor

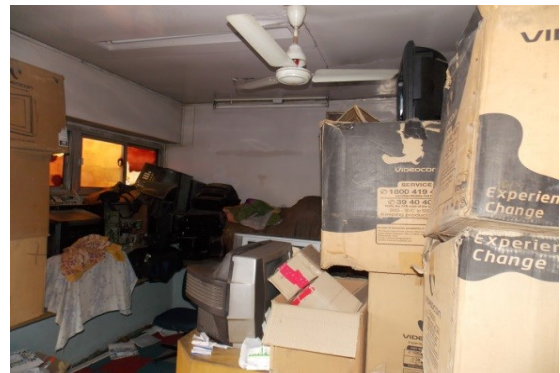
Photo 86

Covered with Materials, All Walls of Room No.3, Third Floor

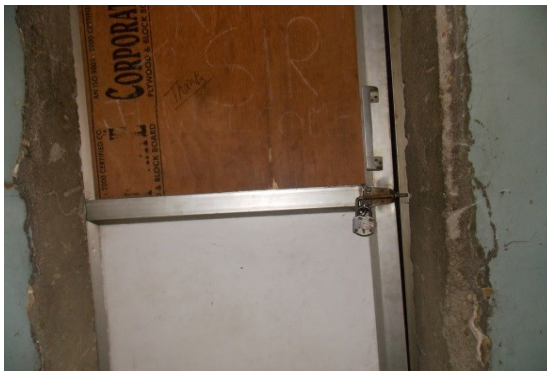
Photo 87

Locked, Closed Area, Third Floor

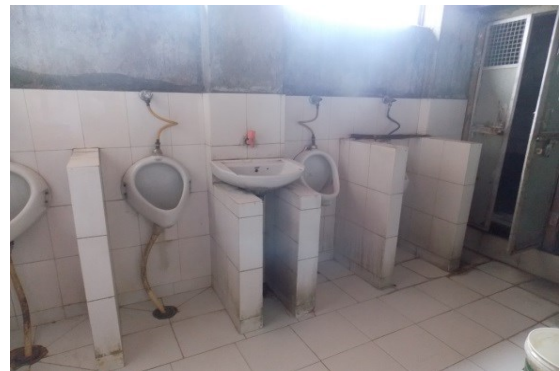
Photo 88

Covered with Tiles, All Walls & Floor of Toilet No.3, Fourth Floor

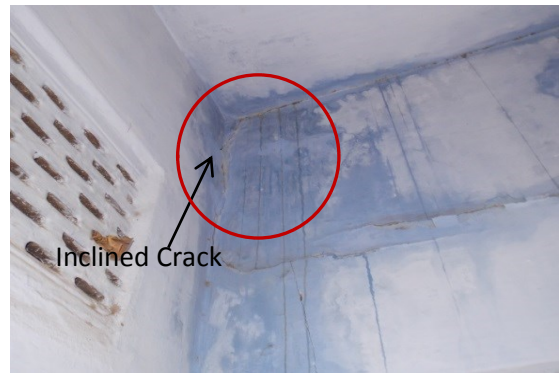
Photo 23
Inclined Crack on Wall No.2 to Roof of Opensky of H.No.1144(F.F.)
Approx. Width = 1.0mm, Approx. Length = 1.50m.
Distance from Wall No.4= 0m, Height from Floor = 2.20m.

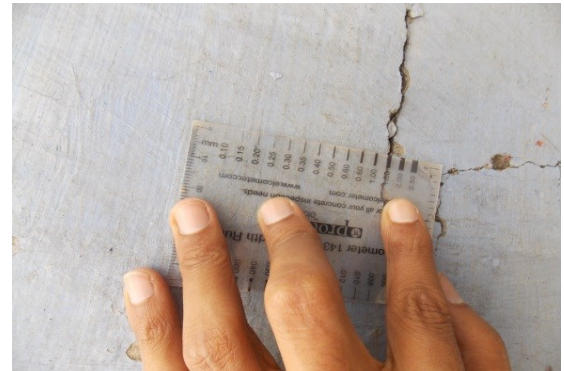
Photo 25C

Inclined Crack on Wall No.4 of Terrace No.1of H.No.1144(Terrace)
Approx. Width = 1.50mm, Approx. Length = 3.0m.
Distance from Wall No.2= 2.50m, Height from Floor = 0.20m.

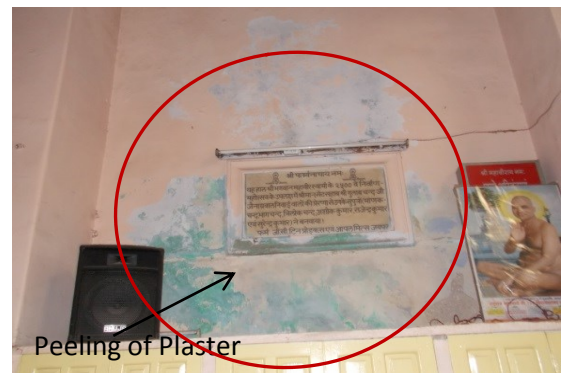
Photo 31
Peeling of Plaster on Wall No.4 of Hall No.2 of H.No.1144
Ground Floor

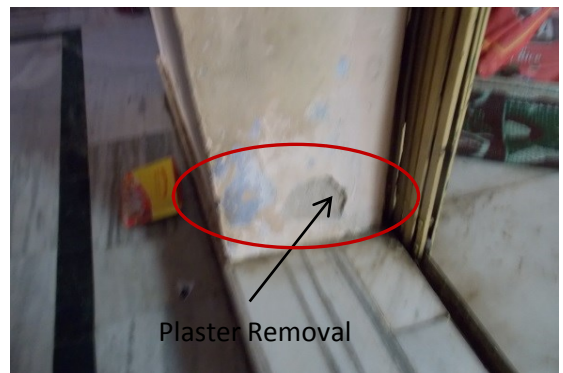
Photo 33
Plaster Removal on Wall No.1 of Gate No.1 of Hall No.2
Ground Floor

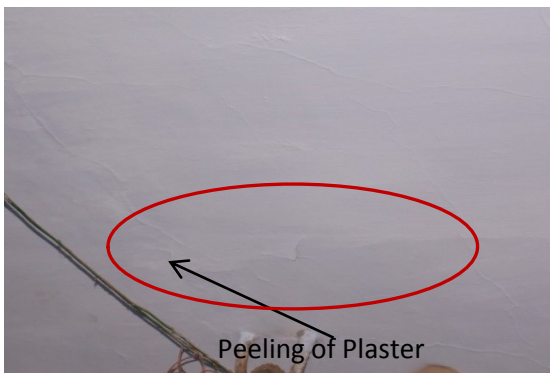
Photo 36
Peeling of Plaster on Roof of Room No.3 of H.No.1144,
First Floor

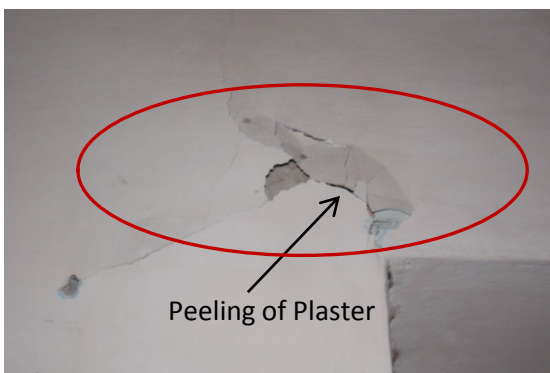
Photo 38
Peeling of Plaster on Wall No.3 of Hall No.1 of H.No.1144,
First Floor

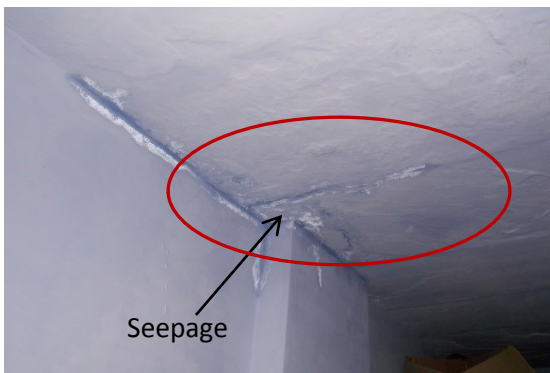
Photo 42
Seepage on Roof of Room No.1 of H.No.1144
First Floor

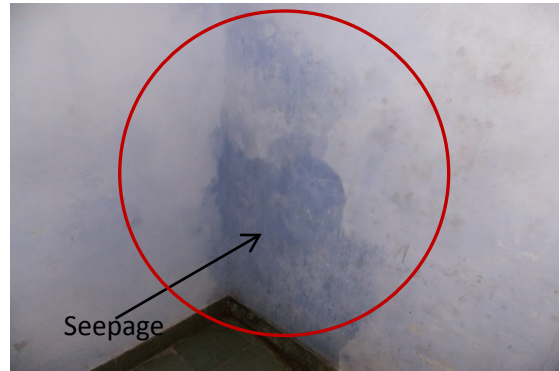
Photo 47
Seepage on Wall No.2 of Room No.9 of H.No.1144
First Floor

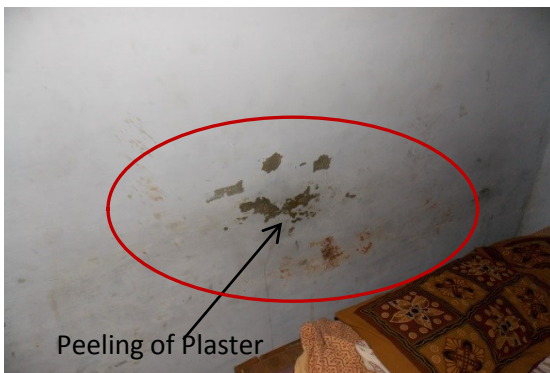
Photo 48
Peeling of Plaster on Wall No.1 of Room No.9 of H.No.1144
First Floor

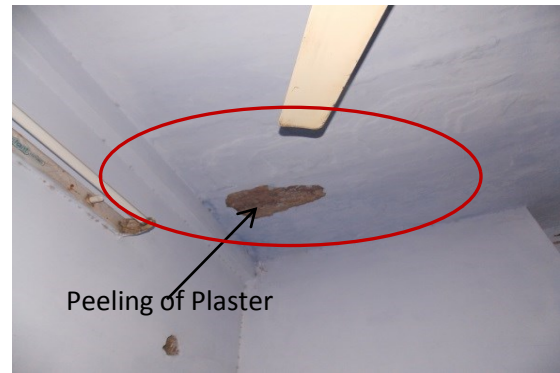
Photo 49
Peeling of Plaster on Roof of Room No.9 of H.No.1144
First Floor

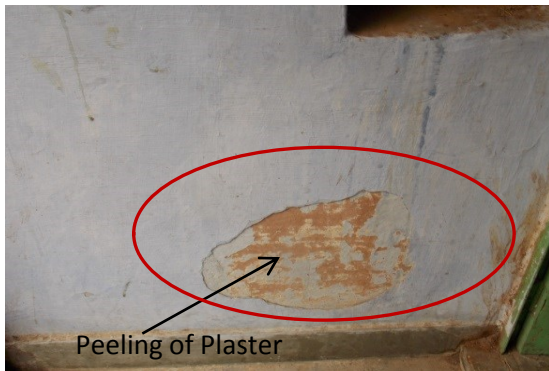
Photo 52
Peeling of Plaster on Wall No.2 of Open Sky of H.No.1144
First Floor

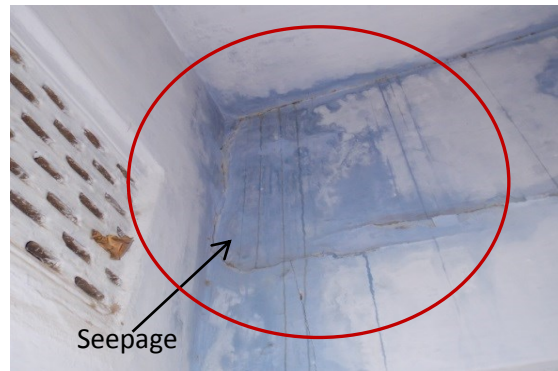
Photo 53
Seepage on Wall No.2 of Open Sky of H.No.1144
First Floor

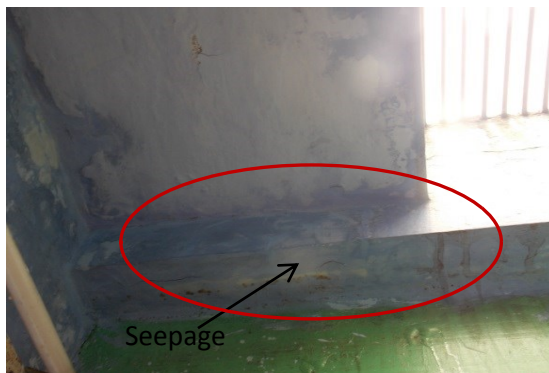
Photo 54
Seepage on Roof of Open Sky of H.No.1144
First Floor

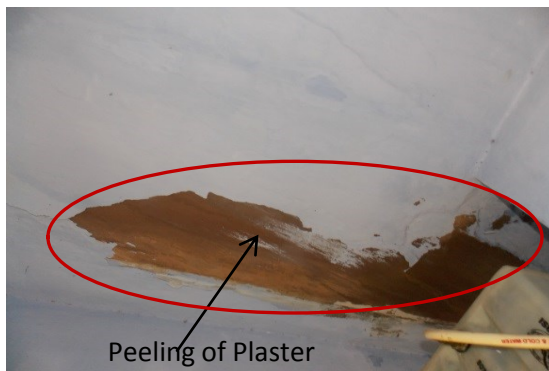
Photo 56
Peeling of Plaster on Roof of Washroom of H.No.1144
First Floor

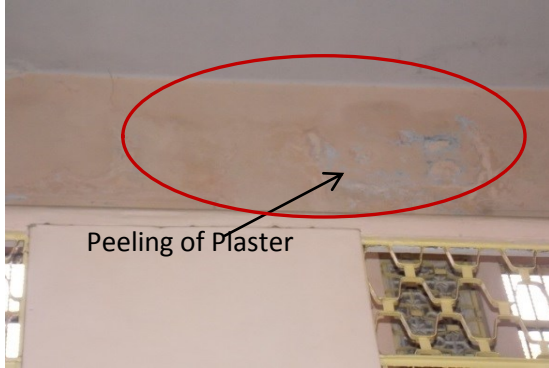
Photo 58
Peeling of Plaster on Wall No.1 of Balcony of H.No.1144
First Floor
