Pre - Condition Building Survey for Construction of Underground Stations from Chandpole to Bari Chouper and reversal line

Hind Hotel
Choura Rasta
Jaipur
Unique ID:CC-BC/DL/0029

Report Number: AIMIL/ESG/JMCEC/CC-BC/DL/0029-294-286-GF-SF, Rev. 00, Dated: AUGUST 2014

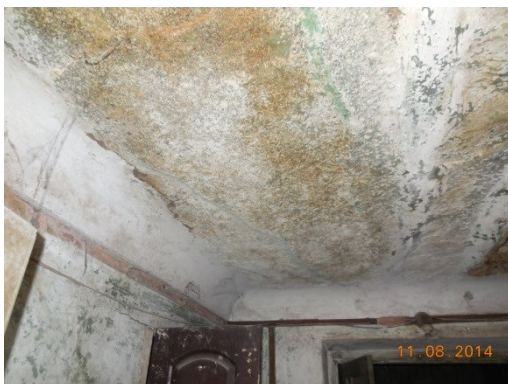
Photo 16

Seepage on Roof of Room No. 1 of Hind Hotel, Ground Floor

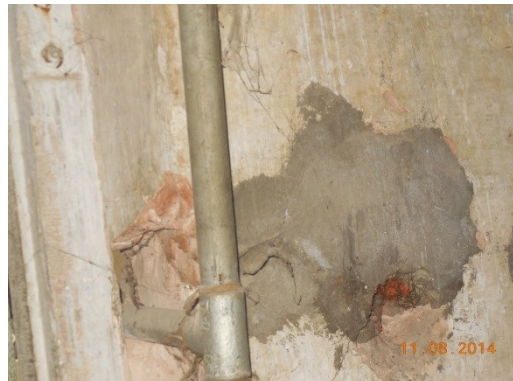
Photo 25

Plaster Removal on Wall No. 3 of Room No. 5 of Hind Hotel, Ground Floor

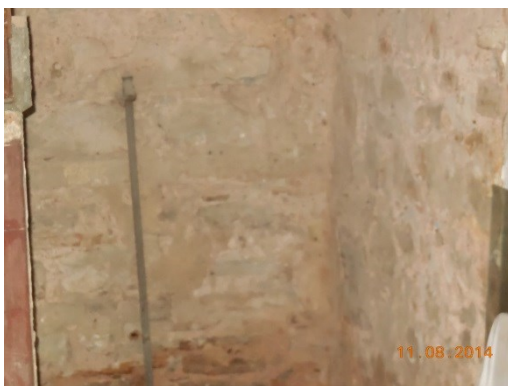
Photo 26

Plaster Removal on All Walls of Store No.2 of Hind Hotel, Ground Floor

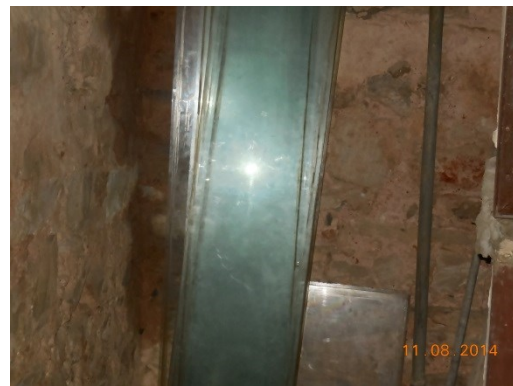
Photo 27

Plaster Removal on All Walls of Store No. 1 of Hind Hotel, Ground Floor

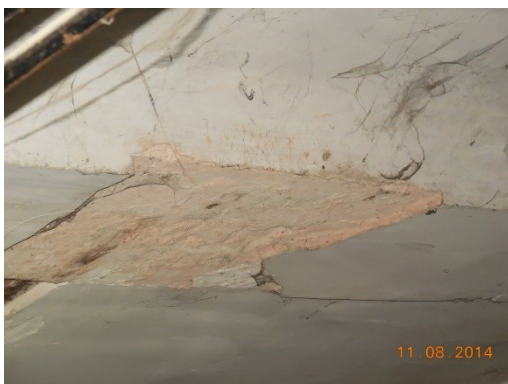
Photo 28

Plaster Removal on Roof of Room No. 4, Part B of Hind Hotel, Ground Floor

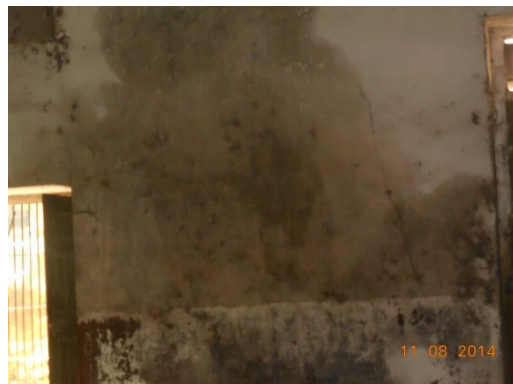
Photo 29

Seepage on Wall No.4 of Room No. 4, Part C of Hind Hotel, Ground floor

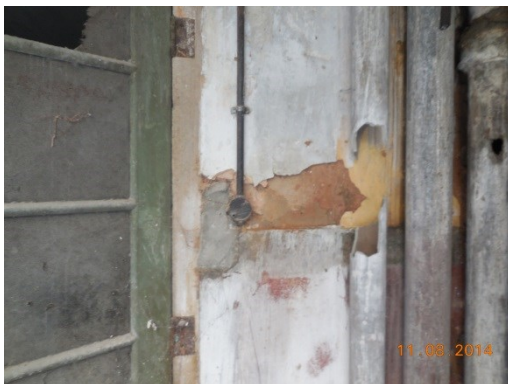
Photo 38

Plaster Removal on Wall No. 4 of Courtyard of Hind Hotel, Ground Floor

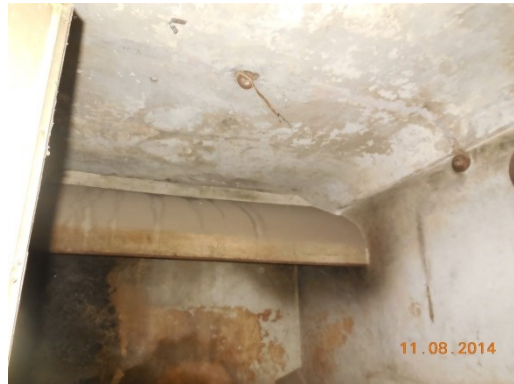
Photo 49

Seepage on All Walls & Roof of Room No. 2 of Hind Hotel, Mazzanin Floor

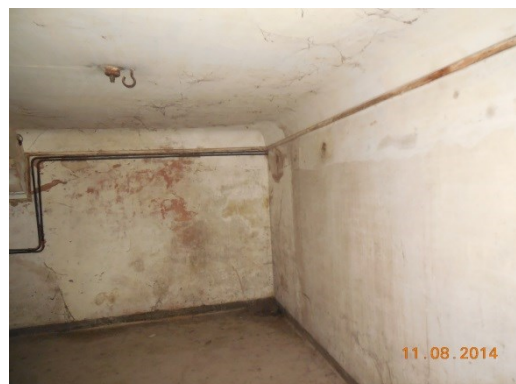
Photo 53

Seepage on Wall No. 2 & 4 of Room No. 4 of Hind Hotel, Mazzanin Floor

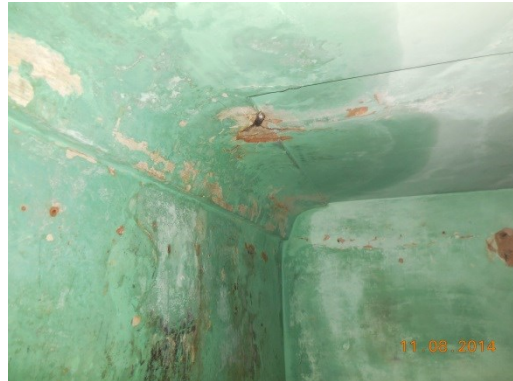
Photo 55

Seepage on Wall No. 1, 3 & Roof of Room No. 5 of Hind Hotel, Mazzanin Floor

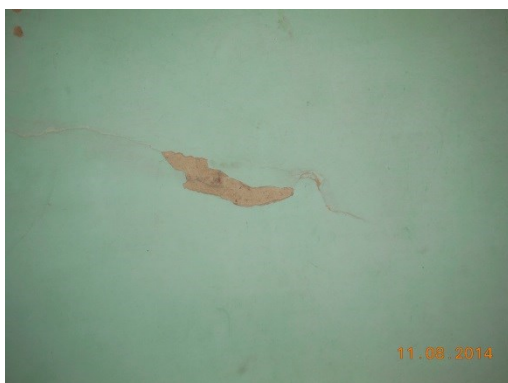
Photo 58

Plaster Removal on Wall No. 4 of Room No. 5 of Hind Hotel, Mazzanine Floor

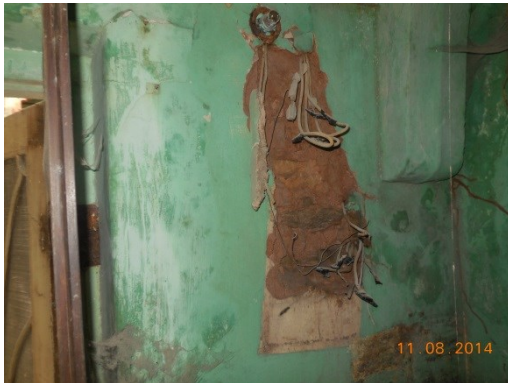
Photo 62

Plaster Removal on Wall No. 3 of Room No.1 of Hind Hotel, Mazzanine Floor

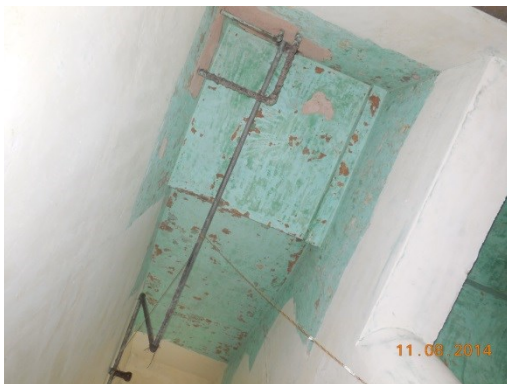
Photo 76

Seepage on Roof of Staircase of MSN to FF of Hind Hotel, Mezzanine Floor

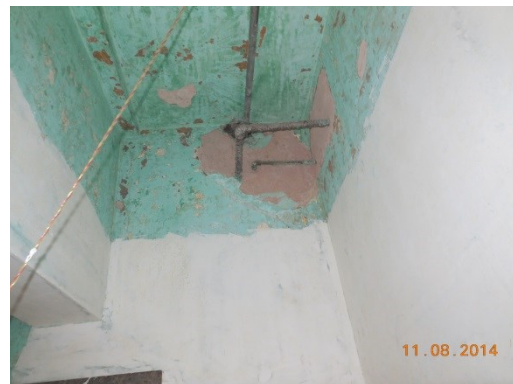
Photo 77

Seepage on Wall No. 3 of Staircase MSN to FF of Hind Hotel Mezzanine Floor

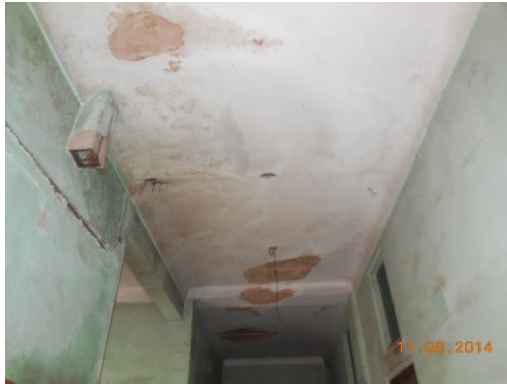
Photo 78

Plaster Removal on Roof of Varanda No. 3 of Hind Hotel, First Floor

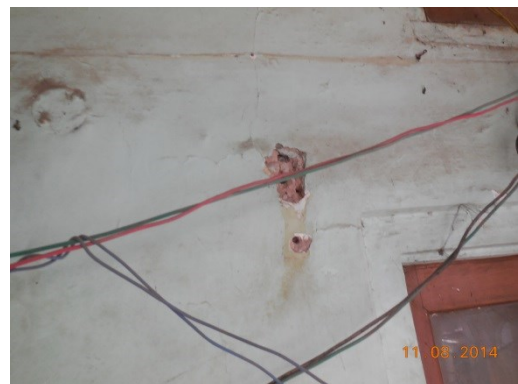
Photo 81

Plaster Removal on Wall No. 4 of Varanda No. 3 of Hind Hotel, First Floor

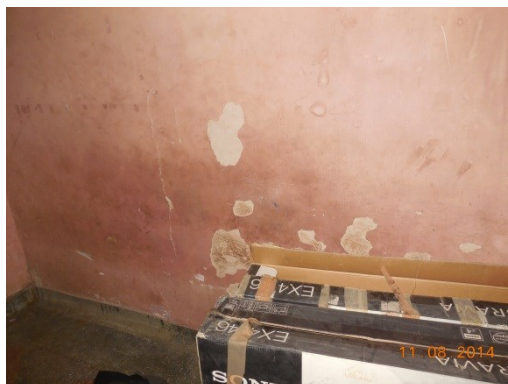
Photo 82

Peeling Plaster on Wall No.2 of Room No.13 of Hind Hotel, First Floor

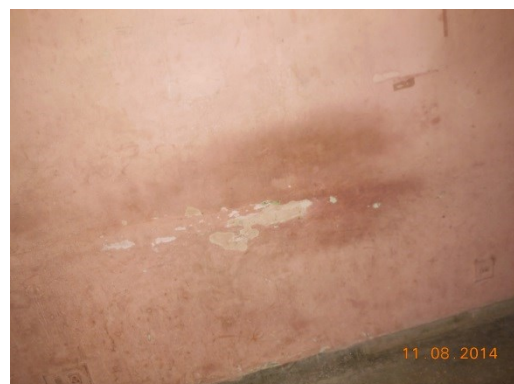
Photo 83

Peeling Plaster on Wall No.1 of Room No.13 of Hind Hotel, First Floor

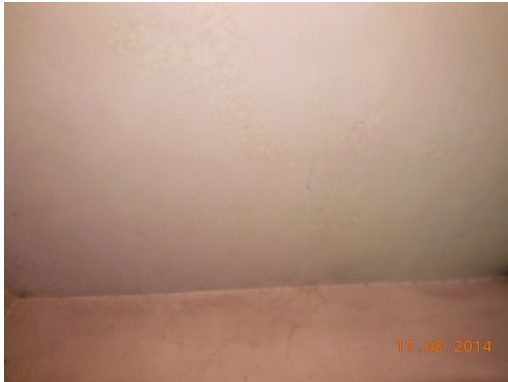
Photo 84

Seepage on Roof of Room No. 13 of Hind Hotel,
First Floor

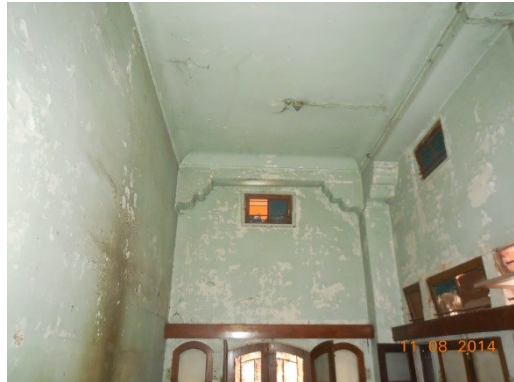
Photo 85

Peeling Plaster on All Walls of Room No. 19 of Hind Hotel,
First Floor

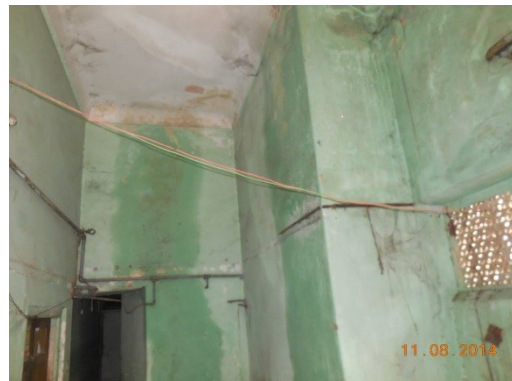
Photo 89

Seepage on Wall No. 2 & 3 of Varanda No. 4 of Hind Hotel,
First Floor

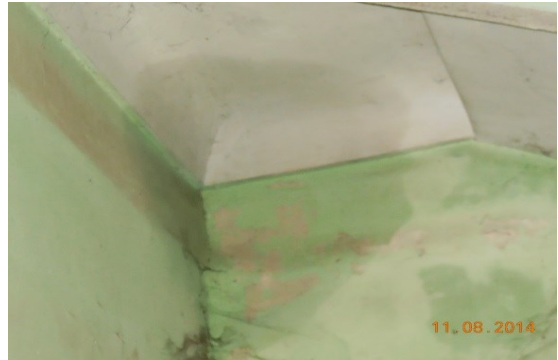
Photo 91

Seepage on Wall No. 1 & Roof of Varanda No. 4 of Hind Hotel, First Floor

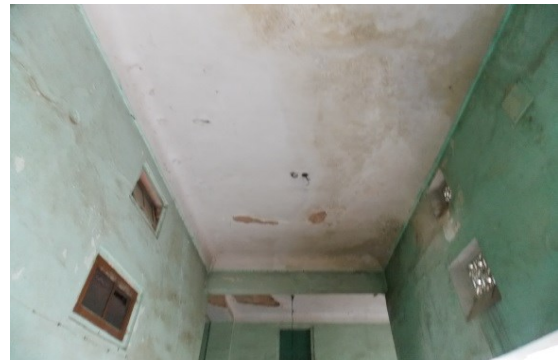
Photo 93

Plaster Removal on Roof of Varanda No. 2 of Hind Hotel, First Floor

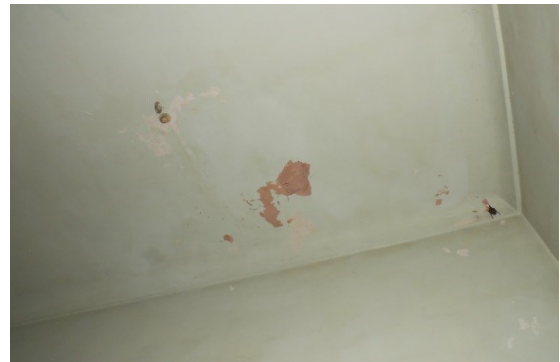
Photo 95

Plaster Removal on Roof of Room No. 8 of Hind Hotel, First Floor

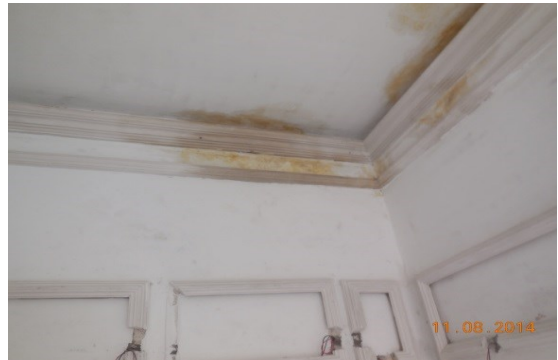
Photo 97

Seepage on Wall No. 1, 2 & Roof of Room No. 2 of Hind Hotel, Second Floor

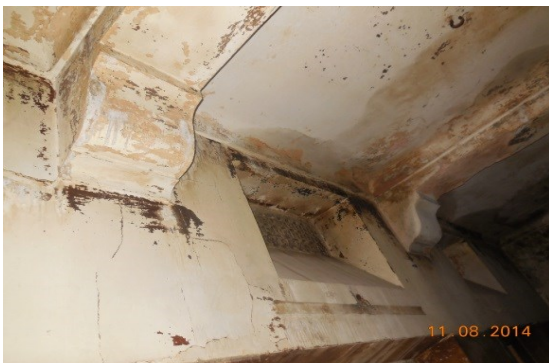
Photo 100

Seepage on Wall No. 3 & Roof of Room No. 7 of Hind Hotel, Second Floor

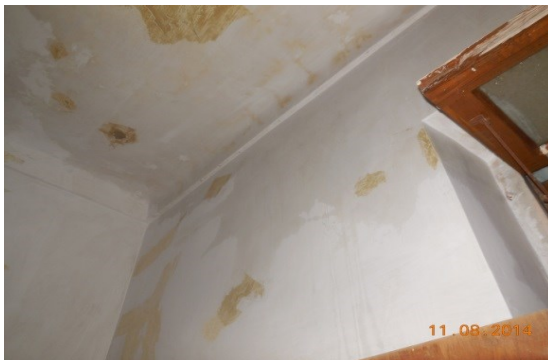
Photo 104
Seepage on Wall No.3 & Roof of Room No. 12 of Hind Hotel,
Second Floor

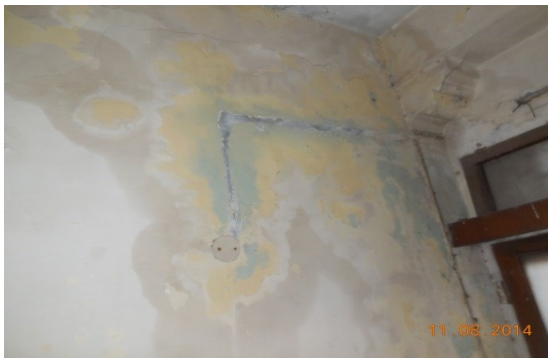
Photo 106
Seepage on Wall No. 3 & 5 of Room No. 13 of Hind Hotel, Second
Floor

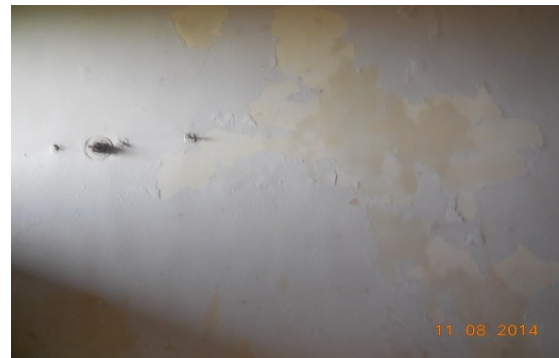
Photo 107
Peeling of Plaster on Wall No. 2 of Room No. 13 of Hind Hotel,
Second Floor

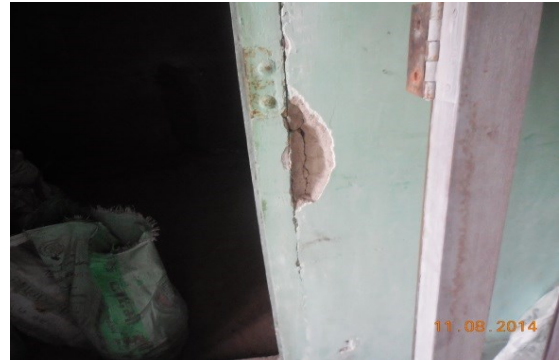
Photo 109

Summary of Defects Other Than Crack			
Defect ID	Location	Description	Photo No.
89	All Walls & Roof of Toilet & Bath of Room No.7,(S.F)	Seepage	102
90	Wall No. 2 & Roof of Room No. 12, Second Floor	Seepage	103
91	Wall No. 3 & Roof of Room No.12,Second Floor	Seepage	104
92	All Walls & Roof of Toilet & Bath of Room No. 7,(S.F.)	Peeling of plaster	105
93	Wall No. 4 & 5 of Room No.13 of Second Floor	Seepage	106
94	Wall No. 2 of Room No.13 of SecondFloor	Peeling of Plaster	107
95	Wall No. 2 of Room No.13 of SecondFloor	Peeling of Plaster	108
96	Wall No. 2 of Room No.14 of SecondFloor	Plaster Removal	109
97	Balcony of Room No.14 of SecondFloor	Plaster Removal	110
98	Wall No. 2 of Varanda No.1 of Second Floor	Seepage	111
99	All Walls of Varanda No.2 of Second Floor	Seepage	112
100	Wall No. 2 of Room No.13 of SecondFloor	Peeling of Plaster	107
101	Wall No. 2 of Room No.13 of SecondFloor	Peeling of Plaster	108
102	Wall No. 2 of Room No.14 of SecondFloor	Plaster Removal	109

Plaster Removal on Wall No. 2 of Room No. 14 of Hind Hotel, Second Floor

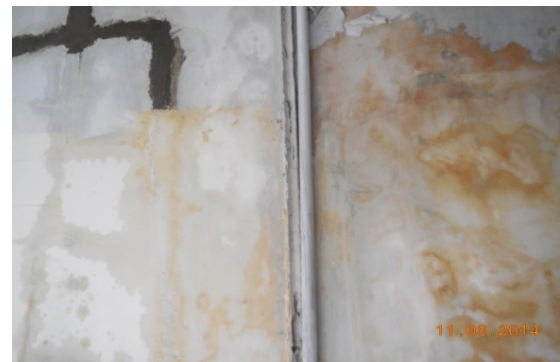
Photo 111

Seepage on Wall No. 2 of Varanda No. 1 of Hind Hotel, Second Floor

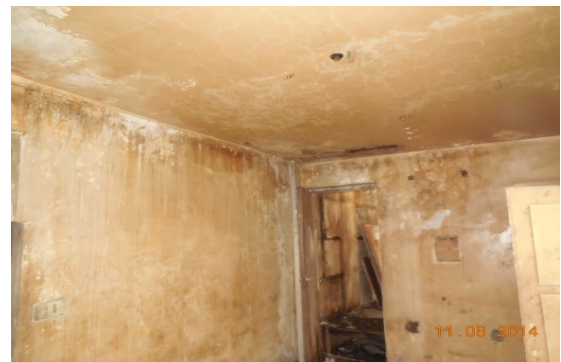
Photo 113

Seepage on All Walls of Room No. 2 of Hind Hotel, Third Floor

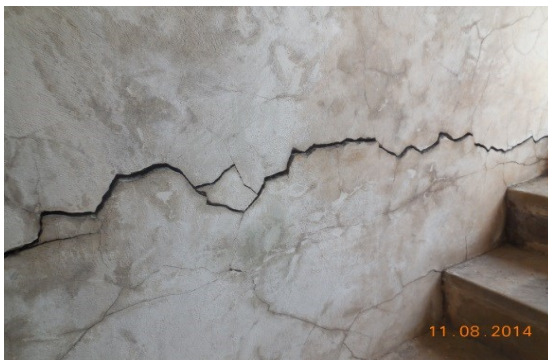
Photo 118
Plaster Removal on Wall No.1 & 4 of Staircase of Hind Hotel,
Third Floor

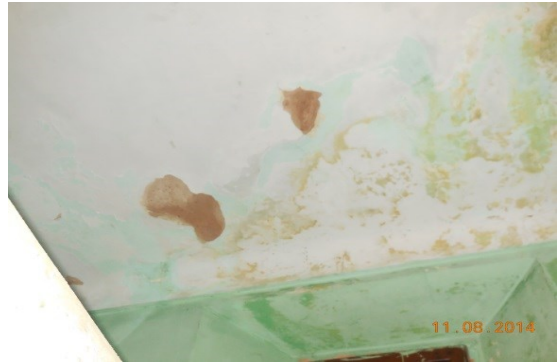
Photo 127

Plaster Removal on Roof of Room No. 2 of Hind Hotel, First Floor

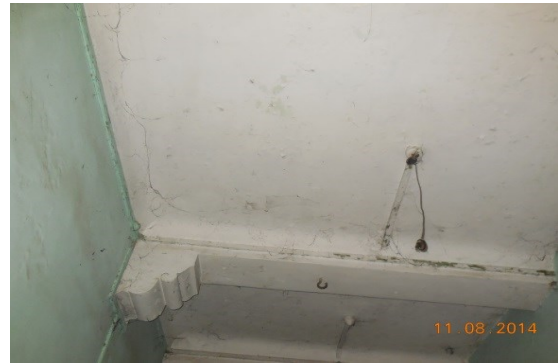
Photo 128

Plaster Removal on Wall No. 3 of Room No. 4 of Hind Hotel, First Floor

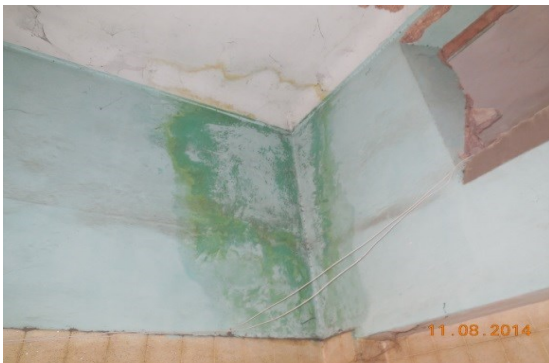
Photo 129

Peeling of Plaster on Roof of Room No. 4 of Hind Hotel, First Floor

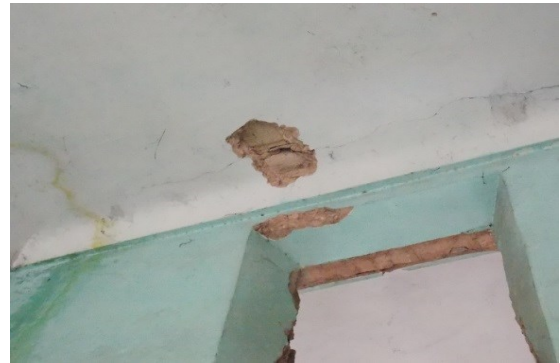
Photo 130

Seepage on Wall No. 2, 3 & Roof of Room No. 1 of Hind Hotel, First Floor

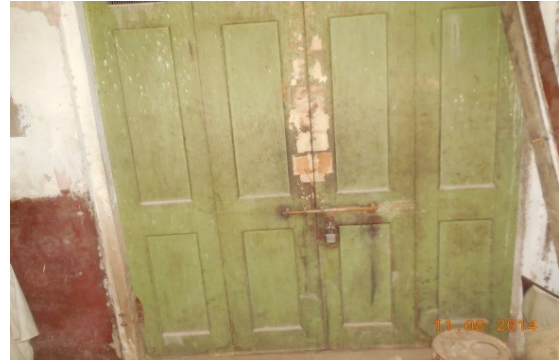
Photo 138

Repair Work on Wall No. 2 of of Passage of Hind Hotel,
Ground Floor

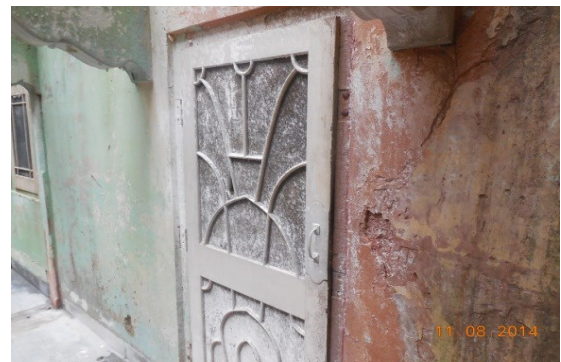
Photo 142

Repair Work on Wall No. 4 & Roof of Room No. 3 of Hind Hotel,
Mazzanin Floor

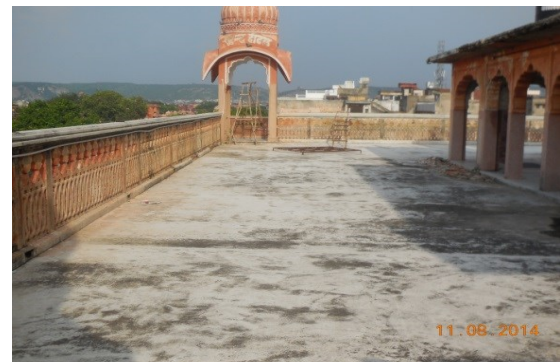
Photo 170

Locked, Room No. 1 of Hind Hotel, Third Floor,

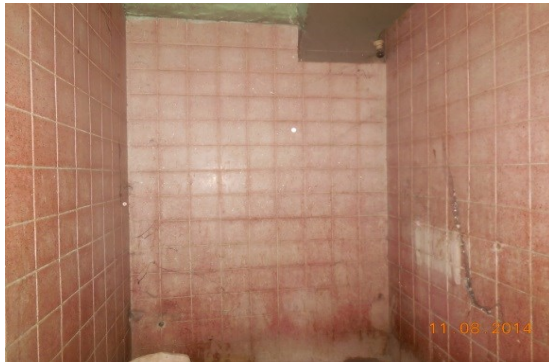
Photo 174

Covered with Tiles, All Walls of Toilet & Bath of Room No.2 of Hind Hotel, First Floor,

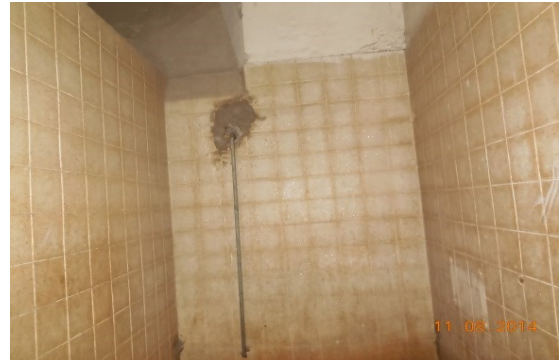
Photo 175

Covered with Tiles, All Walls of Toilet & Bath of Room No.3 of Hind Hotel, First Floor,

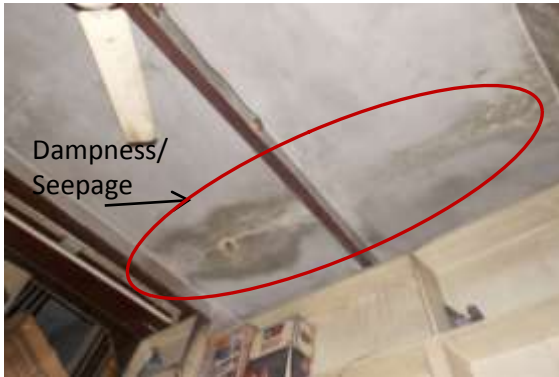
Photo 1

Summary of Cracks						
Defect ID	Location	Orientation	Appx. Width (mm)	Appx. Length (m)	Category	Photo No.
Summary of Defects Other Than Crack						
Defect ID	Location	Description				Photo No.
1	Roof of Shop No. 207,Ground Floor	Dampness/Seepage				1
Summary of Areas that Could not be Surveyed						
Serial No.	Location	Description				Photo No.
1	Wall No. 1 & 4 of Shop No. 207,Ground Floor	Covered with wooden and Material				2
2	Wall No. 2 & 4 of Shop No. 207,Ground Floor	Covered with wooden and Material				3
3	Wall No. 2 & 4 of Shop No. 207,Basement	Covered with wooden and Material				4
4	Wall No. 2 & 3 of Shop No. 207,Basement	Covered with wooden and Material				5

Dampness/Seepage on Roof of Shop No. 207, Ground Floor

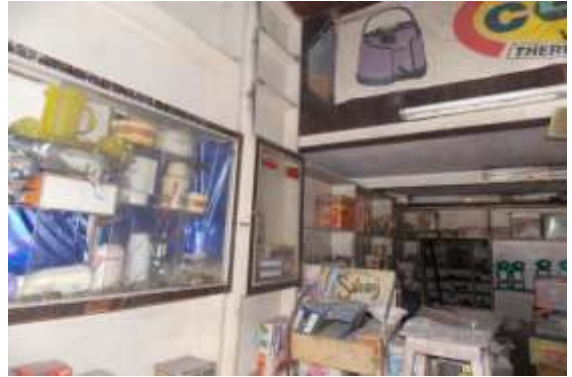
Photo 2

Covered with wooden and Material, Wall No. 1 & 4 of Shop No. 207, Ground Floor
