Pre - Condition Building Survey for Construction of Underground Stations from Chandpole to Bari Chouper and reversal line

Shops
Chandpol Bazar
Jaipur
Unique ID: CP-CC-DL-0151

Report Number: AIMIL/ESG/JMCEC/CP-CC-DL-0151/03/Verandah, Rev. 02, Dated: October, 2014

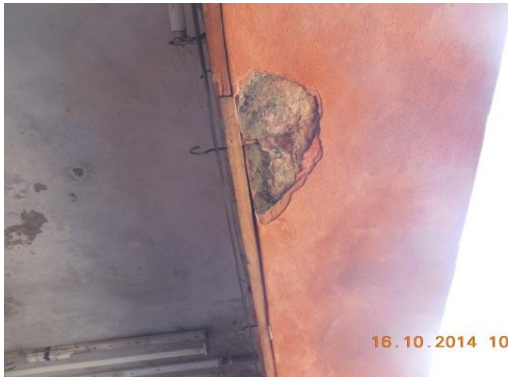
Photo 19

Plaster Removal on Ext. Beam & Roof of Verandah of S.No.263, Ground Floor

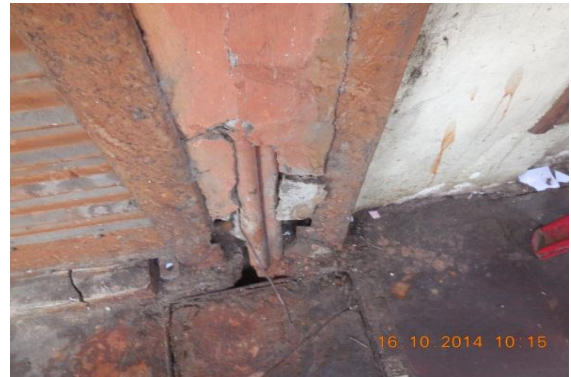
Photo 20

Plaster Removal on Left Int. Col. of Verandah of S.No.263, Ground Floor

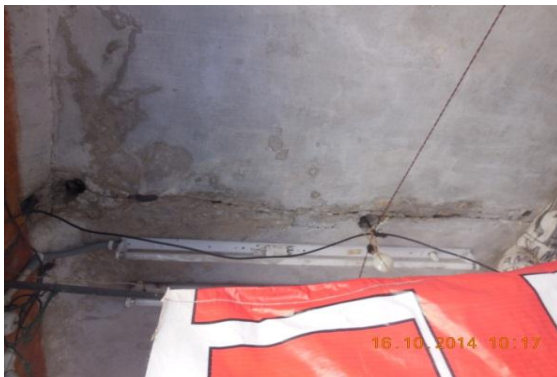
Photo 21

Horizontal Crack on Roof of Verandah of S.No.264, (G.F.)
Approx. Width = 0.60mm, Approx.Length = 2.0m.
Distance from L.Int.Col. = 0.0m, Height from Floor = 2.80m.

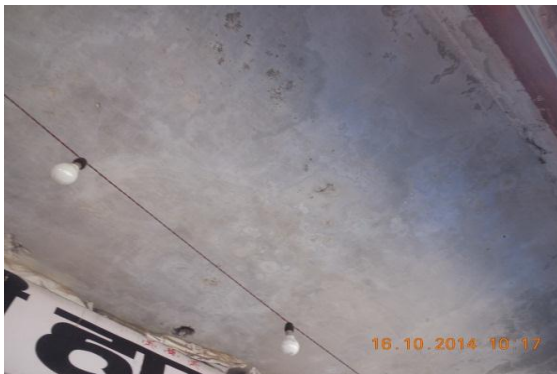
Photo 23

Dampness/Seepage on Roof of Verandah of S.No.264, Ground Floor

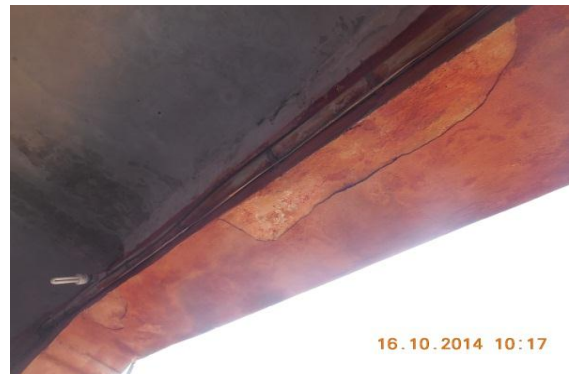
Photo 24

Peeling of Plaster on Ext. Beam of Verandah of S.No.264, Ground Floor

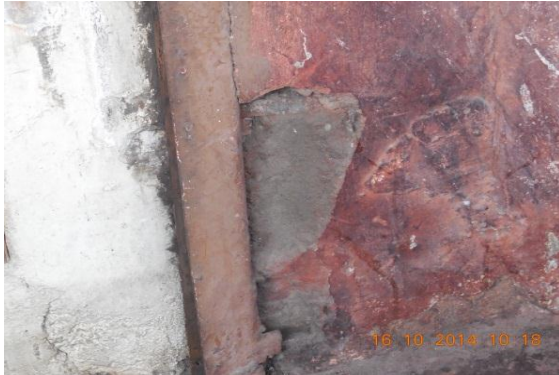
Photo 25

Plaster Removal on Left Int.Col of Verandah of S.No.265, Ground Floor

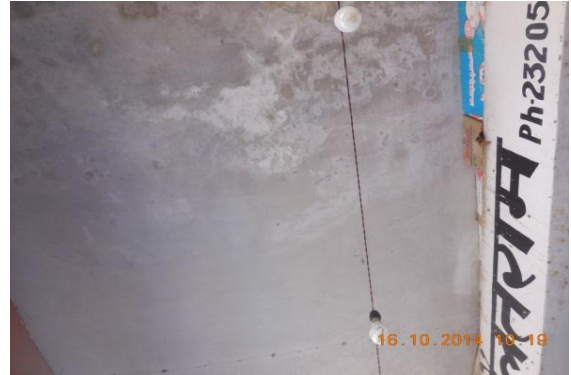
Photo 26

Dampness/Seepage on Roof of Verandah of S.No.265, Ground Floor

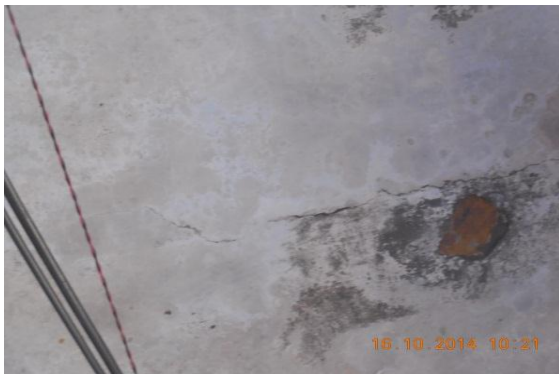
Photo 29

Horizontal Crack on Roof of Verandah of S.No.266, (G.F.), Approx. Width = 1.0mm, Approx.Length = 1.80m. Distance from L.Ext.Col. = 1.20m, Height from Floor = 2.80m.

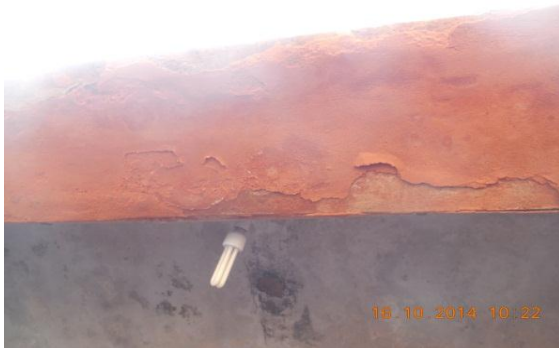
Photo 31
Dampness/Seepage on Beam Roof of Verandah of S.No.266,
Ground Floor

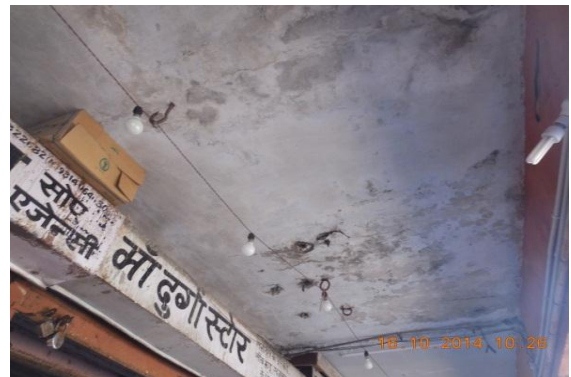
Photo 34
Dampness/Seepage on Roof of Verandah of S.No.267,
Ground Floor

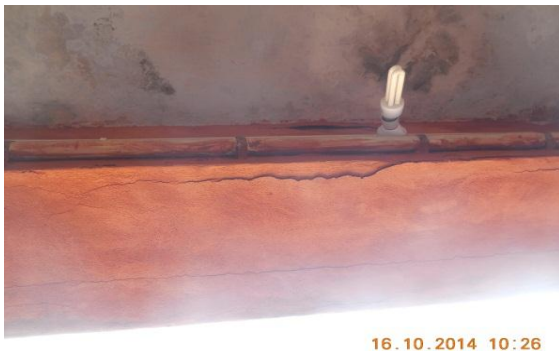
Photo 35
Peeling of Plaster on Ext. Beam Roof of Verandah of S.No.267,
Ground Floor

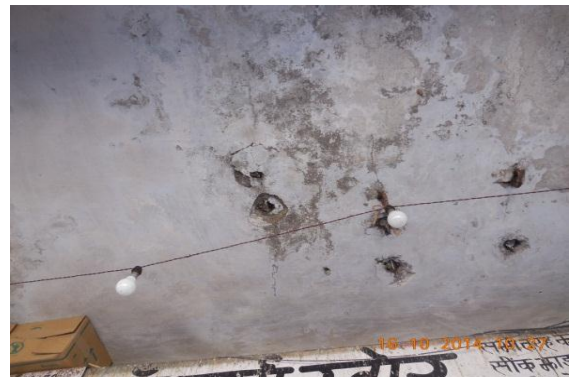
Photo 36
Plaster Removal on Roof of Verandah of S.No.268,
Ground Floor

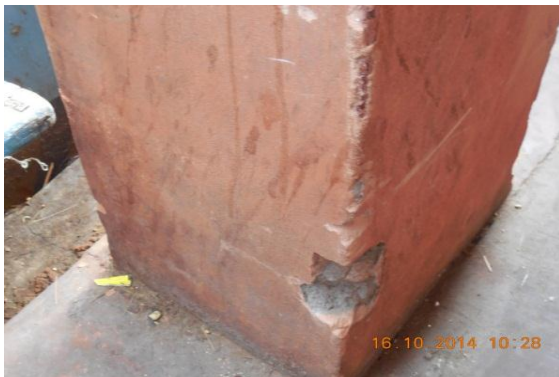
Photo 39
Plaster Removal on Left Ext.Col. of Verandah of S.No.269,
Ground Floor

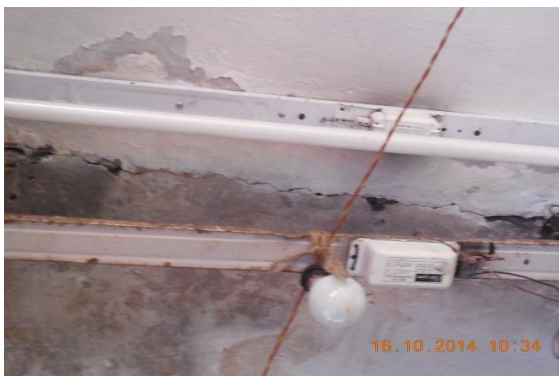
Photo 47

Horizontal Crack on Roof of Varanda of S.No.272,(G.F.)
Approx. Width = 0.60mm, Approx.Length = 2.0m.
Distance from R.Ext.Col. = 0m, Height from Floor = 2.8m.

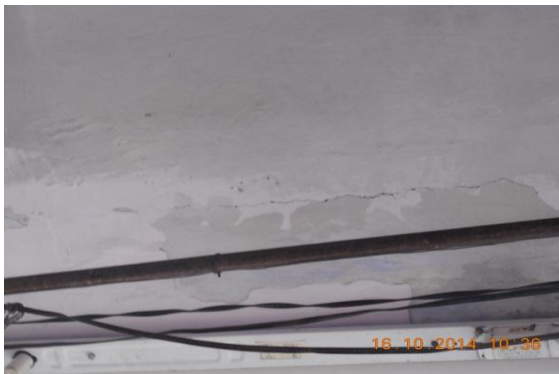
Photo 53
Horizontal Crack on Roof of Verandah of S.No.274,(G.F.)
Approx. Width = 0.25mm, Approx.Length = 2.0m.
Distance from L.Ext.Col. =0m, Height from Floor =2.8m.

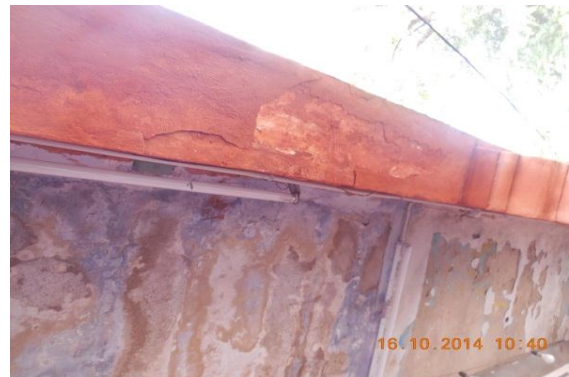
Photo 60

Dampness/Seepage on Ext. Beam Roof of Verandah of S.No.275, Ground Floor

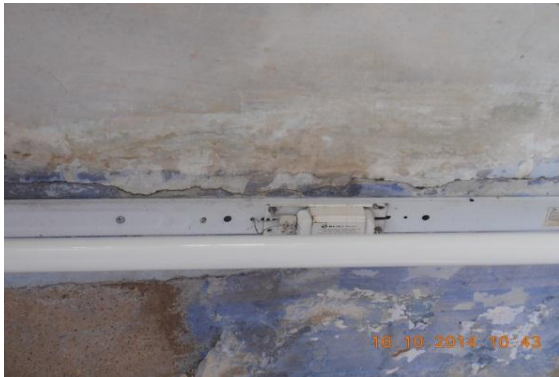
Photo 61

Horizontal Crack on Roof of Verandah of S.No.276,Ground Floor
Approx. Width =0.40mm, Approx.Length = 2.0m.
Distance from L.Int. Col. =0m, Height from Floor =2.8m.

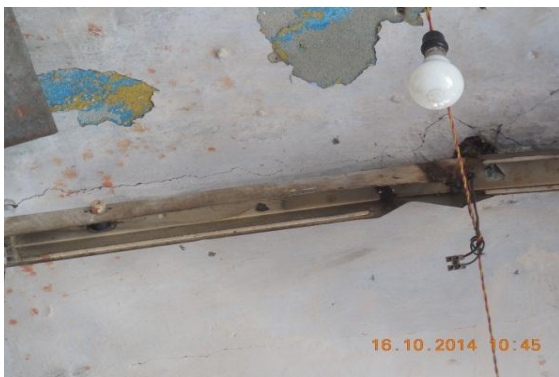
Photo 63

Horizontal Crack on Roof of Verandah of S.No.276,Ground Floor
Approx. Width =0.25mm, Approx.Length = 2.0m.
Distance from R.Ext. Col. =0m, Height from Floor =2.5m.

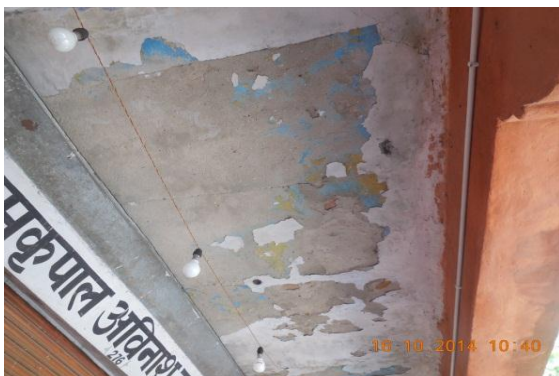
Photo 65

Dampness/Seepage on Roof of Verandah of S.No.276, Ground Floor

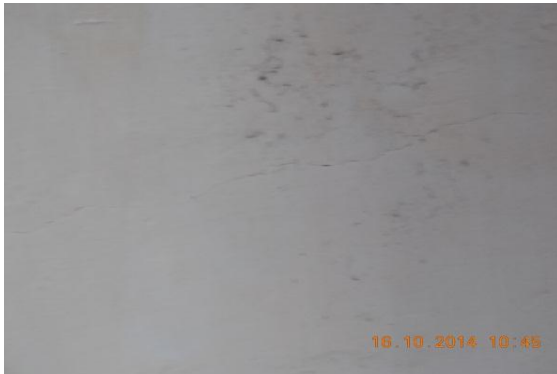
Photo 67

Horizontal Crack on Roof of Verandah of S.No.277,Ground Floor
Approx. Width =0.15mm, Approx.Length = 2.0m.
Distance from L.Int. Col. =1.0m, Height from Floor =2.8m.

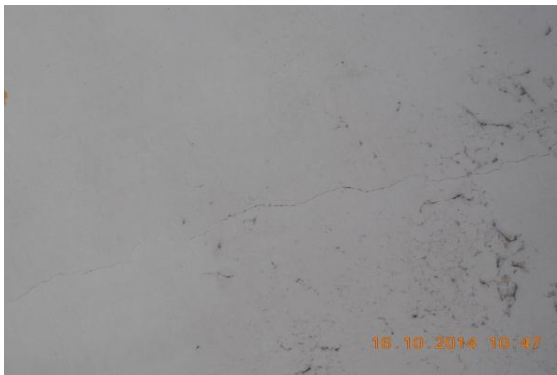
Photo 69

Plaster Crack on Roof of Verandah of S.No.277,Ground Floor

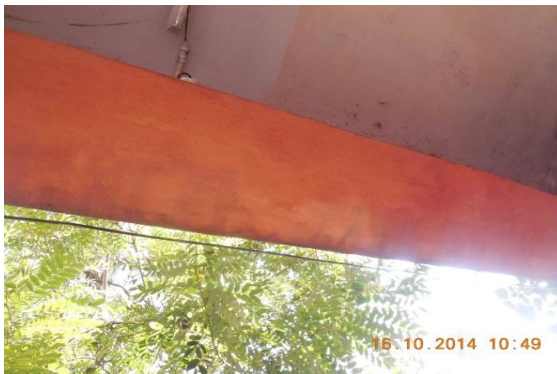
Photo 71

Dampness/Seepage on Ext.Beam of Verandah of S.No.277,
Ground Floor

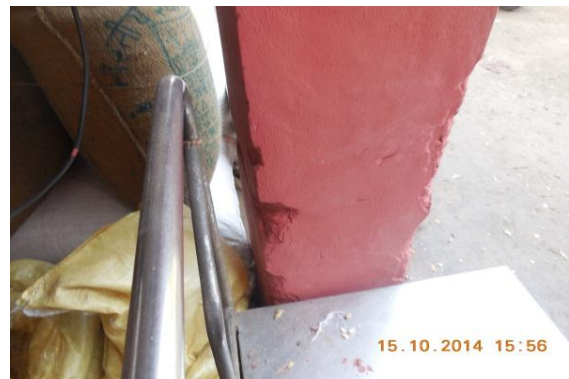
Photo 28
Plaster Removal on Right Ext. Col. of Verandah of Shop No.238

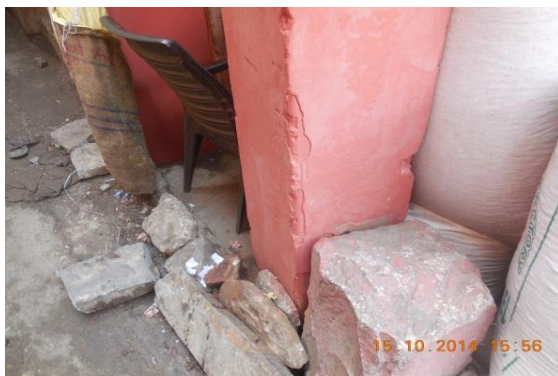
Photo 29
Plaster Removal on Left Ext. Col. of Verandah of Shop No.238

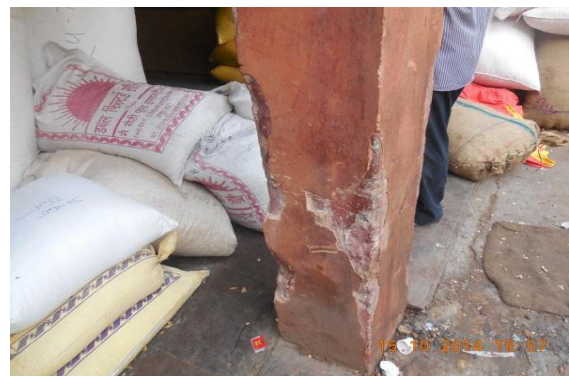
Photo 30
Plaster Removal on Right Ext. Col. of Verandah of Shop No.239

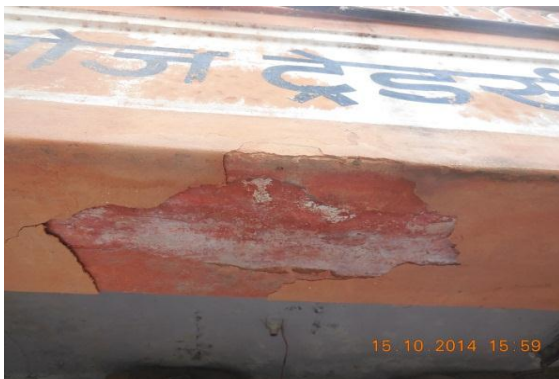
Photo 33
Peeling of Plaster on Ext. Beam of Verandah of S.No.241,
Ground Floor

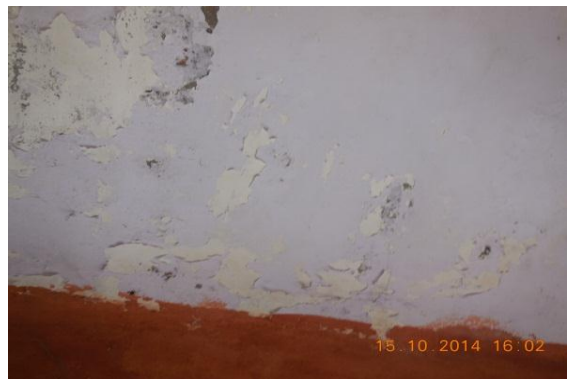
Photo 34
Peeling of Plaster on Roof of Verandah of S.No.241,Ground Floor

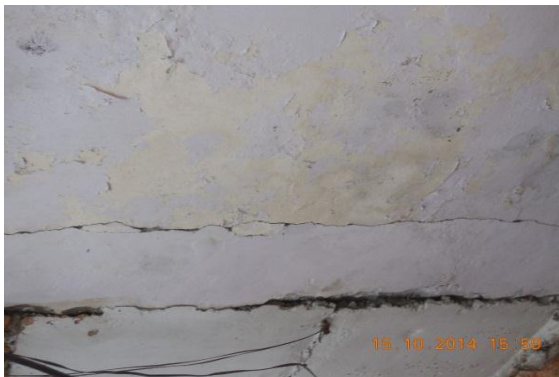
Photo 35
Horizontal Crack on Roof of Varanda of Shop No.241,(G. Floor)
Approx. Width = 1.0mm, Approx.Length = 2.0m.
Distance from L.Ext.Col. =0.0m, Height from Floor =2.50m.

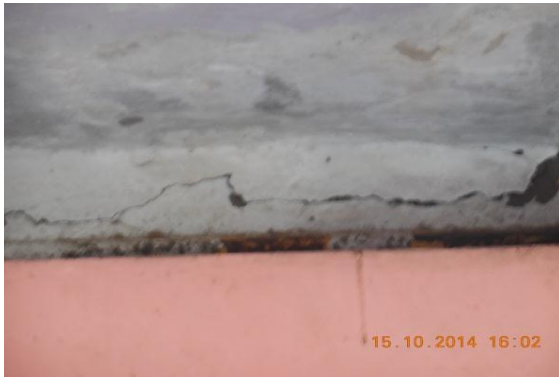
Photo 37

Inclined Crack on Wall No.4 of Varanda of Shop No.241,(G. Floor)
Approx. Width = 1.0mm, Approx.Length = 1.30m.
Distance from Entry Gate =0m, Height from Floor =2.40m.

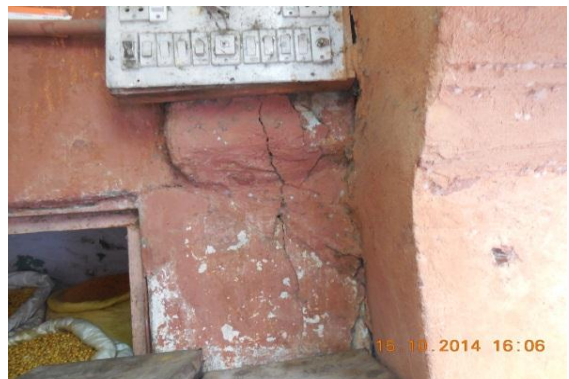
Photo 40

Vertical Crack on Wall No.2 of Varanda of S.No.242,(G. Floor)
Approx. Width = 1.0mm, Approx.Length = 0.40m.
Distance from R.Ext.Col. =0.15m, Height from Floor =1.6m.

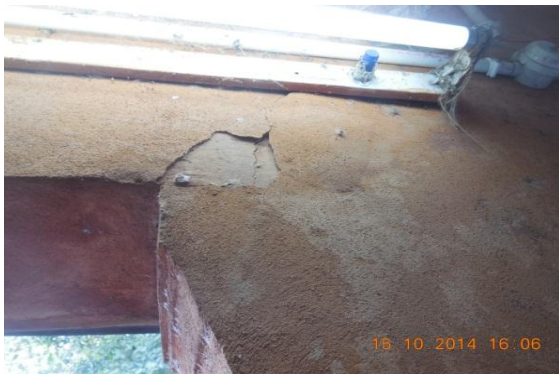
Photo 41

Inclined Crack on Ext. Beam of Varanda of S.No.242,(G. Floor)
Approx. Width = 0.6mm, Approx.Length = 0.20m.
Distance from L.Ext.Col. =0.25m, Height from Floor =2.0m.

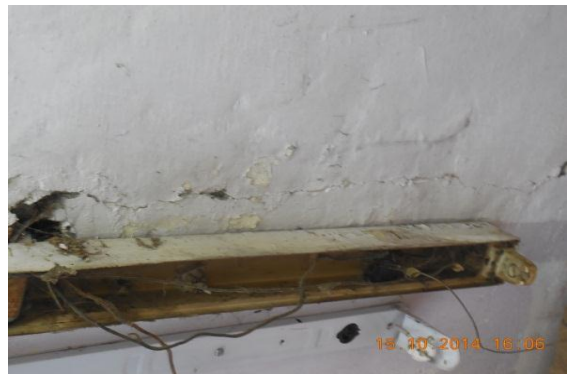
Photo 42

Horizontal Crack on Roof of Varanda of S.No.242,(G. Floor)
Approx. Width = 0.6mm, Approx.Length = 1.80m.
Distance from L.Ext.Col. =0m, Height from Floor =2.80m.

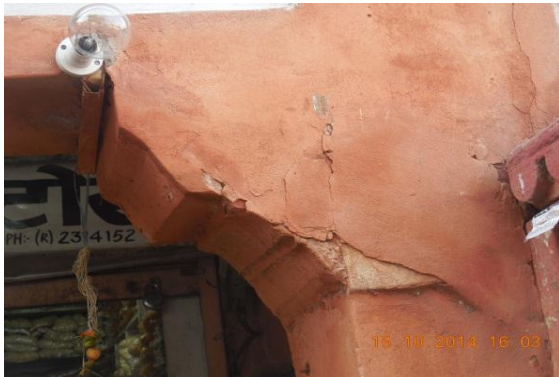
Photo 43

Plaster Removal on Right Ext.Col of Varanda of S.No.242, Ground Floor

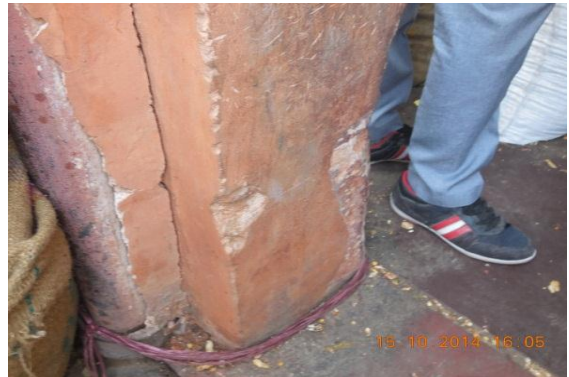
Photo 44

Plaster Removal on Left Ext.Col of Varanda of S.No.242, Ground Floor

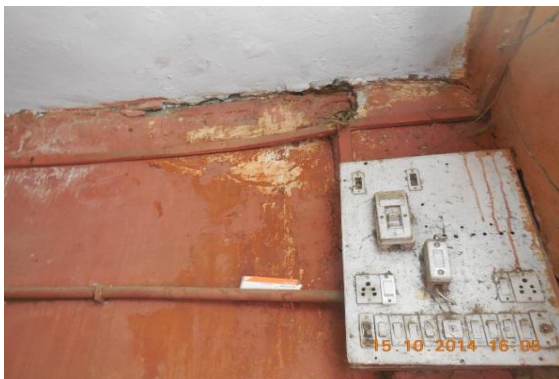
Photo 45

Plaster Removal on Wall No.2 of Varanda of S.No.242, Ground Floor

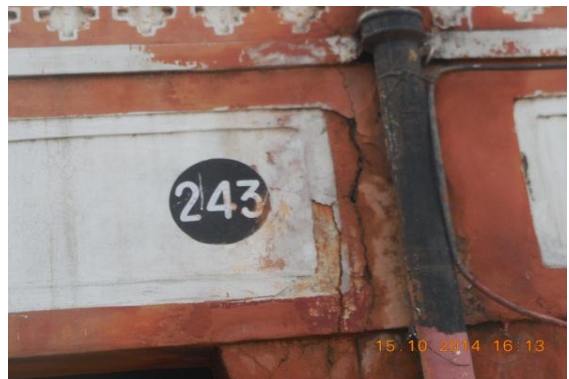
Photo 46

Inclined Crack on Right Ext.Col of Varanda No.1 of S.No.243,(G.F.)
Approx. Width = 5.0mm, Approx.Length = 1.0m.
Distance from R.Ext.Col. = 0m, Height from Floor = 1.8m.

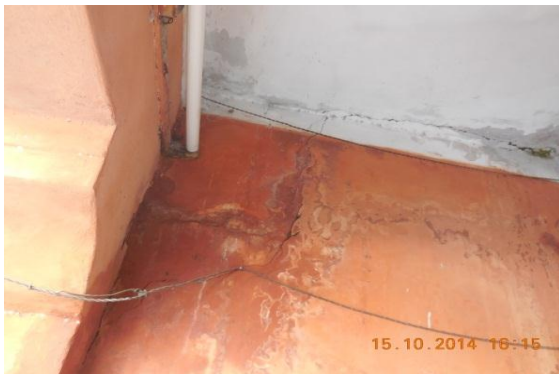
Photo 47

Inclined Crack on Wall No.1 of Varanda of S.No.243,(G. Floor)
Approx. Width = 1.8mm, Approx.Length = 2.50m.
Distance from L.Ext.Col. = 0m, Height from Floor = 1.70m.

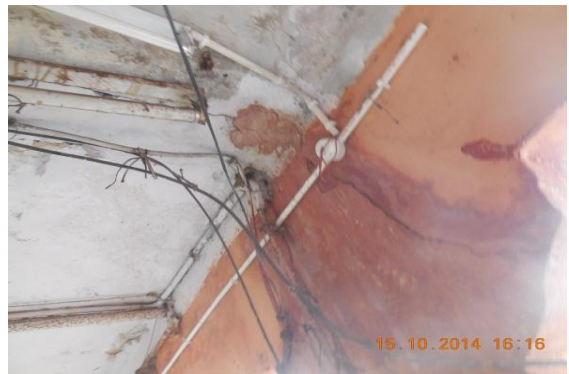
Photo 48A

Inclined Crack on Beam & Roof of Varanda No.1 of S.No.243,(G.F.)
Approx. Width = 1.0mm, Approx.Length = 6.0m.
Distance from R.Ext.Col. = 0m, Height from Floor = 1.60m.

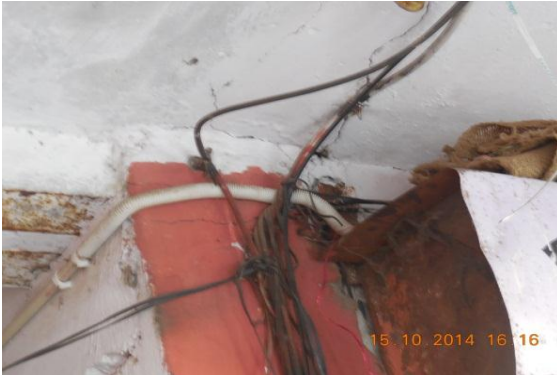
Photo 48B

Inclined Crack on Beam & Roof of Varanda No.1 of S.No.243, (G.F.)
Approx. Width = 1.0mm, Approx.Length = 6.0m.
Distance from R.Ext.Col. = 0m, Height from Floor = 1.60m.

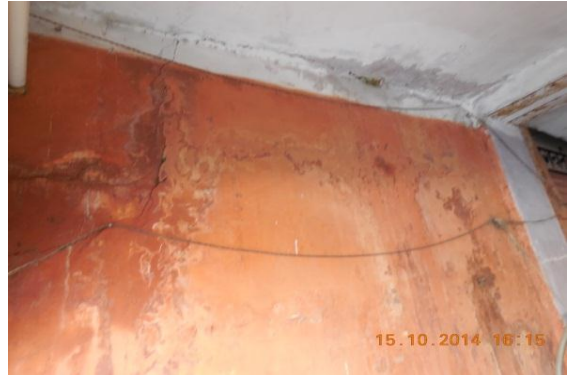
Photo 49

Dampness/Seepage on Wall No.1 of Varanda No.1 of S.No.243,
Ground Floor

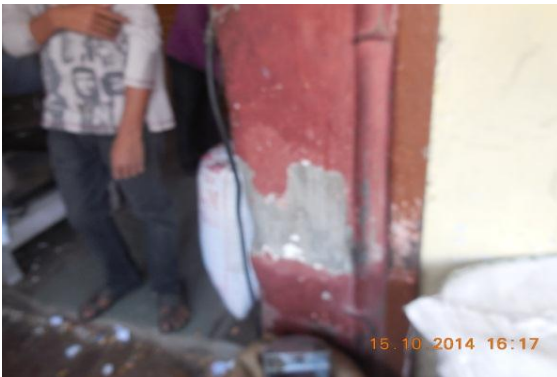
Photo 50

Plaster Removal on Wall No.2 of Varanda No.2 of S.No.243, Ground
Floor

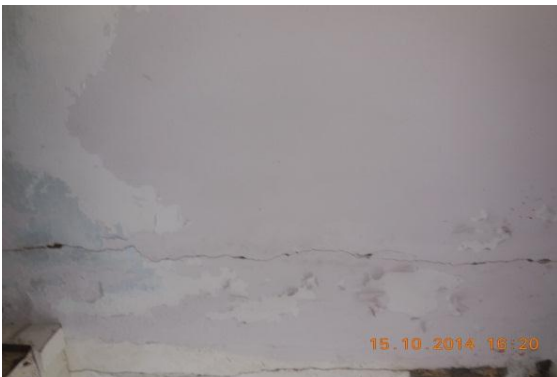
Photo 52

Horizontal Crack on Roof of Varanda of S.No.244, (G.F.)
Approx. Width = 0.60mm, Approx.Length = 2.0m.
Distance from R.Ext.Col. = 0m, Height from Floor = 2.8m.

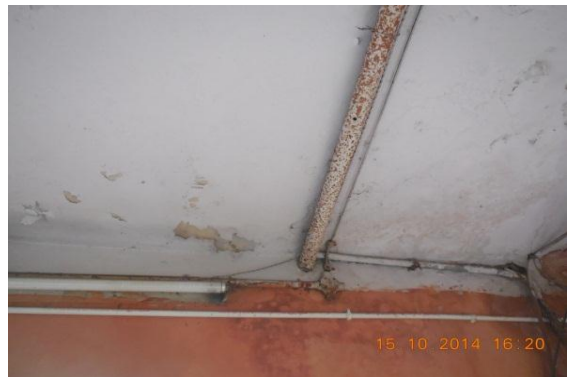
Photo 53

Dampness/Seepage on Roof of Varanda of S.No.244,
Ground Floor

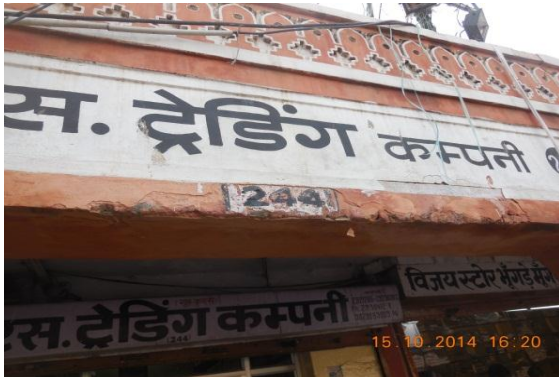
Photo 54

Plaster Removal on Ext. Beam of Varanda of S.No.244, Ground Floor

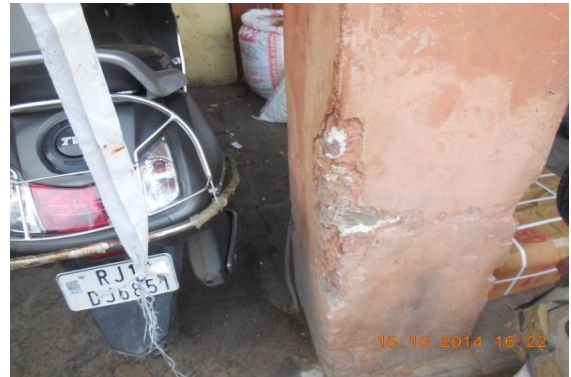
Photo 55

Plaster Removal on Right Ext.Col of Varanda of S.No.244, Ground Floor

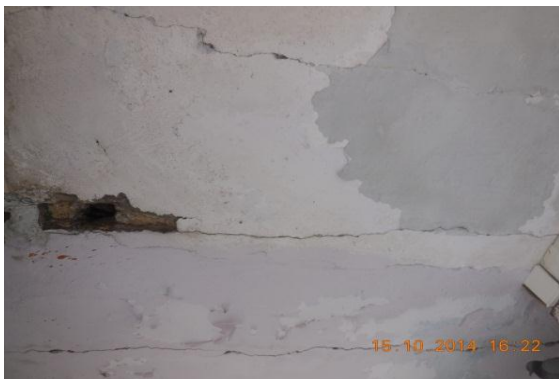
Photo 56

Horizontal Crack on Roof of Varanda of S.No.245,Ground Floor
Approx. Width = 0.60mm, Approx.Length = 1.20m.
Distance from Wall No.4 =0m, Height from Floor =2.8m.

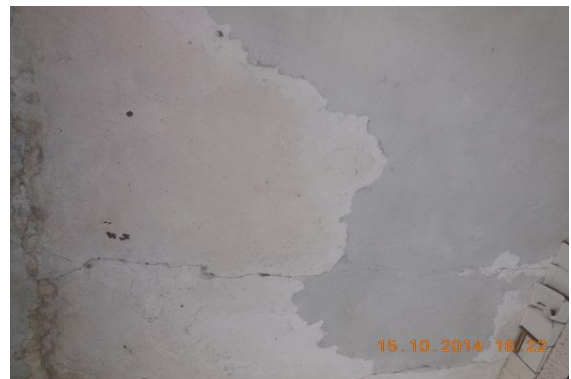
Photo 57

Horizontal Crack on Roof of Varanda of S.No.245,Ground Floor
Approx. Width = 0.60mm, Approx.Length = 1.80m.
Distance from Beam =0m, Height from Floor =2.8m.

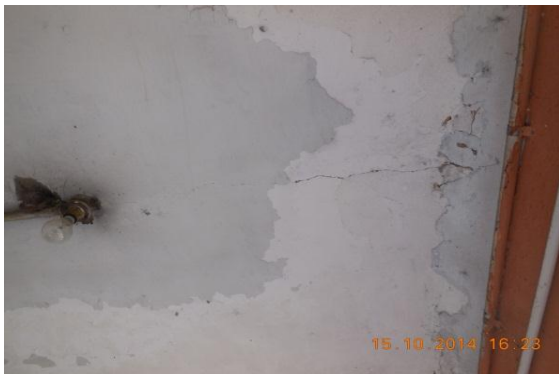
Photo 58

Horizontal Crack on Roof of Varanda of S.No.245,Ground Floor
Approx. Width = 0.25mm, Approx.Length = 1.80m.
Distance from L.Ext. Col. =1.60m, Height from Floor =2.8m.

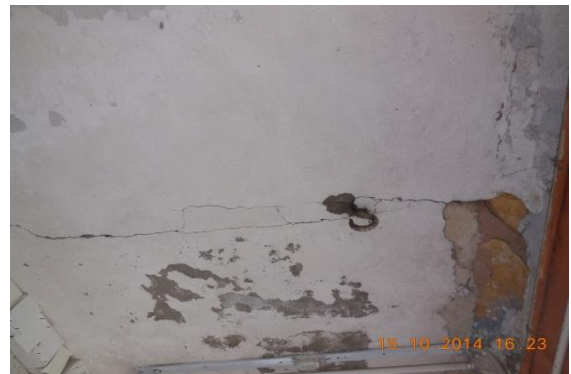
Photo 59

Horizontal Crack on Roof of Varanda of S.No.245,Ground Floor
Approx. Width = 1.0mm, Approx.Length = 1.80m.
Distance from R.Ext. Col. =0.70m, Height from Floor =2.8m.

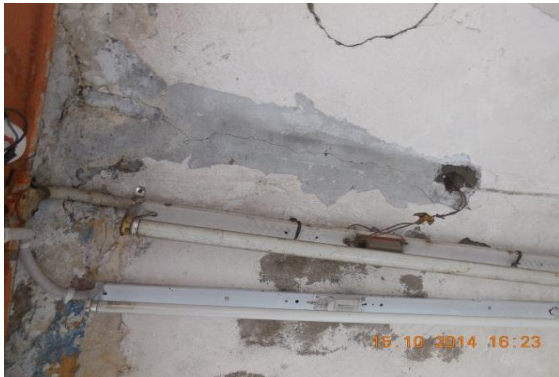
Photo 60

Horizontal Crack on Roof of Varanda of S.No.246,Ground Floor
Approx. Width =0.15mm, Approx.Length = 1.80m.
Distance from L.Ext. Col. =0.20m, Height from Floor =2.8m.

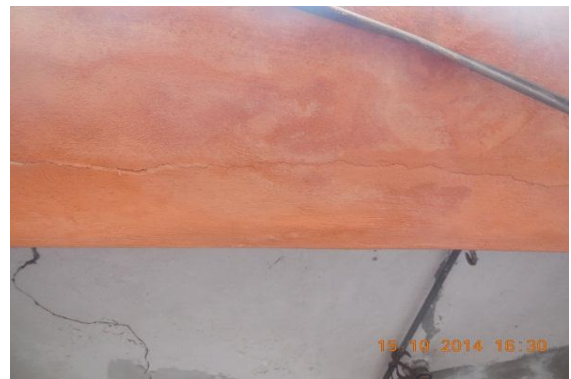
Photo 63

Horizontal Crack on Ext.Beam of Varanda of S.No.245,G. Floor
Approx. Width = 0.15mm, Approx.Length = 2.10m.
Distance from R.Ext. Col. =0.20m, Height from Floor =2.5m.

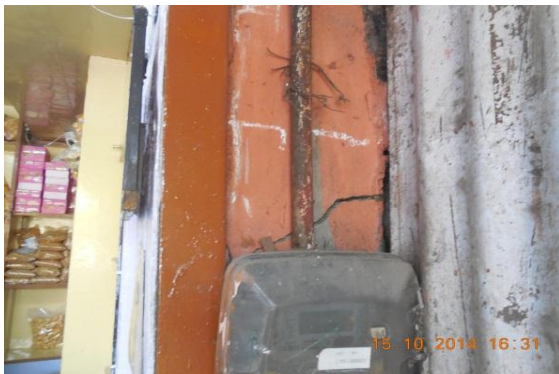
Photo 64

Horizontal Crack on Right Int.Col. of Varanda of S.No.245, G. Floor
Approx. Width = 5.0mm, Approx.Length = 0.30m.
Distance from R.Int.Col. =0m, Height from Floor =1.5m.

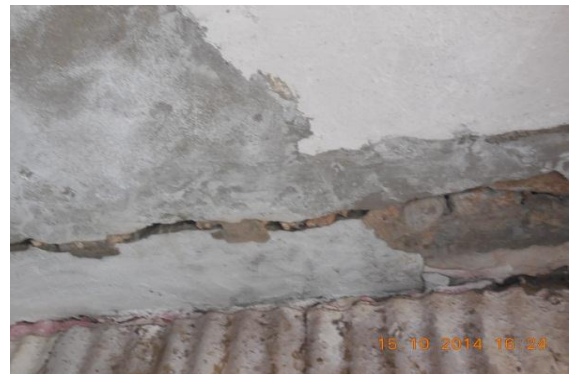
Photo 65

Damage on Roof of Varanda of S.No.246,Ground Floor

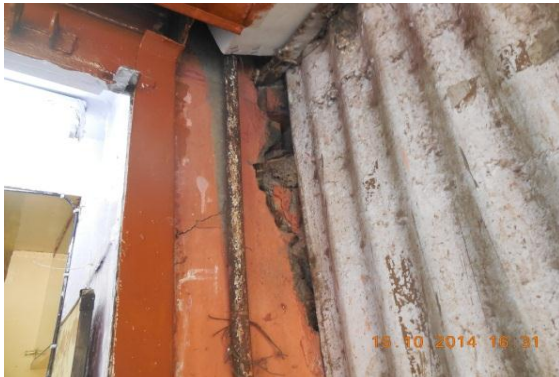
Photo 66

Damage on Right Int.Col. of Varanda of S.No.246, Ground Floor

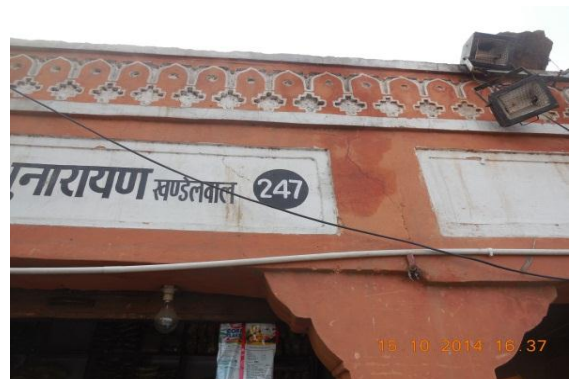
Photo 69A

Plaster Crack on Wall No.3 of Varanda of S.No.247, Ground Floor

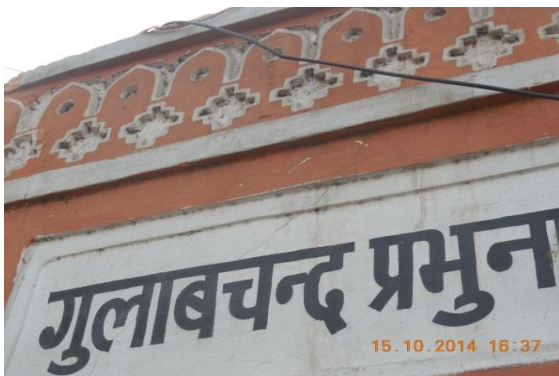
Photo 69B

Plaster Crack on Wall No.3 of Varanda of S.No.247, Ground Floor

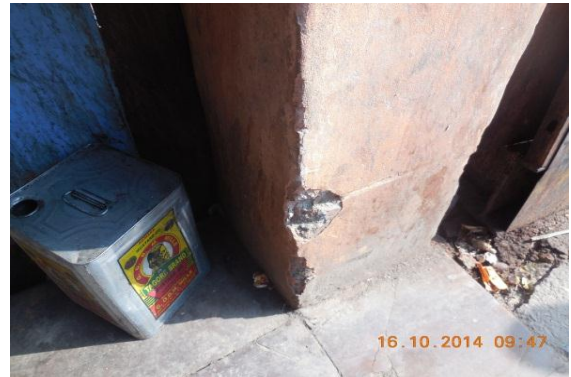
Photo 72

Plaster Removal on Left Ext.Col. of Verandah of S.No.248 & 249, Ground Floor

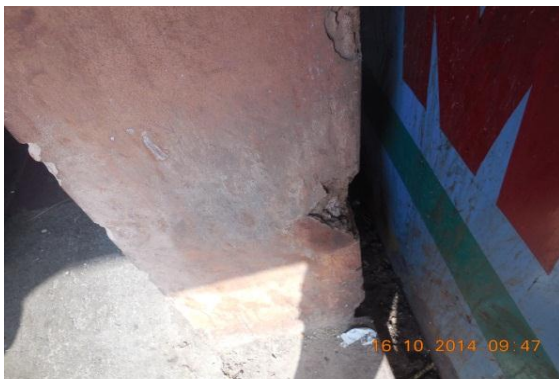
Photo 73

Plaster Removal on Right Ext. Col of Verandah of S.No.248 & 249, Ground Floor

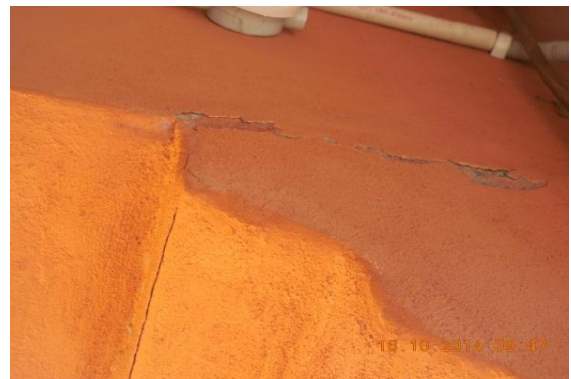
Photo 74

Peeling of Plaster on Ext.Beam of Verandah of S.No.248 & 249, Ground Floor

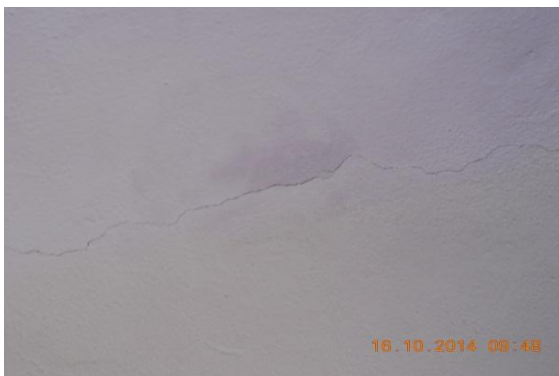
Photo 75

Horizontal Crack on Roof of Varanda of S.No.250,Ground Floor
Approx. Width = 0.25mm, Approx.Length = 1.80m.
Distance from R.Ext. Col. =0m, Height from Floor =2.8m.

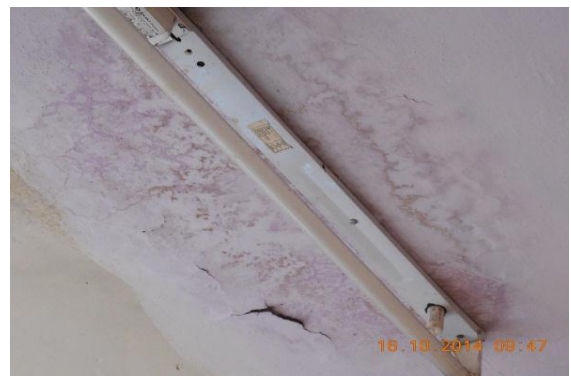
Photo 76

Dampness/Seepage on Roof of Verandah of S.No.250, Ground Floor

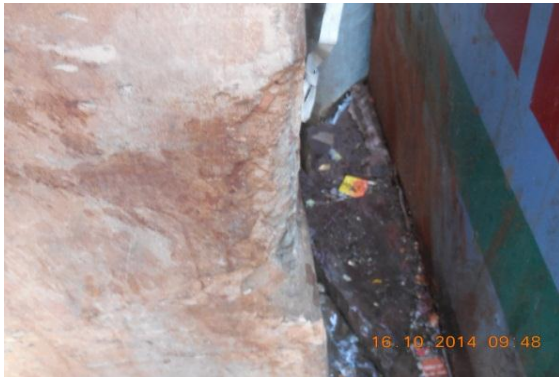
Photo 77

Plaster Removal on Right Ext. Col of Verandah of S.No.250, Ground Floor

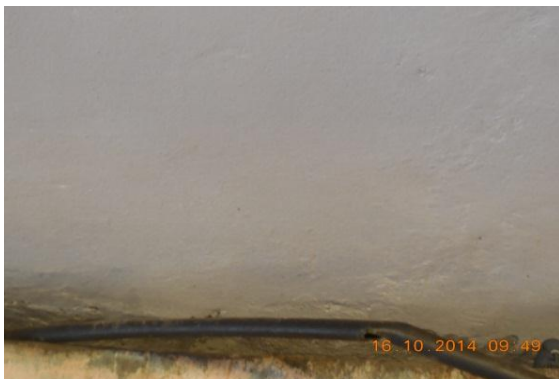
Photo 79

Peeling of Plaster on Roof of Verandah of S.No.251, Ground Floor

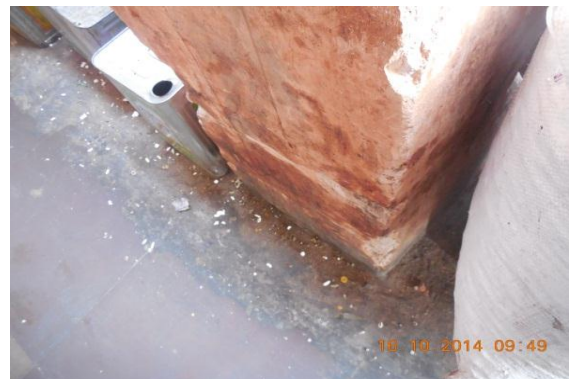
Photo 80

Plaster Removal on Right Ext.Col of Verandah of S.No.251, Ground Floor

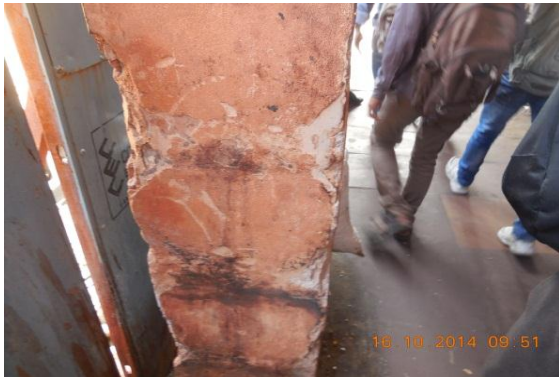
Photo 83

Plaster Removal on Left Ext.Col of Verandah of S.No.252, Ground Floor

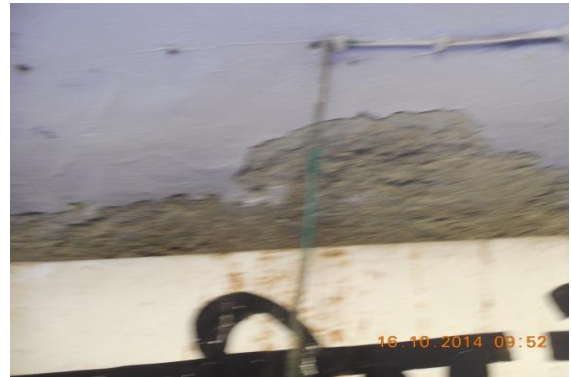
Photo 84

Peeling of Plaster on Roof of Verandah of S.No.252, Ground Floor

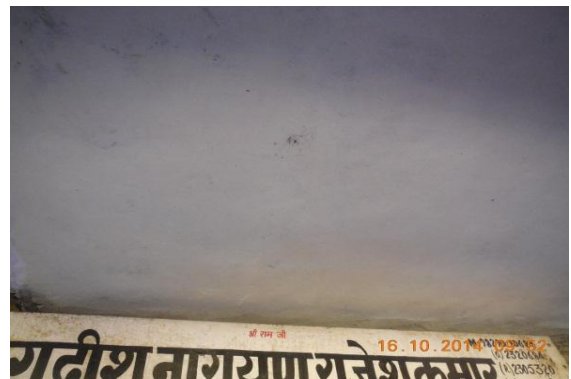
Photo 86

View of Roof of Verandah of S.No.252A, Ground Floor

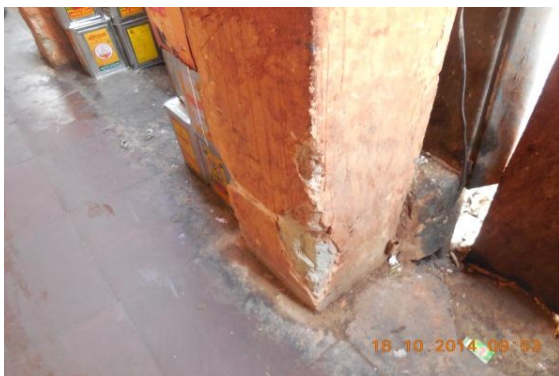
Photo 87

Plaster Removal on Right Ext.Col of Verandah of S.No.252A, Ground Floor

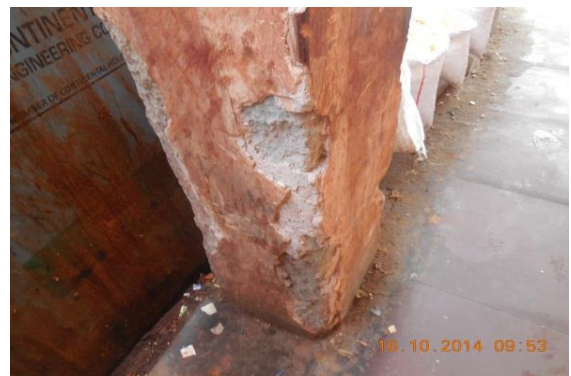
Photo 88

Plaster Removal on Left Ext.Col of Verandah of S.No.252A, Ground Floor

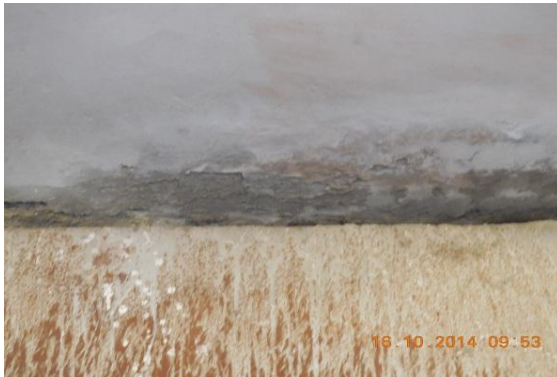
Photo 89

Dampness/Seepage on Roof of Verandah of S.No.253, Ground Floor

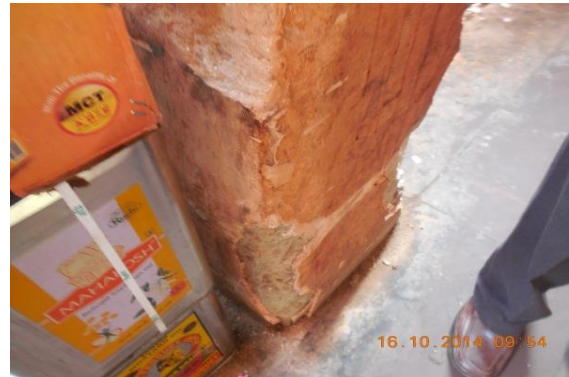
Photo 90

Plaster Removal on Right Ext.Col of Verandah of S.No.253, Ground Floor

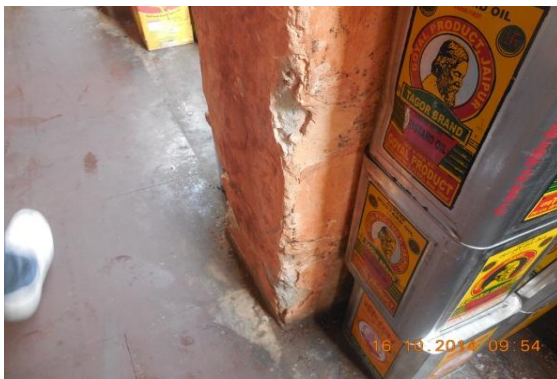
Photo 91

Plaster Removal on Left Ext.Col of Verandah of S.No.253, Ground Floor

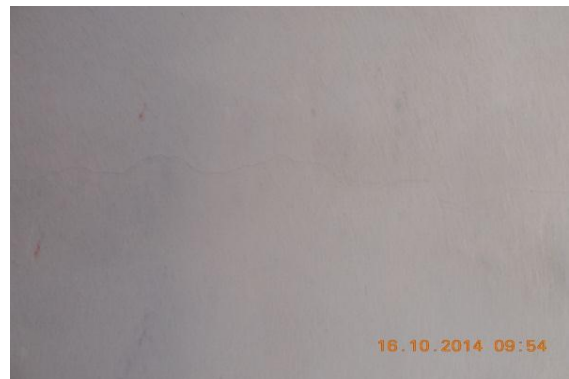
Photo 92

Plaster Crack on Roof of Verandah of S.No.253, Ground Floor

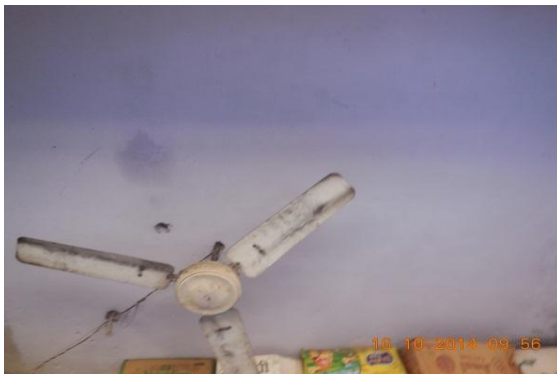
Photo 93

View of Roof of Verandah of S.No.254, Ground Floor

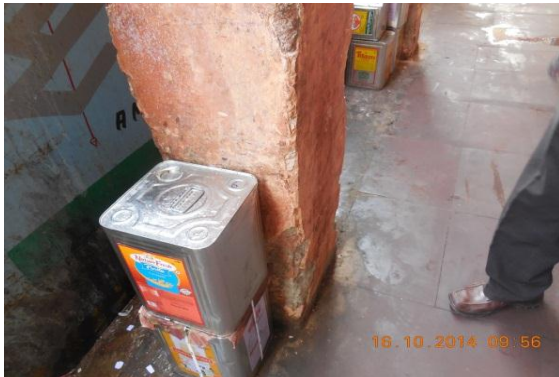
Photo 95

Plaster Crack on Right Ext.Col of Verandah of S.No.254, Ground Floor

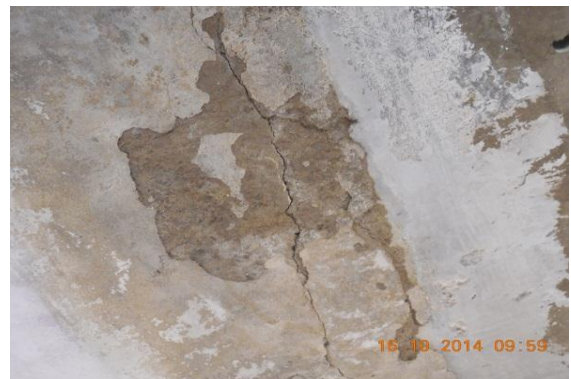
Photo 98

Dampness/Seepage on Roof of Verandah of S.No.255, Ground Floor

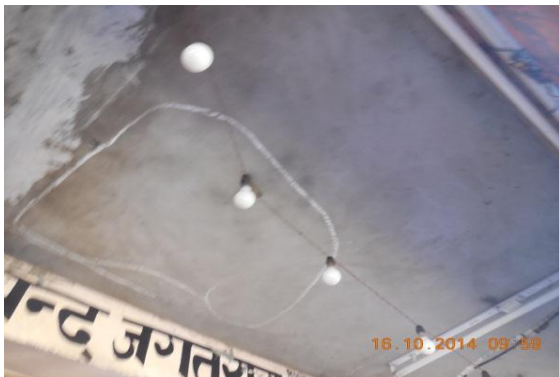
Photo 99

Repairing Work on Roof of Verandah of S.No.255, Ground Floor

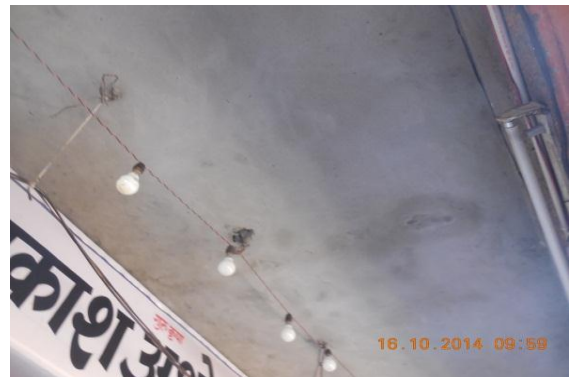
Photo 100

View of Roof of Verandah of S.No.255, Ground Floor

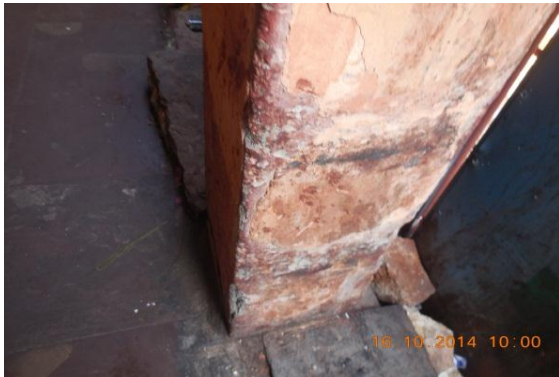
Photo 101

Peeling of Plaster on Right Ext.Col of Verandah of S.No.256, Ground Floor

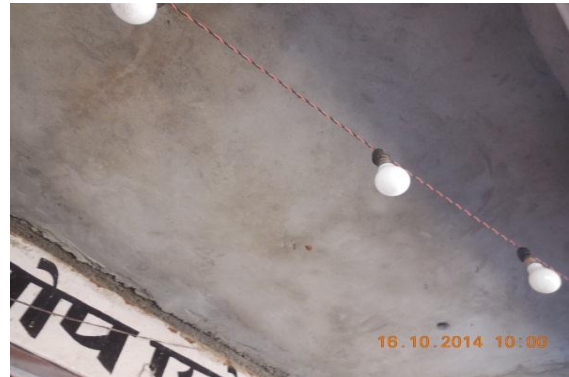
Photo 102

View of Roof of Verandah of S.No.257, Ground Floor

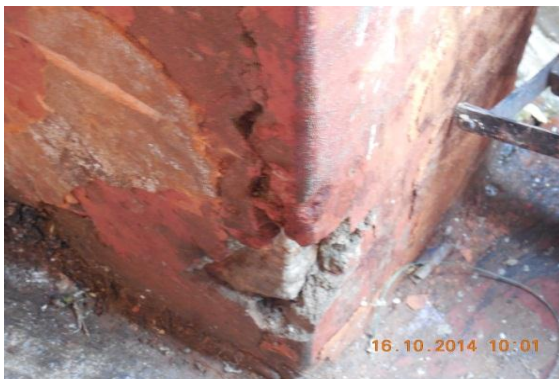
Photo 103

Plaster Removal on Right Ext.Col of Verandah of S.No.257, Ground Floor

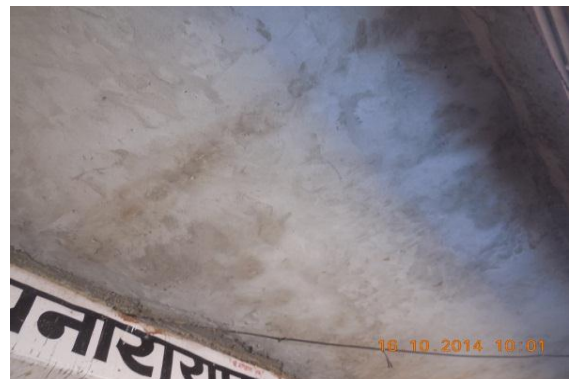
Photo 104

View of Roof of Verandah of S.No.258, Ground Floor

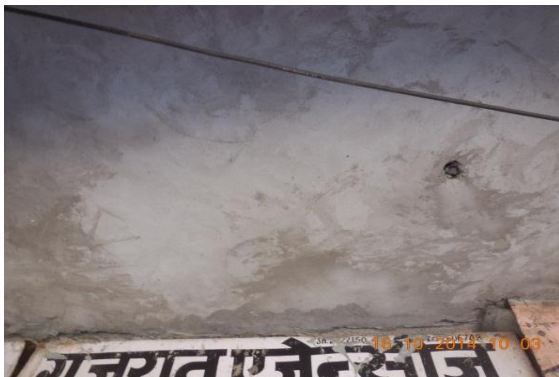
Photo 105

View of Roof of Verandah of S.No.259, Ground Floor

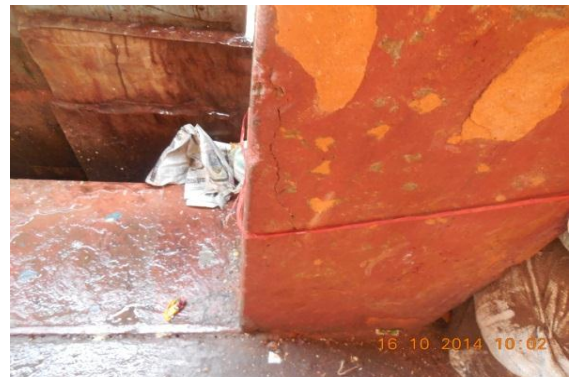
Photo 106

Horizontal Crack on Left Ext.Col. of Verandah of S.No.259, G.F.
Approx. Width = 0.60mm, Approx.Length = 0.35m.
Distance from L.Ext. Col. = 0m, Height from Floor = 2.8m.

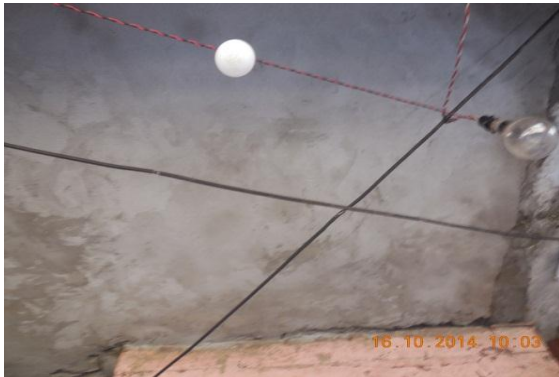
Photo 107

View of Roof of Verandah of S.No.259A, Ground Floor

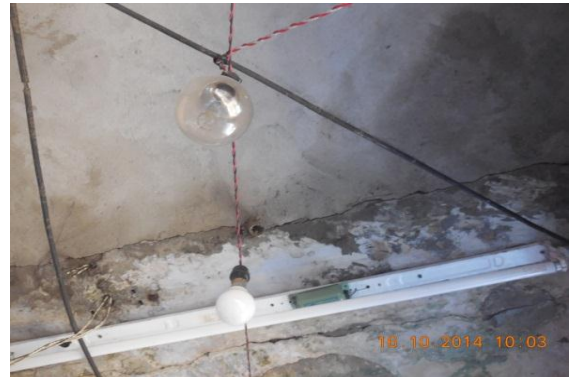
Photo 108A

Horizontal Crack on Roof & R.Ext.Col.of Verandah of S.No.259A, (G.F.)
Approx. Width = 1.50mm, Approx.Length = 2.60m.
Distance from R.Ext. Col. =0m, Height from Floor =2.8m.

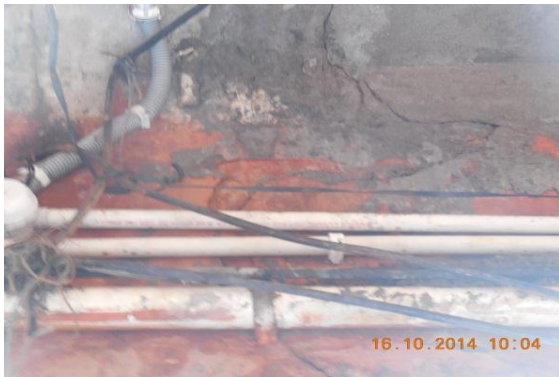
Photo 108B

Horizontal Crack on Roof & R.Ext.Col.of Verandah of S.No.259A, (G.F.)
Approx. Width = 1.50mm, Approx.Length = 2.60m.
Distance from R.Ext. Col. =0m, Height from Floor =2.8m.

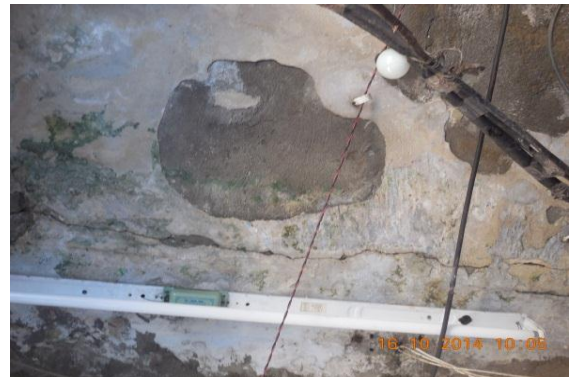
Photo 109

Horizontal Crack on Roof of Verandah of S.No.260, (G.F.) Approx.
Width = 0.80mm, Approx.Length = 2.0m.
Distance from L.Int. Col. =0m, Height from Floor =2.8m.

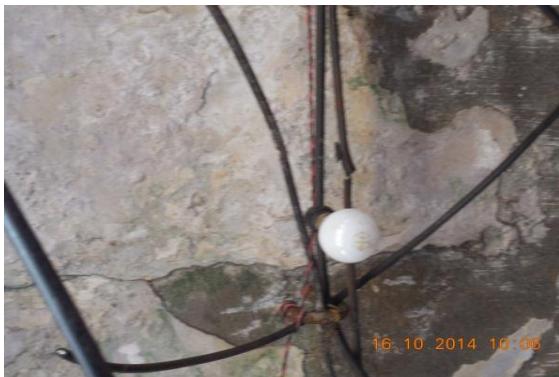
Photo 110

Horizontal Crack on Roof of Verandah of S.No.260, (G.F.) Approx.
Width = 0.80mm, Approx.Length = 2.0m.
Distance from L.Ext. Col. =1.0m, Height from Floor =2.8m.

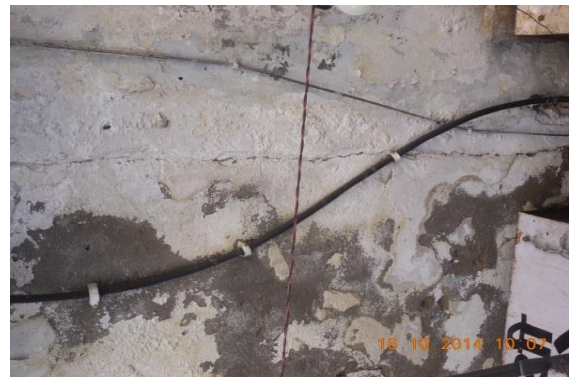
Photo 111

Horizontal Crack on Roof of Verandah of S.No.260, (G.F.) Approx.
Width = 0.60mm, Approx.Length = 2.0m.
Distance from R.Ext. Col. =0m, Height from Floor =2.8m.

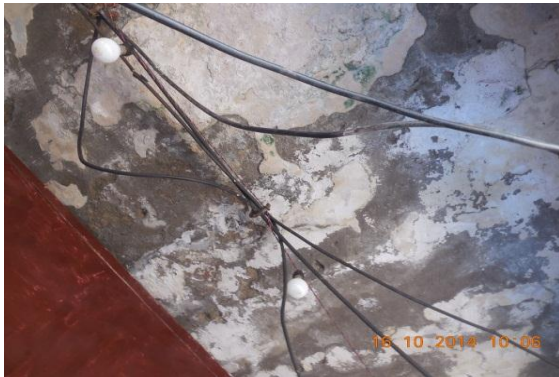
Photo 112

Dampness/Seepage on Roof of Verandah of S.No.260, Ground Floor

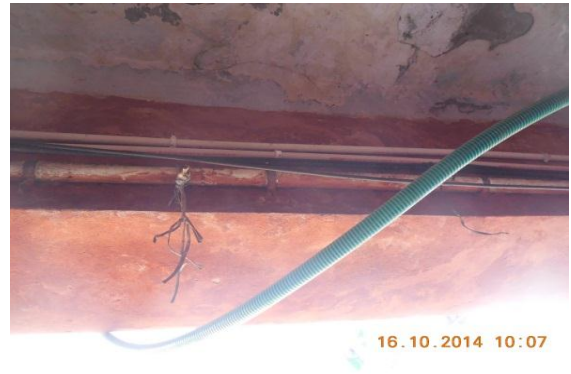
Photo 113

Dampness/Seepage on External Beam of Verandah of S.No.260, Ground Floor

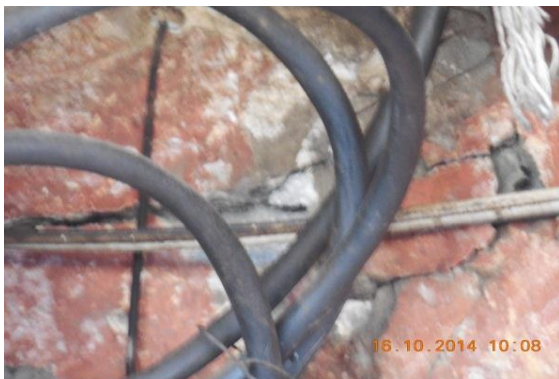
Photo 114

Plaster Removal on Roof of Verandah of S.No.260, Ground Floor

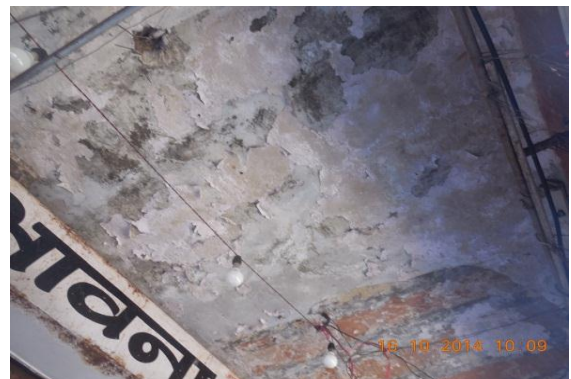
Photo 115

Dampness/Seepage on Roof of Verandah of S.No.261, Ground Floor

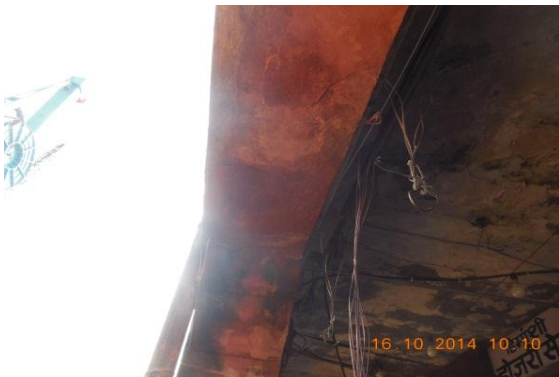
Photo 116

Dampness/Seepage on Beam & Left Ext.Col.of Verandah of S.No.261, Ground Floor
