Pre - Condition Building Survey for Construction of Underground Stations from Chandpole to Bari Chouper and reversal line

Shops
Chandpol Bazar
Jaipur
Unique ID: CP-CC-DL-0151

Report Number: AIMIL/ESG/JMCEC/CP-CC-DL-0151/03/Verandah, Rev. 02, Dated: October, 2014

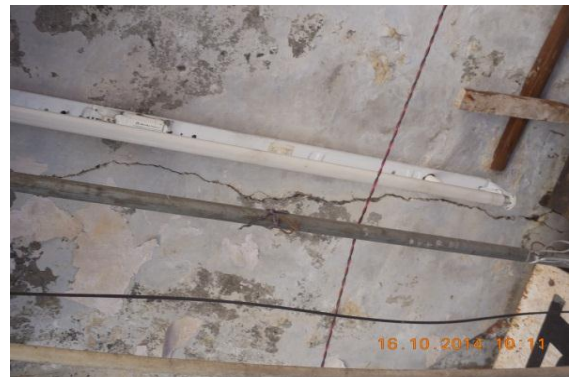
Photo 117

Horizontal Crack on Roof of Verandah of S.No.262, (G.F.) Approx. Width = 0.80mm, Approx.Length = 2.0m. Distance from L.Ext. Col. =0m, Height from Floor =2.8m.

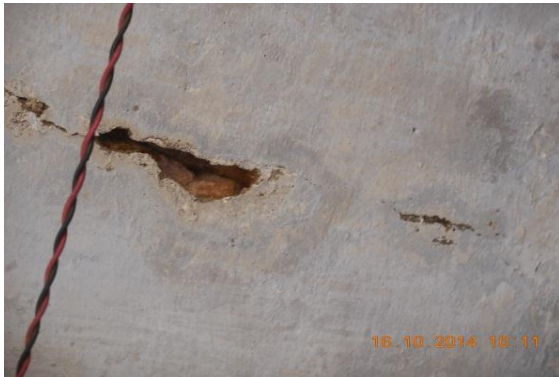
Photo 118
Plaster Removal on Roof of Verandah of S.No.262,
Ground Floor

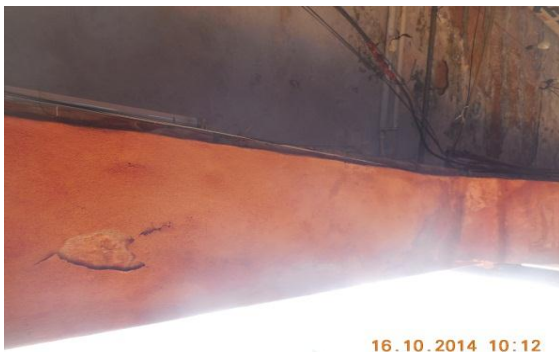
Photo 120
Dampness/Seepage on Ext.Beam & Col. of Verandah of S.No.262,
Ground Floor

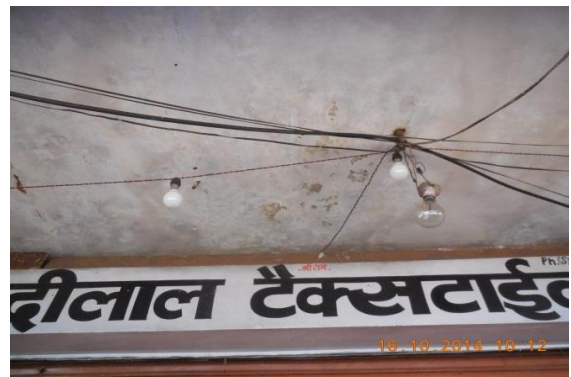
Photo 121
Dampness/Seepage on Roof of Verandah of S.No.262,
Ground Floor
