**JAIPUR METRO Jaipur Metro Rail Corporation**

Pre - Condition Building Survey for Construction of Underground Stations from Chandpole to Bari Chouper and reversal line

Shops  
Chandpol Bazar  
Jaipur  
Unique ID: CP-CC-UP-0071

Report Number: AIMIL/ESG/JMCEC/CP-CC-UP-0071/02/Verandah, Rev. 02, Dated: October, 2014

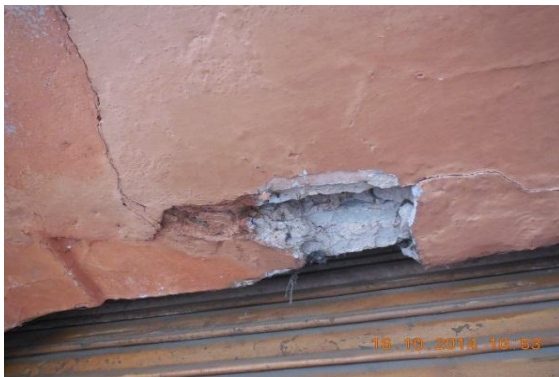
Photo 11  
Plaster Removal on Int. Beam of Verandah of S.No.189,  
Ground Floor

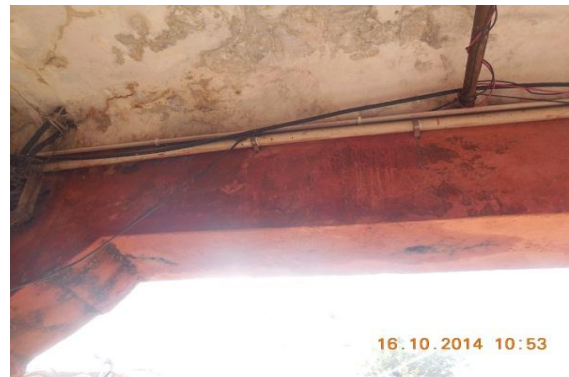
Photo 12  
Dampness/Seepage on Ext. Beam of Verandah of S.No.189,  
Ground Floor

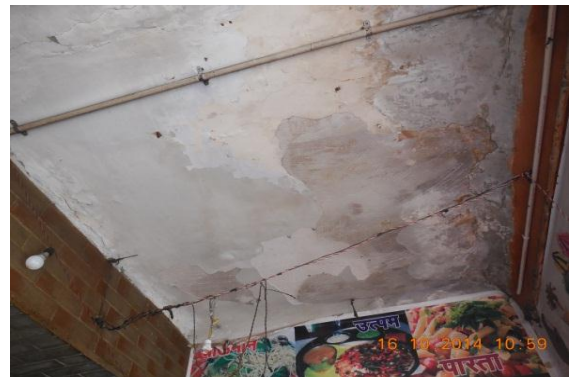
Photo 17

Peeling of Plaster on Roof of Verandah of S.No.191,  
Ground Floor

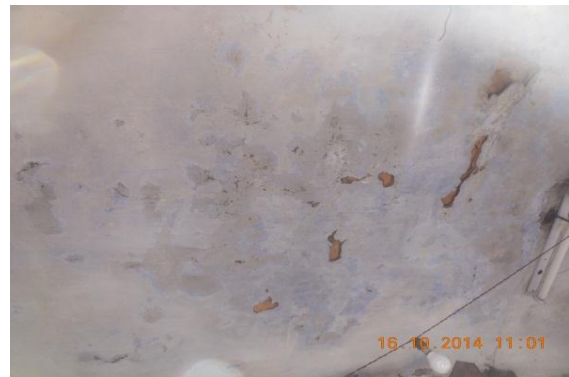
Photo 21

Dampness/Seepage on Roof of Verandah of S.No.192,  
Ground Floor

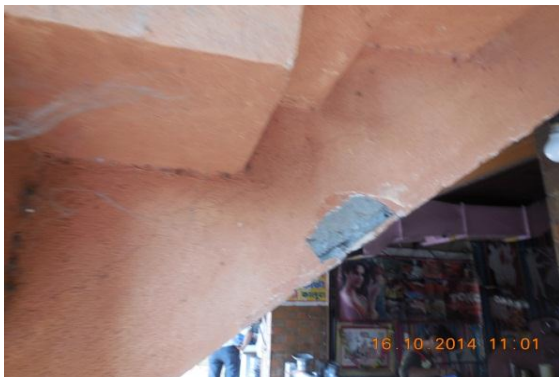
Photo 22

Plaster Removal on Wall No.1 of Verandah of S.No.192,  
Ground Floor

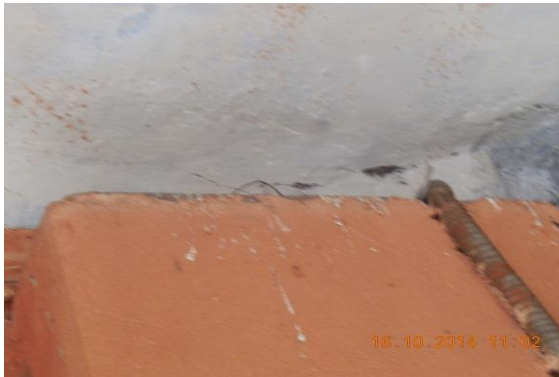
Photo 24  
Plaster Removal on Roof of Verandah of S.No.192,  
Ground Floor

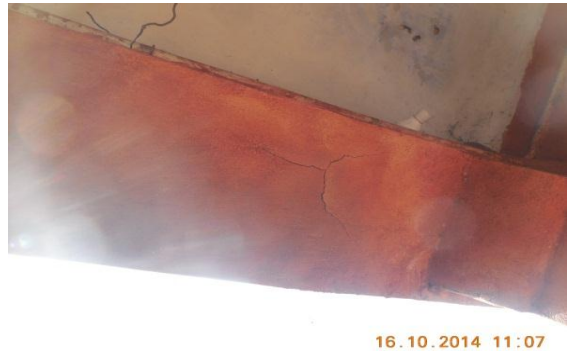
Photo 25  
Dampness/Seepage on Ext.Beam of Verandah of S.No.192,  
Ground Floor

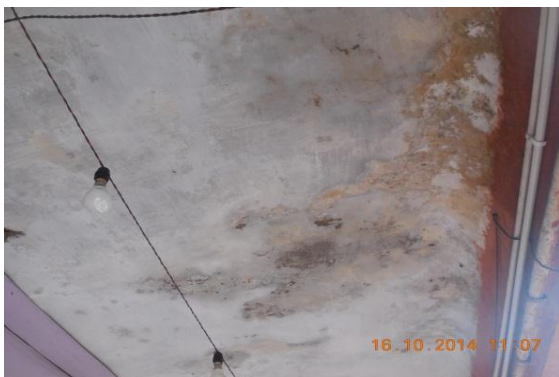
Photo 26  
Dampness/Seepage on Roof of Verandah of S.No.193,  
Ground Floor

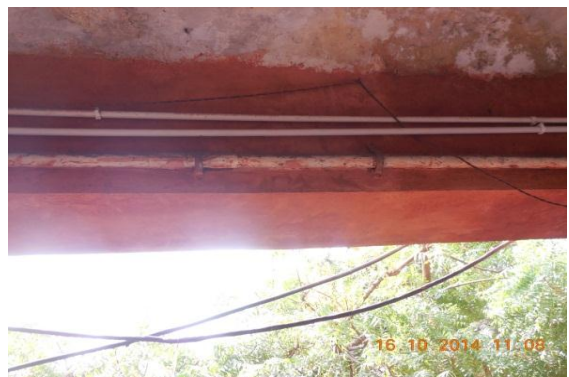
Photo 27  
Dampness/Seepage on Ext. Beam of Verandah of S.No.193,  
Ground Floor

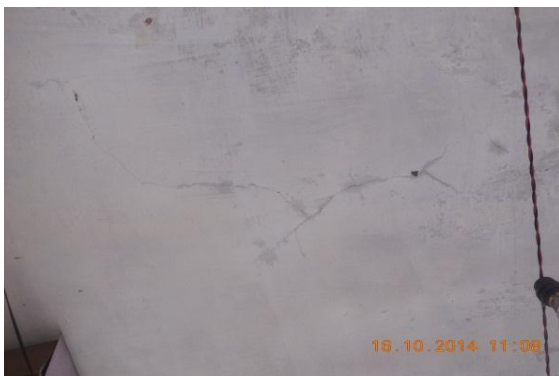
| Summary of Defects Other Than Crack | | | |
|---|---|---|---|
| 13 | Roof of Verandah of S.No.193,Ground Floor | Plaster Crack | 28 |

Photo 28  
Plaster Crack on Roof of Verandah of S.No.193,  
Ground Floor

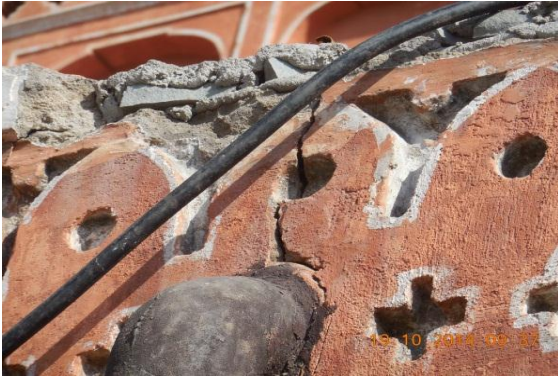
Photo 30

Inclined Crack on Outer R.Ext.Col. of Verandah of S.No.194, (G.F.),  
Approx. Width = 2.50mm, Approx.Length = 1.20m.  
Distance from Right Ext.Col. = 0m, Height from Floor = 2.50m.

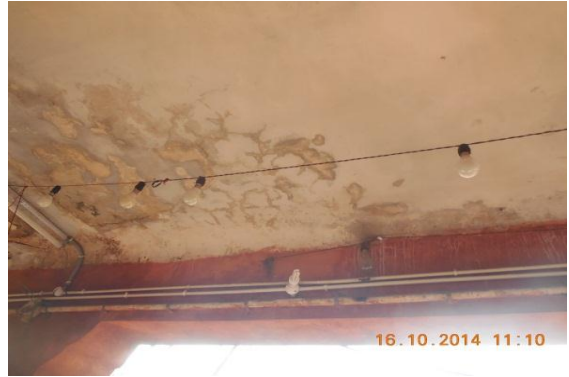
Photo 31

Dampness/Seepage on Roof of Verandah of S.No.194,  
Ground Floor

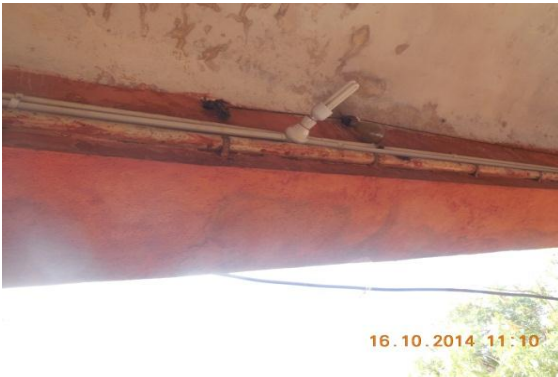
Photo 32

Dampness/Seepage on Ext. Beam of Verandah of S.No.194,  
Ground Floor

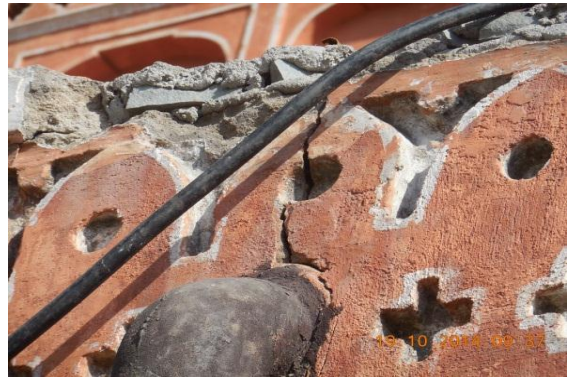
Photo 33

Plaster Removal on Outer R.Ext.Col. of Verandah of S.No.194,  
Ground Floor

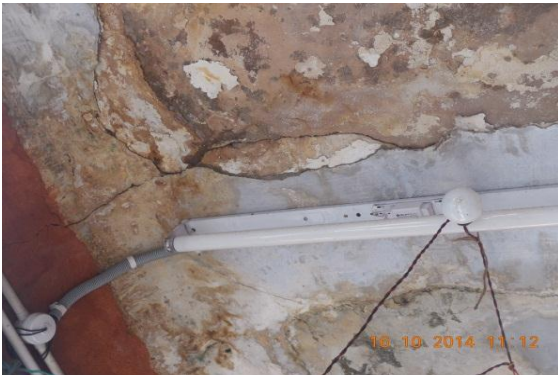
Photo 34

Horizontal Crack on Roof of Verandah of S.No.195, (G.F.), Approx.  
Width = 1.0mm, Approx.Length = 2.0m.  
Distance from Left Int.Col. = 0m, Height from Floor = 2.80m.

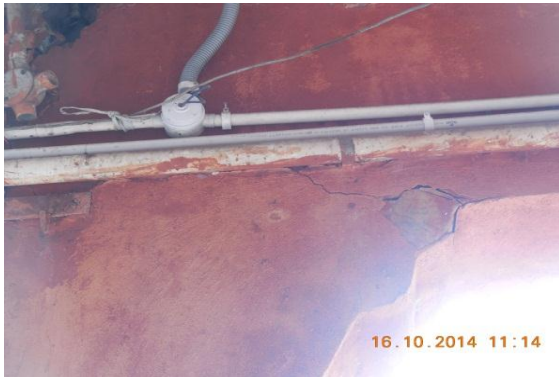
Photo 36

Inclined Crack on Right Ext.Col. of Verandah of S.No.195, (G.F.),  
Approx. Width = 2.0mm, Approx.Length = 0.30m.  
Distance from Joint of Beam & Col. = 0m, Height from Floor = 2.50m.

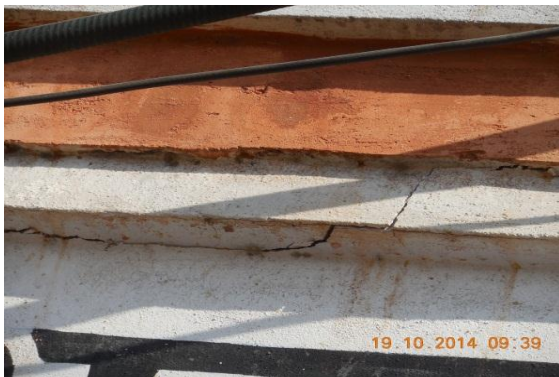
Photo 37A

Horizontal Crack on Outer Ext.Beam of Verandah of  
S.No.195&196, (G.F.), Approx. Width=2.0mm, Approx.Length=4.0m.  
Distance from Right Ext.Col. = 0m, Height from Floor = 2.50m.

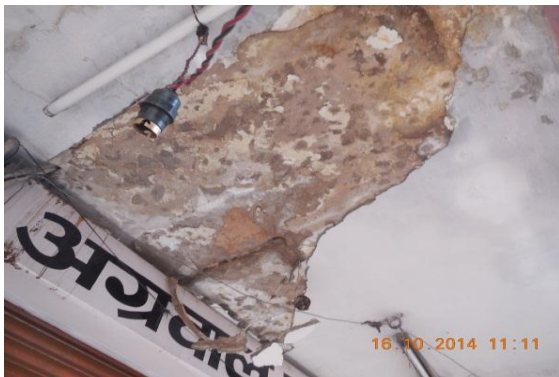
Photo 39

Plaster Removal on Roof of Verandah of S.No.195,  
Ground Floor

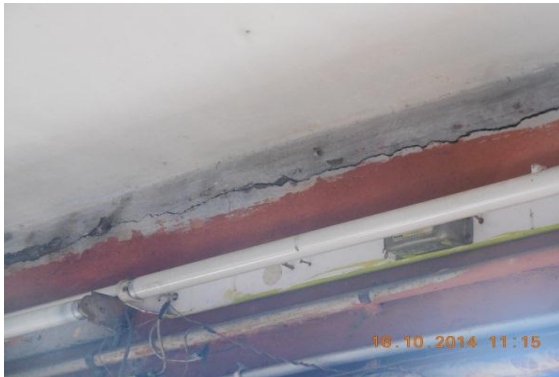
Photo 7

Horizontal Crack on Ext. Beam of Verandah of S.No.196,(G. Floor)  
Approx. Width = 2.5mm, Approx.Length = 2.3m.  
Distance from L.Ext.Col. =0m, Height from Floor =2.80m.

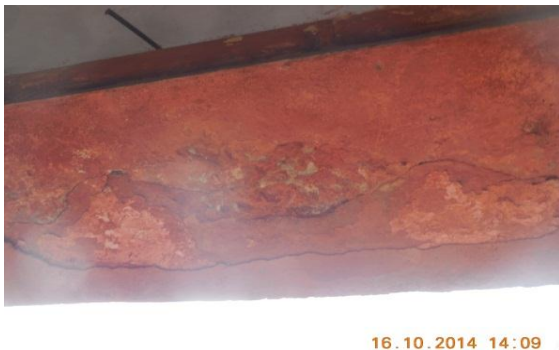
Photo 9

Inclined Crack on Ext. Beam of Verandah of S.No.197,(G. Floor)  
Approx. Width = 0.60mm, Approx.Length = 1.8m.  
Distance from Left Ext. Col. = 0.40m, Height from Floor =2.0m.

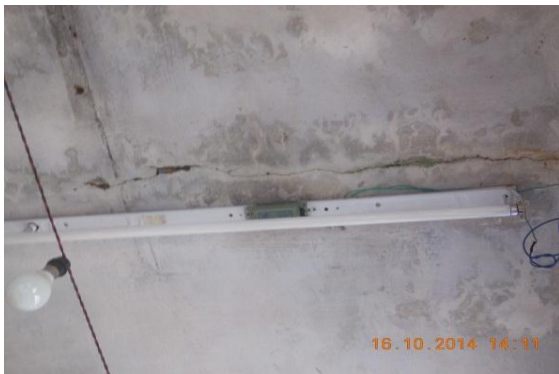
Photo 11

Horizontal Crack on Roof of Veranda of Ganpati Guest House,(GF)  
Approx. Width = 0.50mm, Approx.Length = 1.8m.  
Distance from R.Ext.Col. =0.4m, Height from Floor =2.5m.

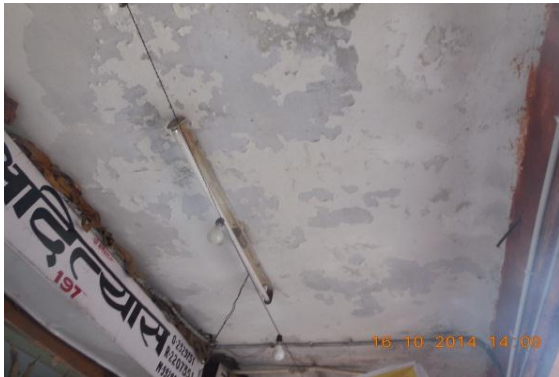
Photo 13

Peeling of Plaster on Roof of Verandah of S.No.197,  
Ground Floor

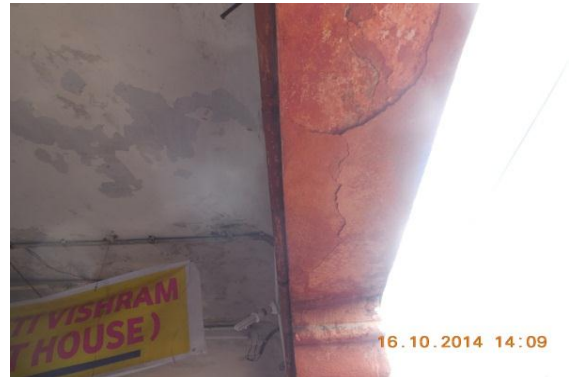
Photo 14

Dampness/Seepage on Ext. Beam of Verandah of S.No.197,  
Ground Floor

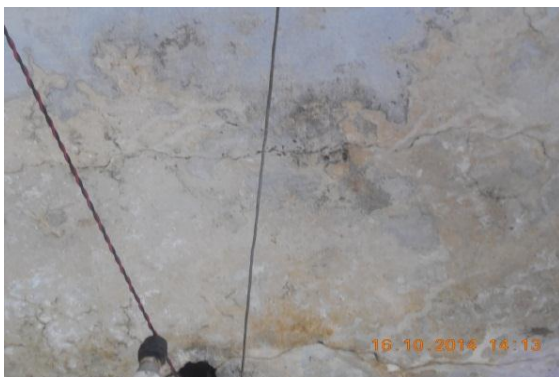
Photo 15

Horizontal Crack on Roof of Verandah of S.No.198,(G. Floor)  
Approx. Width = 0.35mm, Approx.Length = 1.30m.  
Distance from R.Ext.Col. =0m, Height from Floor =2.80m.

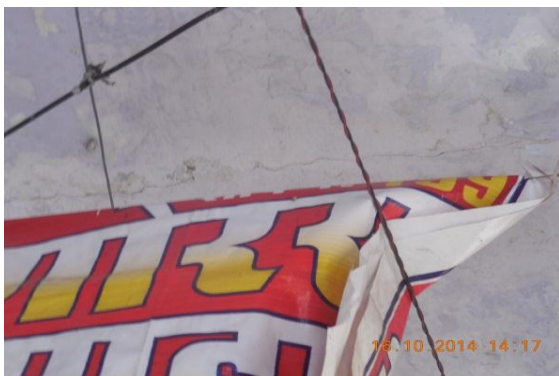
Photo 17

Dampness/Seepage on Roof of Verandah of S.No.198,,  
Ground Floor

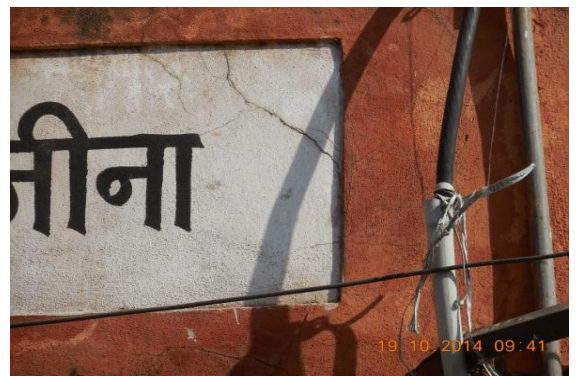
Photo 18

Dampness/Seepage on Outer Left Ext.Col.of Verandah of S.No.198,  
Ground Floor

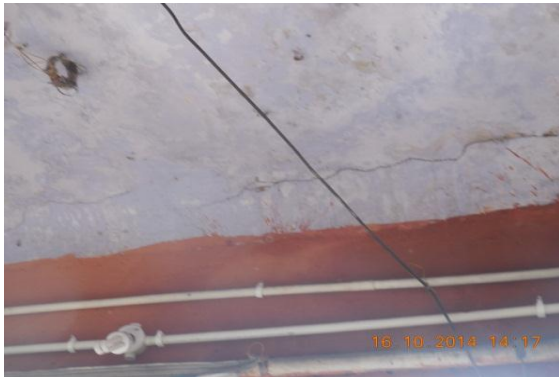
Photo 19

Horizontal Crack on Ext.Beam & Roof of Verandah of S.No.199,GF  
Approx. Width = 0.40mm, Approx.Length = 2.30m.  
Distance from Left Ext.Col.=0.0m, Height from Floor =2.80m.

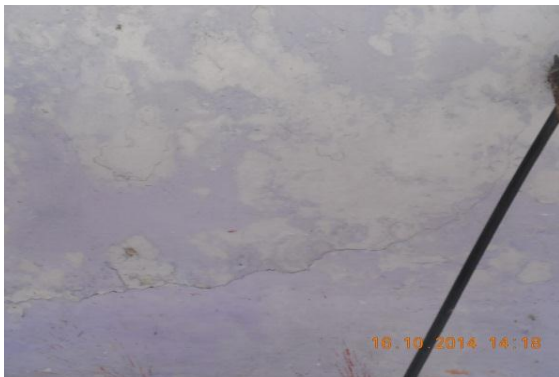
Photo 21

Plaster Crack on Ext.Beam & Roof of Verandah of S.No.199,  
Ground Floor

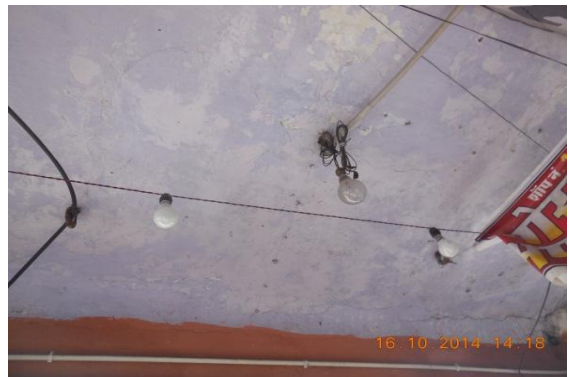
Photo 22

Dampness/Seepage on Roof of Verandah of S.No.199,  
Ground Floor

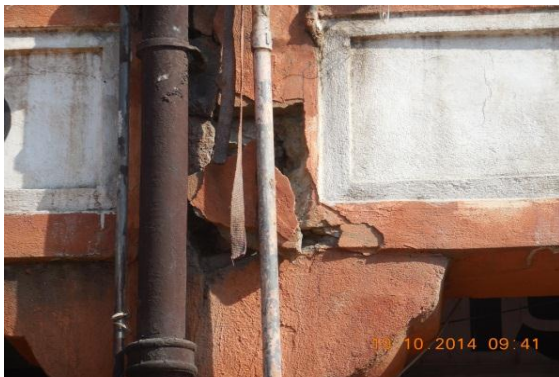
Photo 23

Plaster Removal on Outer Left Ext.Col.of Verandah of S.No.199,  
Ground Floor

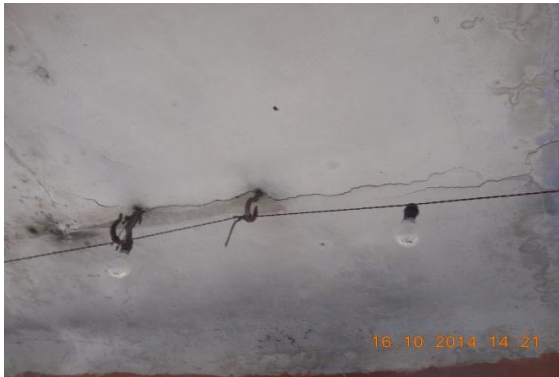
Photo 24B

Horizontal Crack on Roof of Verandah of S.No.200, (G.F.), Approx.  
Width = 1.0mm, Approx.Length = 2.80m.  
Distance from L.Ext.Col. = 0.1m, Height from Floor = 2.80m.

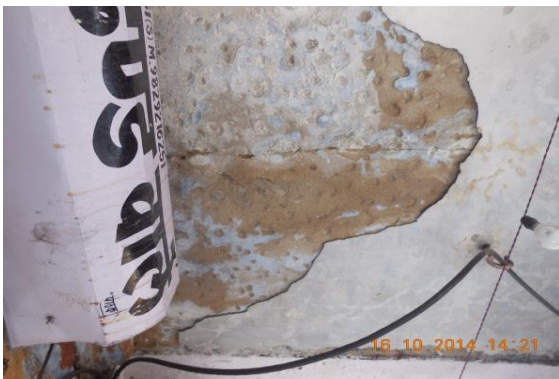
Photo 26

Dampness/Seepage on Roof of Verandah of S.No.200,  
Ground Floor

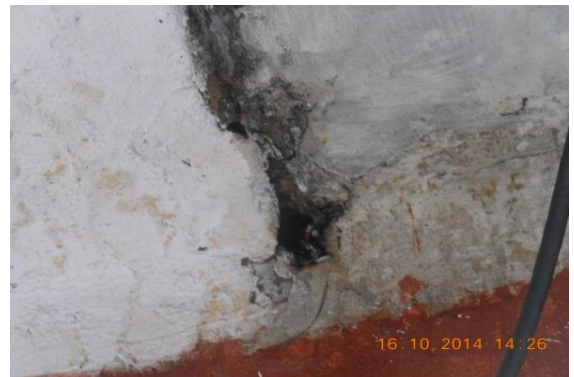
Photo 6  
Plaster Removal on Roof of Verandah of S.No.201,  
Ground Floor

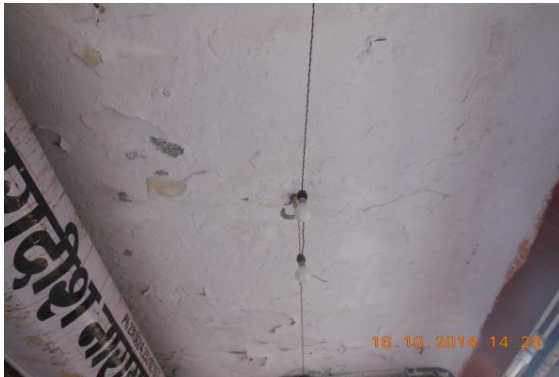
Photo 7

Dampness/Seepage on Roof of Verandah of S.No.201,  
Ground Floor

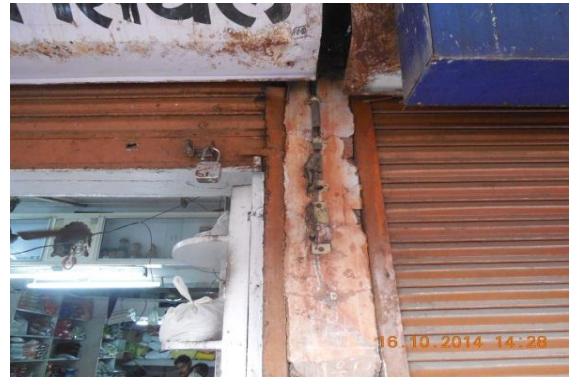
Photo 8

Plaster Removal on Right Int. Col. of Verandah of S.No.201,  
Ground Floor

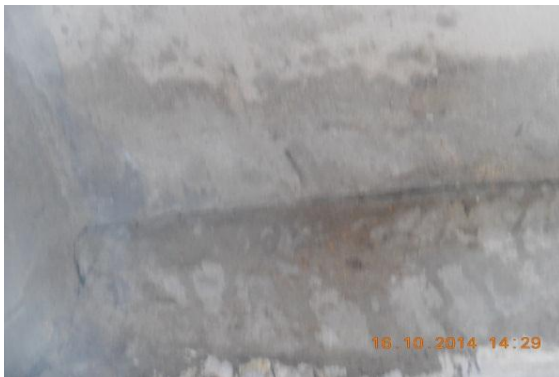
Photo 9

Horizontal Crack on Roof of Verandah of S.No.202, (G. Floor)  
Approx. Width = 0.50mm, Approx.Length = 2.0m.  
Distance from Right Ext. Col. = 0m, Height from Floor = 2.80m.

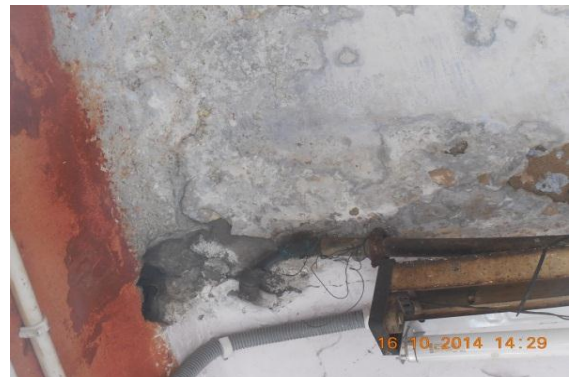
Photo 10

Plaster Removal on Roof of Verandah of S.No.202,  
Ground Floor

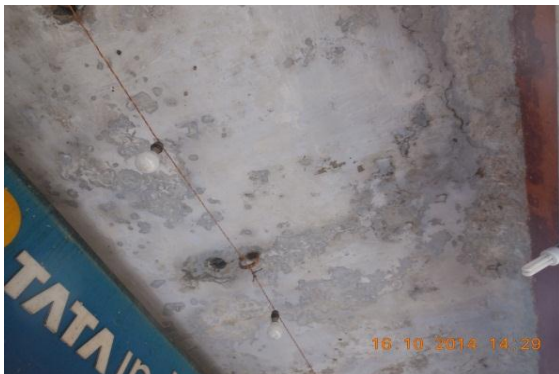
Photo 11

Dampness/Seepage on Roof of Verandah of S.No.202,  
Ground Floor

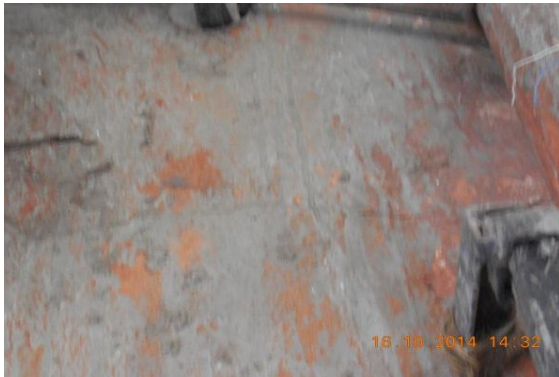
Photo 7

Inclined Crack on Right Int. Col. of Verandah of S.No.204, (G.F.)  
Approx. Width = 0.60mm, Approx.Length = 0.50m.  
Distance from R.Side Wall = 0m, Height from Floor = 2.20m.

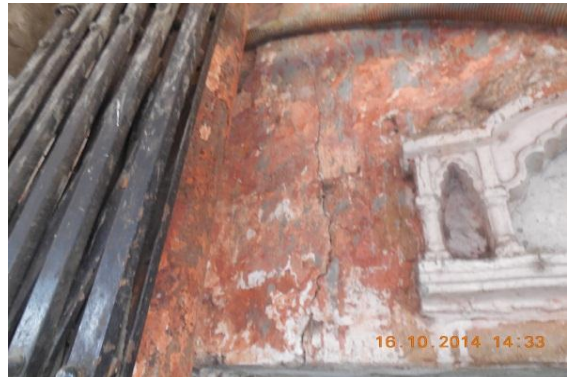
Photo 8

Vertical Crack on Int. Beam of Verandah of S.No.204 & 205, (G.F.)  
Approx. Width = 0.60mm, Approx.Length = 1.0m.  
Distance from L.Int.Col. = 0.30m, Height from Floor = 1.80m.

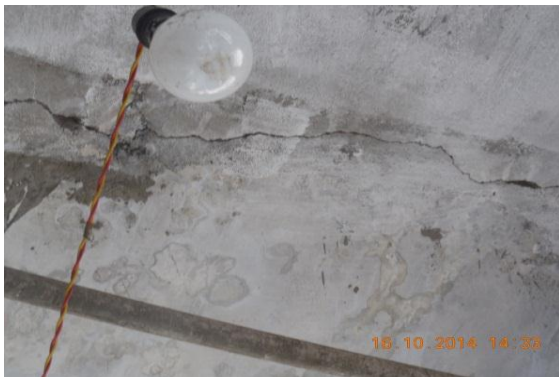
Photo 9

Horizontal Crack on Roof of Verandah of S.No.205, (G.F.)  
Approx. Width = 0.60mm, Approx.Length = 2.0m.  
Distance from L.Ext.Col. = 0m, Height from Floor = 2.8m.

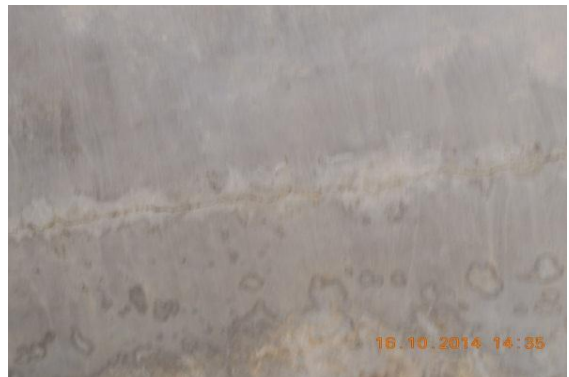
Photo 10

Horizontal Crack on Roof of Verandah of S.No.205, (G.F.)  
Approx. Width = 0.25mm, Approx.Length = 1.80m.  
Distance from R.Ext.Col. = 0.50m, Height from Floor = 2.8m.

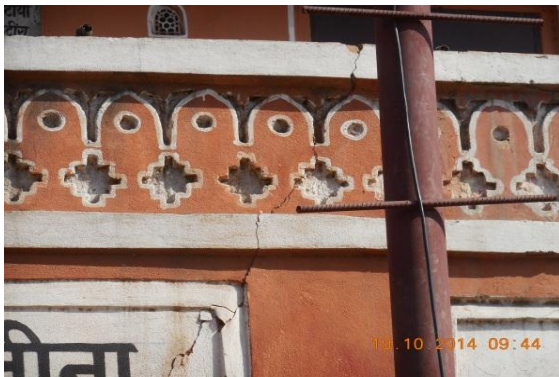
Photo 11

Inclined Crack on Outsideside L.Ext.Col. of Verandah of S.No.205, GF  
Approx. Width = 2.50mm, Approx.Length = 1.30m.  
Distance from L.Ext.Col. = 0m, Height from Floor = 2.5m.

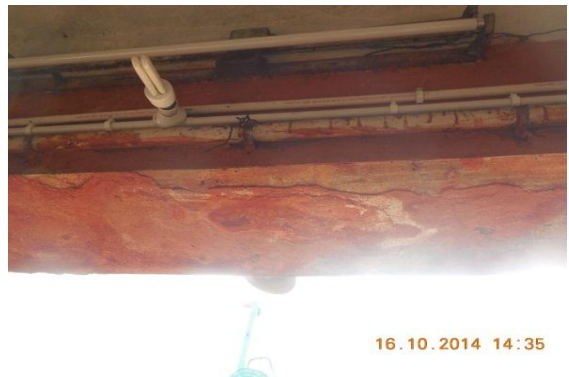
Photo 12

Dampness/Seepage on Ext. Beam of Verandah of S.No.205,  
Ground Floor

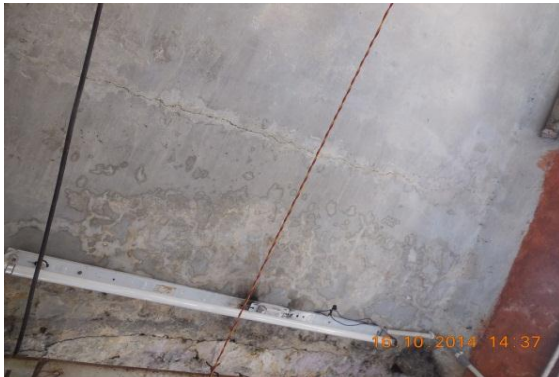
Photo 13

Dampness/Seepage on Roof of Verandah of S.No.205,  
Ground Floor

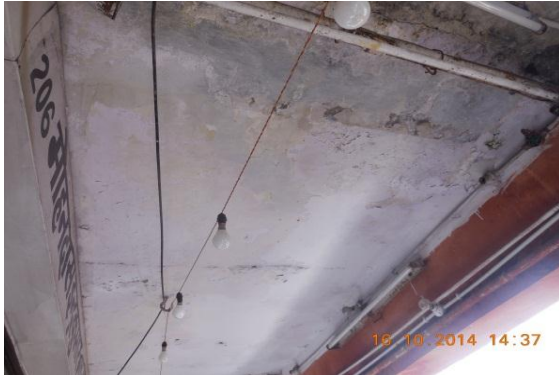
Photo 13  
Dampness/Seepage on Ext.Beam of Verandah of S.No.206,  
Ground Floor

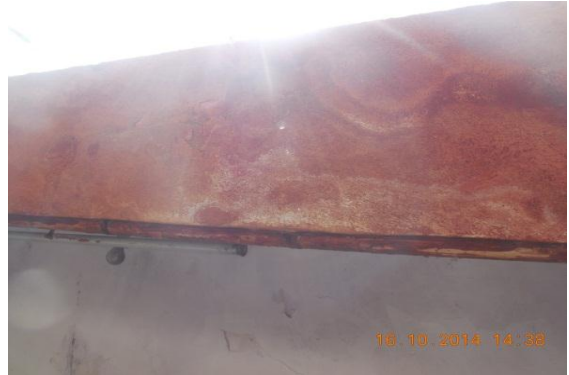
Photo 14  
Dampness/Seepage on Roof of Verandah of S.No.206,  
Ground Floor

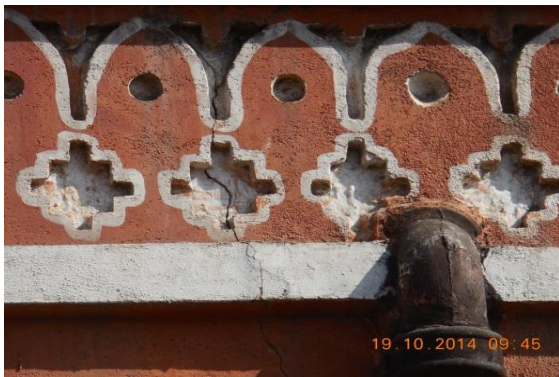
Photo 16B  
Inclined Crack on Outer L.Ext.Col. of Verandah of S.No.207(G.F)  
Approx. Width = 1.50mm, Approx.Length = 1.0m.  
Distance from L.Ext.Col. = 0m, Height from Floor = 2.70m.

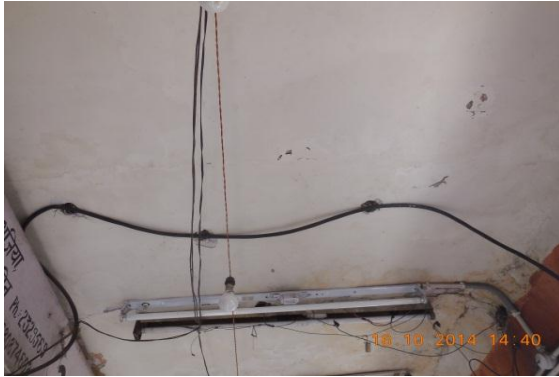
**Photo 18**  
Dampness/Seepage on Roof of Verandah of S.No.207,  
Ground Floor

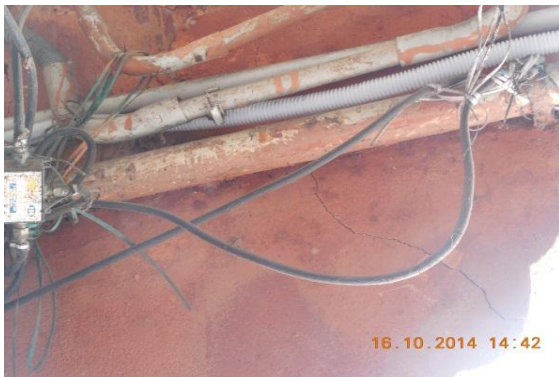
**Photo 20**  
Inclined Crack on RHS Col.& Verandah Beam of S.No.208,(G.F.)  
Approx. Width = 0.80mm, Approx.Length = 0.80m.  
Distance from Right Ext.Col.=0.0m, Height from Floor =2.0m.

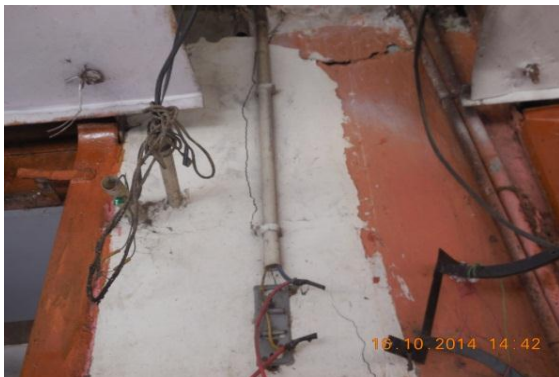
**Photo 21B**  
Inclined Crack on Roof & Right.Int.Col.of Verandah of S.No.208,GF  
Approx. Width = 0.80mm, Approx.Length = 0.80m.  
Distance from Right Ext.Col.=0.0m, Height from Floor =2.0m.

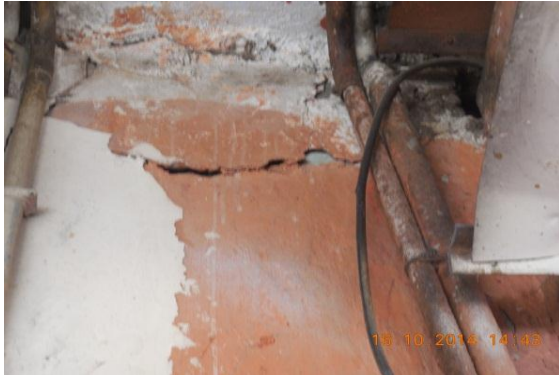
Photo 23

Plaster Removal on Int.RHS Col.of Verandah of S.No.208,  
Ground Floor

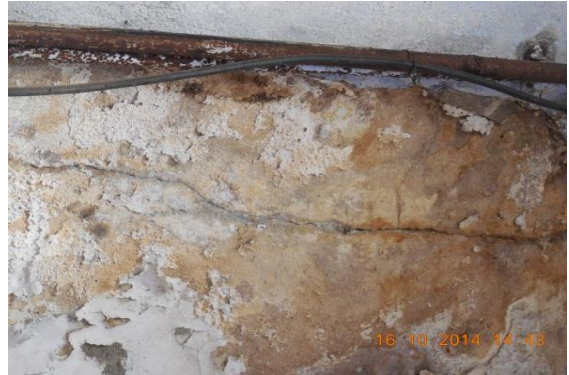
Photo 24

Horizontal Crack on Roof of Verandah of S.No.209,(G.F.), Approx.  
Width = 1.0mm, Approx.Length = 1.0m.  
Distance from L.Ext.Col. =0m, Height from Floor =2.80m.

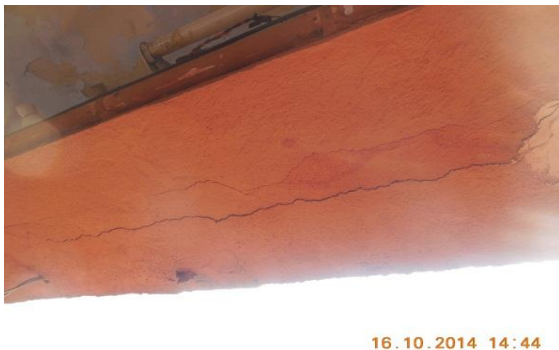
Photo 25

Horizontal Crack on Roof of Verandah of S.No.209,(G.F.), Approx.  
Width = 1.0mm, Approx.Length = 1.20m.  
Distance from R.Ext.Col. =0.40m, Height from Floor =2.20m.

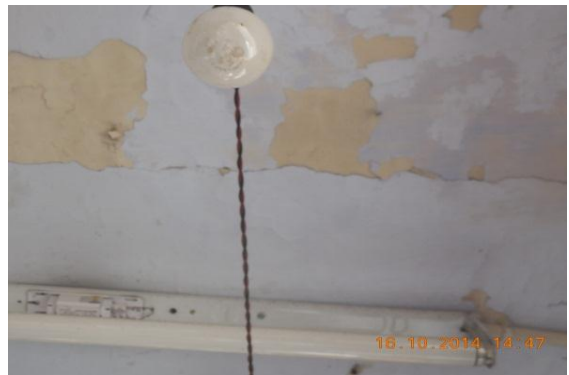
Photo 26

Horizontal Crack on Roof of Verandah of S.No.209,(G.F.), Approx.  
Width = 0.80mm, Approx.Length = 2.0m.  
Distance from R.Ext.Col. =0m, Height from Floor =2.80m.

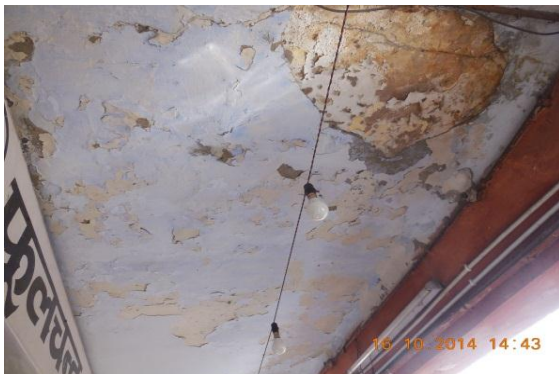
Photo 27

Dampness/Seepage on Roof of Verandah of S.No.209,  
Ground Floor

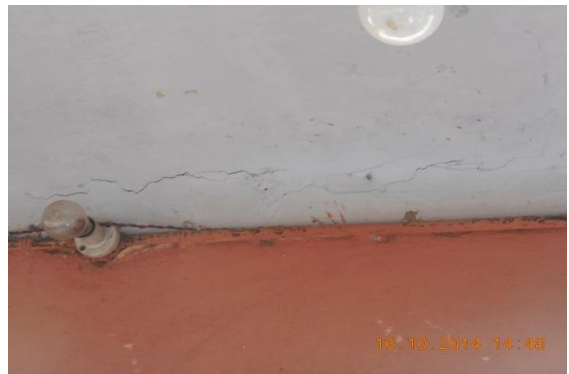
Photo 28

Horizontal Crack on Roof of Verandah of S.No.210,(G.F.), Approx.  
Width = 0.80mm, Approx.Length = 2.0m.  
Distance from R.Ext.Col. =0m, Height from Floor =2.80m.

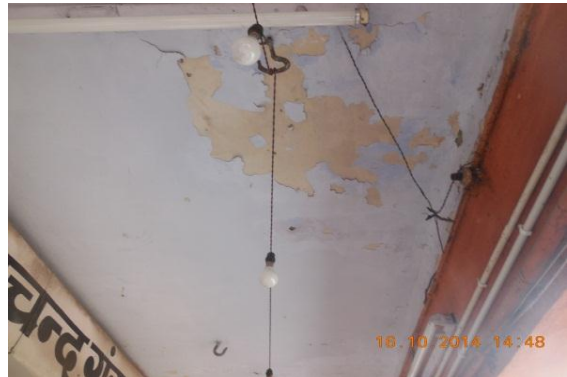
Photo 30

Peeling of Plaster on Roof of Verandah of S.No.210,  
Floor

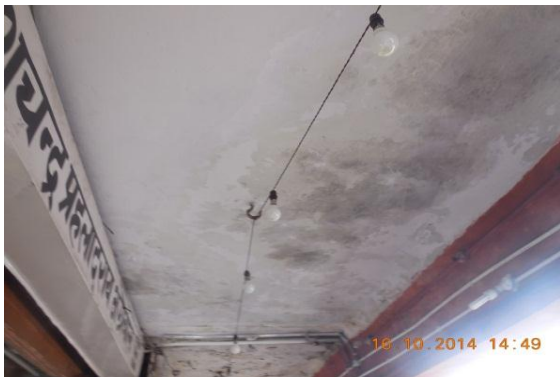
Photo 33

Dampness/Seepage on Roof of Verandah of S.No.211,  
Ground Floor

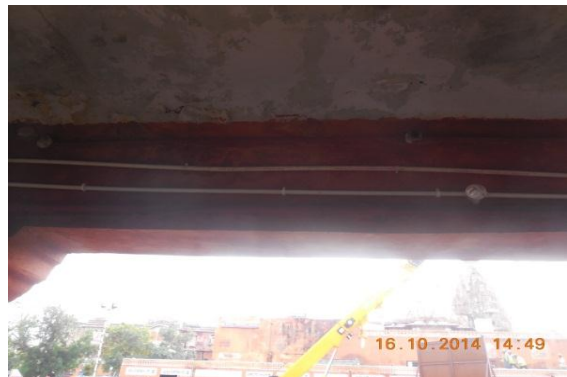
Photo 34

Dampness/Seepage on Ext.Beam of Verandah of S.No.211,  
Ground Floor

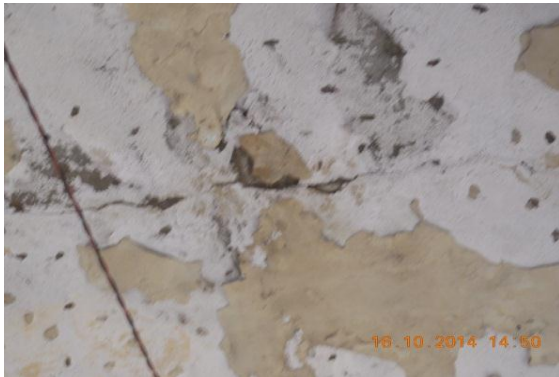
Photo 35

Horizontal Crack on Roof of Verandah of S.No.212, (G.F.), Approx.  
Width = 0.80mm, Approx.Length = 1.80m.  
Distance from Left Ext.Col. = 0m, Height from Floor = 2.80m.

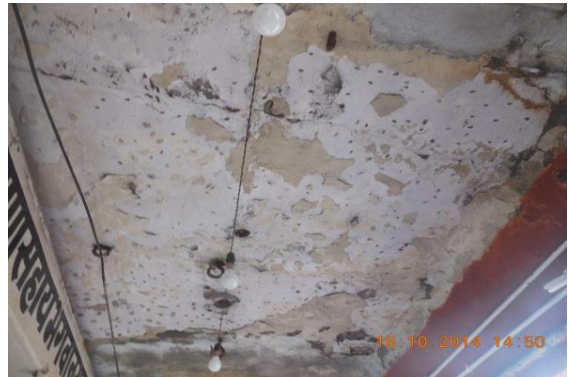
Photo 36

Dampness/Seepage on Roof of Verandah of S.No.212,  
Ground Floor

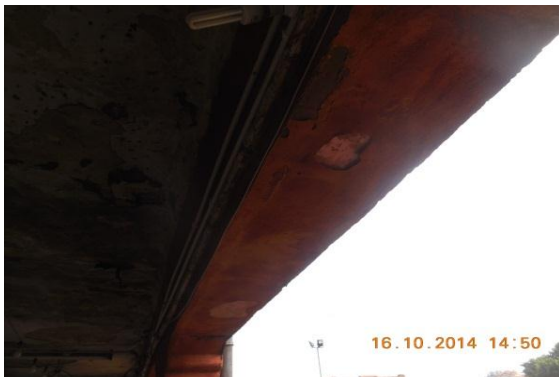
Photo 37

Dampness/Seepage on Ext. Beam of Verandah of S.No.212,  
Ground Floor

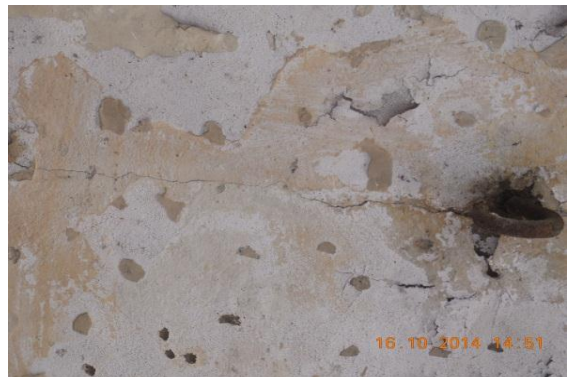
Photo 38

| Summary of Defects Other Than Crack | | | |
|---|--|---|---|
| 14 | Roof of Verandah of S.No.212,Ground Floor | Plaster Crack | 38 |

Plaster Crack on Roof of Verandah of S.No.212,  
Ground Floor

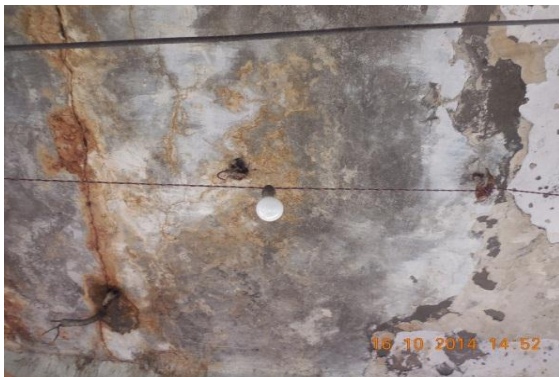
Photo 39

Dampness/Seepage on Roof of Verandah of S.No.212,  
Ground Floor

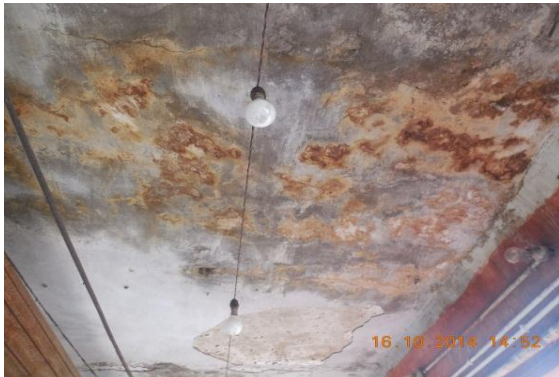
**Photo 41**  
Dampness/Seepage on Roof of Verandah of S.No.213,  
Ground Floor

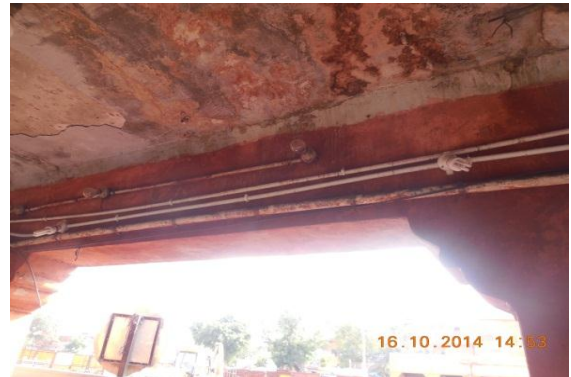
**Photo 42**  
Dampness/Seepage on Ext.Beam of Verandah of S.No.213,  
Ground Floor

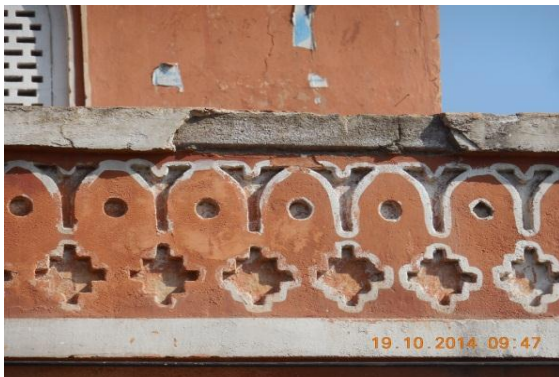
**Photo 43**  
Plaster Removal on Outer Ext.Beam of Verandah of S.No.213,  
Ground Floor

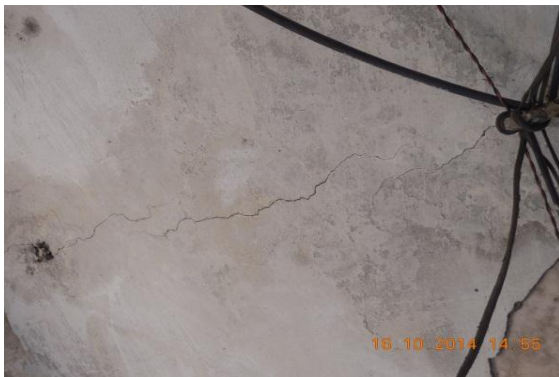
**Photo 45**  
Horizontal Crack on Roof of Verandah of S.No.214,(G.F.), Approx.  
Width = 1.0mm, Approx.Length = 2.0m.  
Distance from Right Ext.Col. =1.30m, Height from Floor =2.80m.

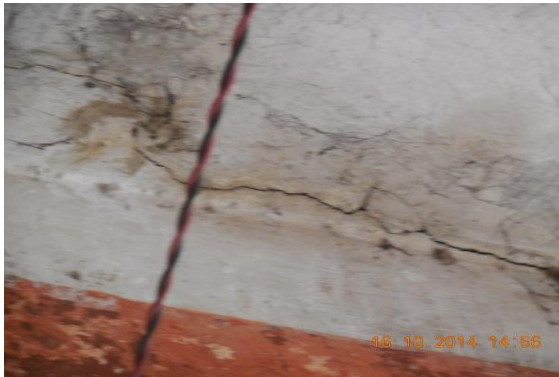
Photo 47

Horizontal Crack on R.Ext.Beam of Verandah of S.No.214, (G.F.),  
Approx. Width = 1.50mm, Approx.Length = 1.0m.  
Distance from Right Ext.Col. = 0m, Height from Floor = 2.60m.

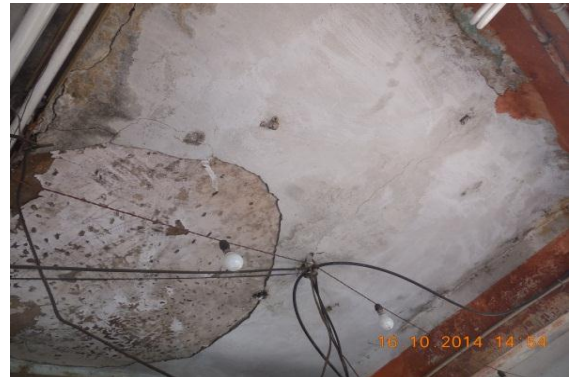
Photo 48

Dampness/Seepage on Roof of Verandah of S.No.214,  
Ground Floor

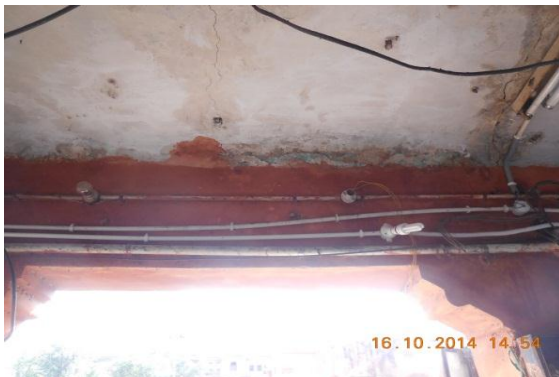
Photo 49

Dampness/Seepage on Ext.Beam of Verandah of S.No.214,  
Ground Floor

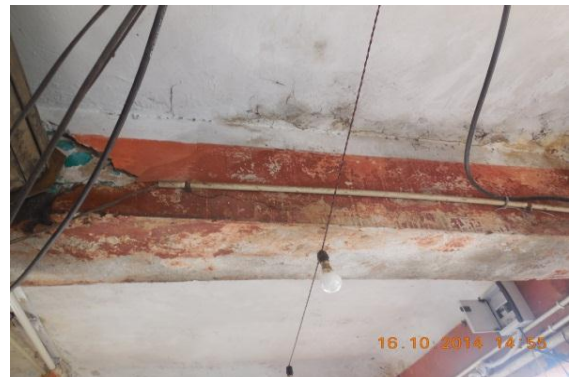
Photo 50

Dampness/Seepage on RHS Ext.Beam of Verandah of S.No.214  
Ground Floor

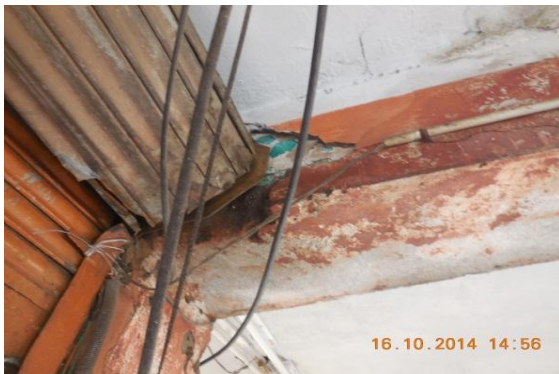
Photo 51

Plaster Removal on RHS Ext.Beam of Verandah of S.No.214  
Ground Floor

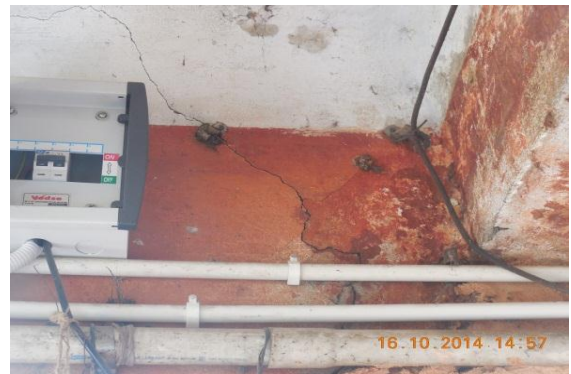
Photo 52

Inclined Crack on Roof & Ext.Beam of Verandah of S.No.215, (G.F.),  
Approx. Width = 0.60mm, Approx.Length = 0.80m.  
Distance from L.Ext. Col. = 0.20m, Height from Floor = 2.60m.

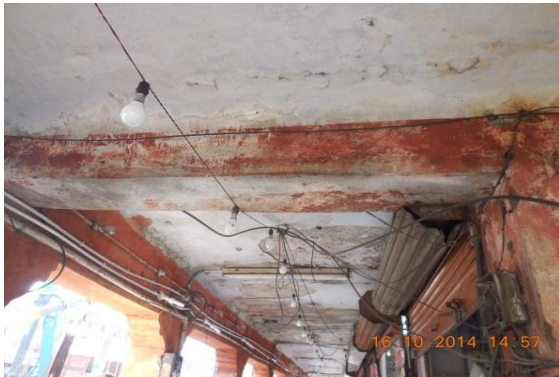
Photo 53

Dampness/Seepage on Ext.Beam of Verandah of S.No.215  
Ground Floor

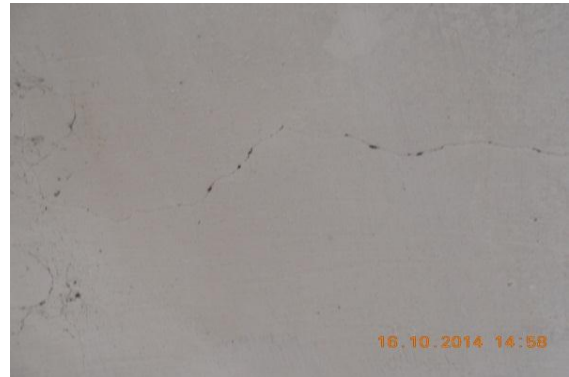
Photo 54

| Summary of Defects Other Than Crack | | | |
|---|--|---|---|
| 24 | Roof of Verandah of S.No.215,G.Floor | Plaster Crack | 54 |

Plaster Crack on Roof of Verandah of S.No.215,  
Ground Floor

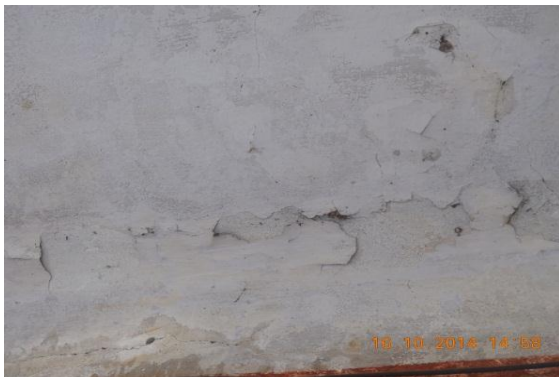
Photo 55

Peeling of Plaster on Roof of Verandah of S.No.215,  
Ground Floor

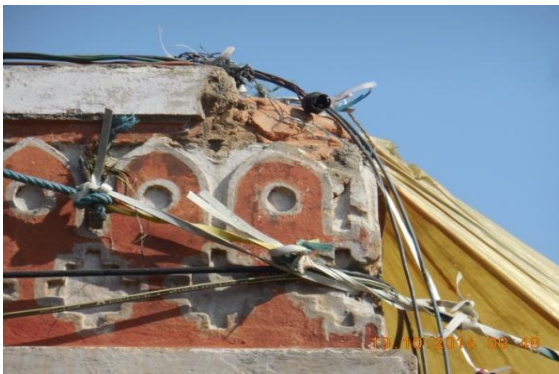
Photo 57

| Summary of Defects Other Than Crack | | | |
|---|--|---|---|
| 27 | Outer R.Ext.Col. of Verandah of S.No.215,G.Floor | Damage | 57 |

Damage on Outer R.Ext.Col. of Verandah of S.No.215  
Ground Floor
