Pre - Condition Building Survey for Construction of Underground Stations from Chandpole to Bari Chouper and reversal line

Shop No.362-363
Choti Choper
Jaipur
Unique ID: CC-BC-DL-0008

Report Number: AIMIL/ESG/JMCEC/CC-BC-DL-0008/02/Verandah, Rev. 02, Dated: October, 2014

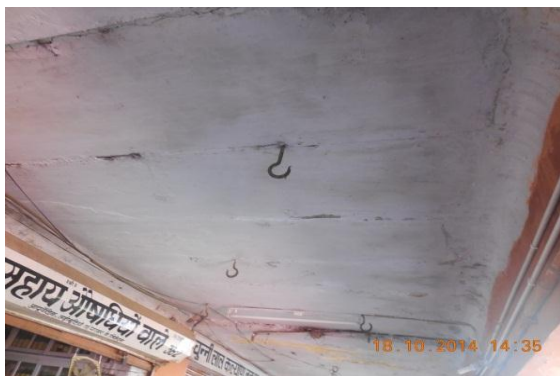
Photo 5
Dampness/Seepage on Roof of Verandah of S.No.362,
Ground Floor

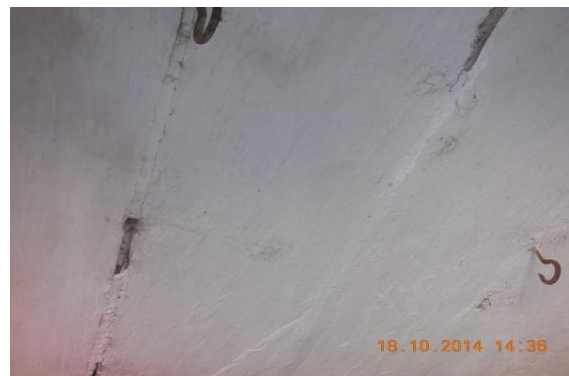
Photo 6
Joint Gap on Roof of Verandah of S.No.362,
Ground Floor

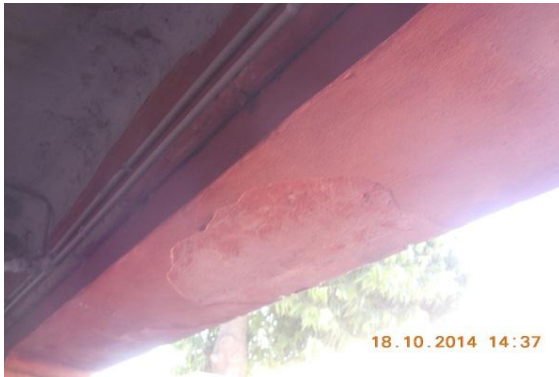
Photo 7

Dampness/Seepage on Ext.Beam of Verandah of S.No.362, Ground Floor

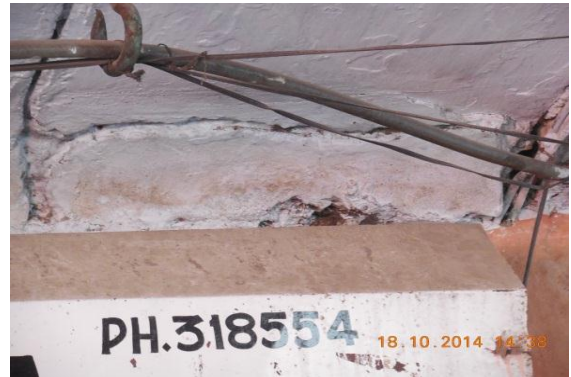
Photo 8

Plaster Removal on Roof & Int.Beam of Verandah of S.No.362, Ground Floor

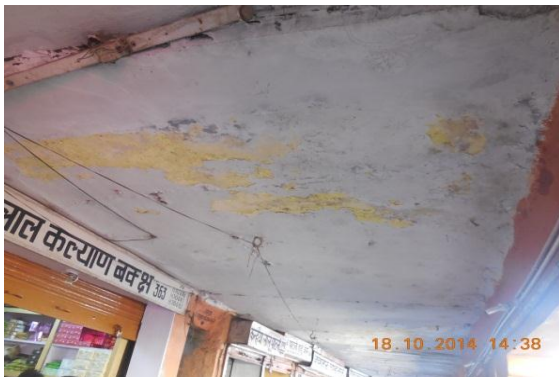
Photo 11

Dampness/Seepage on Roof of Verandah of S.No.363, Ground Floor

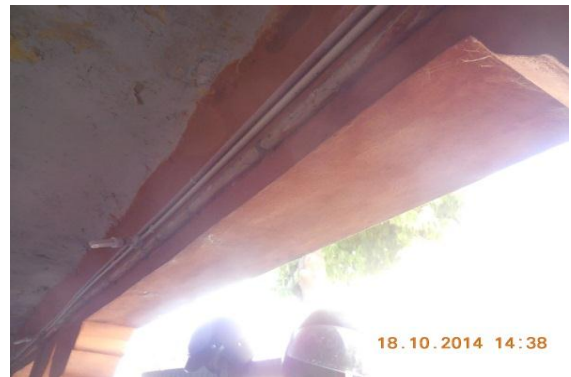
Photo 12

Dampness/Seepage on Ext.Beam of Verandah of S.No.363, Ground Floor

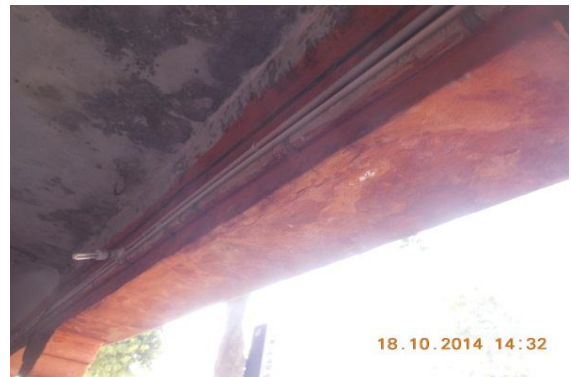
Photo 6
Dampness/Seepage on Ext.Beam of Verandah of S.No.359,
Ground Floor

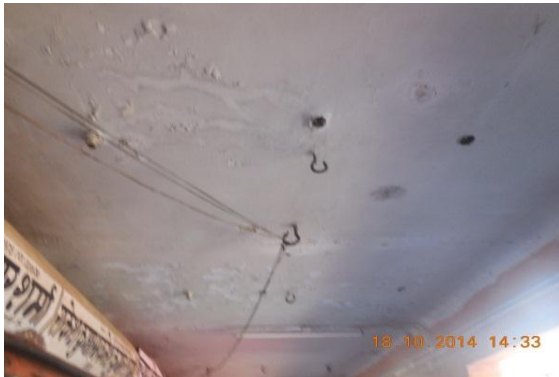
Photo 7

Dampness/Seepage on Roof of Verandah of S.No.360A & 360B,
Ground Floor

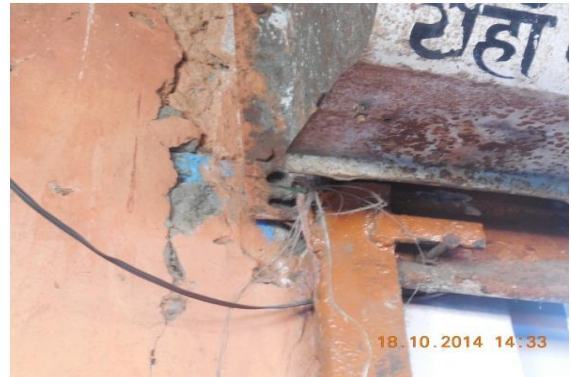
Photo 8

Plaster Removal on Left Int.Col.of Verandah of S.No.360A & 360B,
Ground Floor

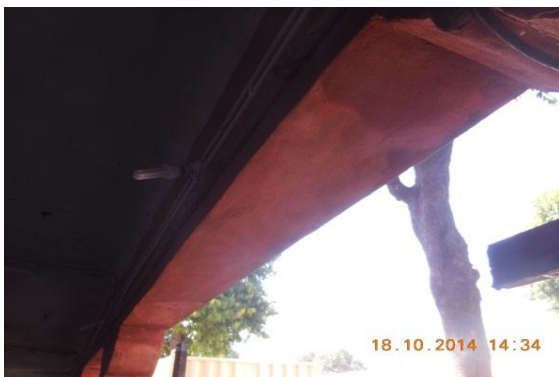
Photo 9

Dampness/Seepage on Ext.Beam of Verandah of
S.No.360A & 360B, Ground Floor

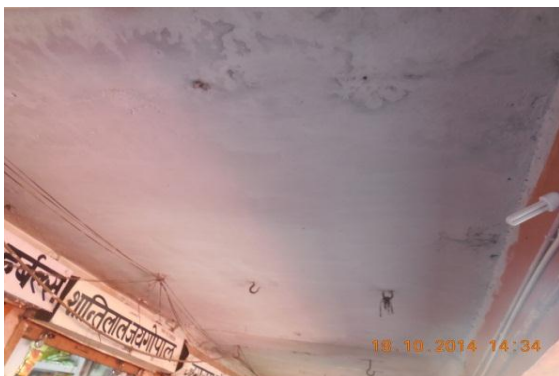
Photo 11

Dampness/Seepage on Roof of Verandah of S.No.361A & 361B,
Ground Floor

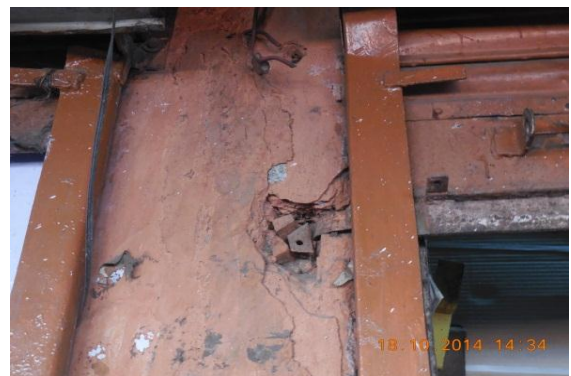
Photo 12

Plaster Removal on Left Int.Col.of Verandah of S.No.361A & 361B,
Ground Floor

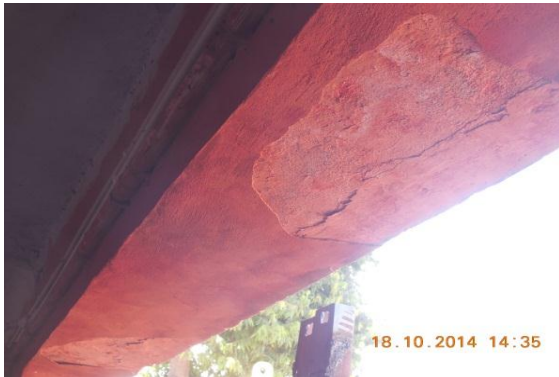
Photo 13

Dampness/Seepage on Ext.Beam of Verandah of
Shop No. 361A & 361B, Ground Floor

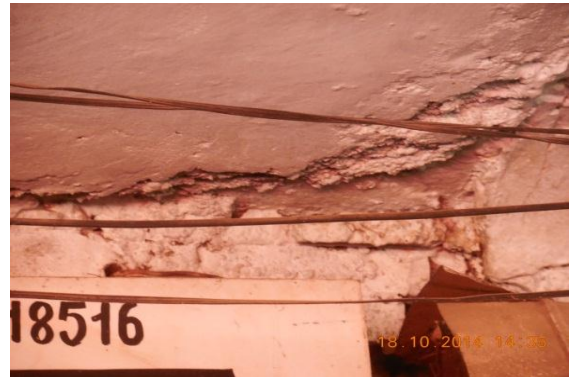
Photo 14

Plaster Removal on Roof of Verandah of S.No.361A & 361B,
Ground Floor

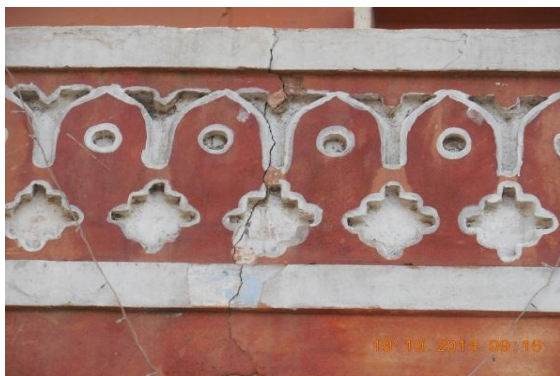
Photo 5
Inclined Crack on Outer Left Ext.Col. of Verandah of S.No.356, G.F.
Approx. Width = 1.50mm, Approx.Length = 0.60m.
Distance from Left Ext.Col. = 0m, Height from Floor = 2.30m.

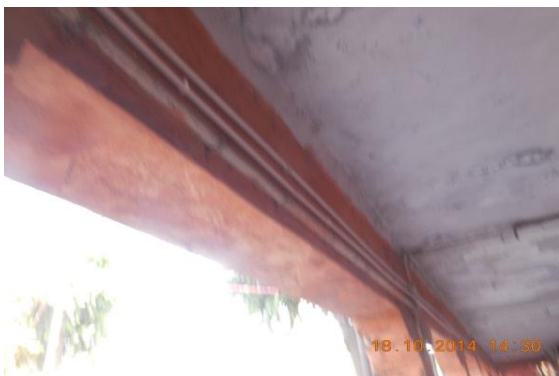
Photo 11
Dampness/Seepage on Ext.Beam of Verandah of S.No.357,
Ground Floor

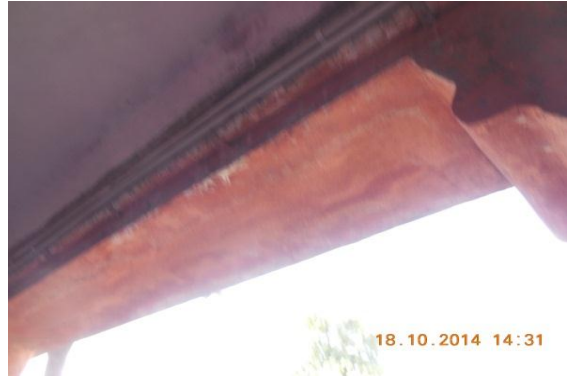
Photo 14

Dampness/Seepage on Ext.Beam of Verandah of S.No.358,
Ground Floor

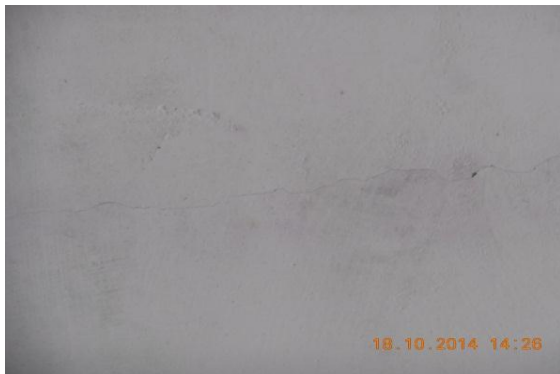
Photo 5
Plaster Crack on Roof of Verandah of S.No.354,
Ground Floor

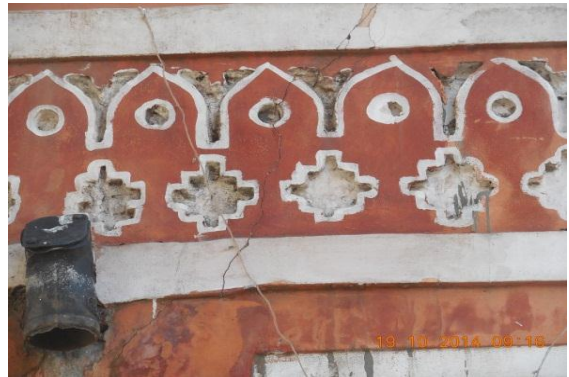
Photo 8

Inclined Crack on Outer L.Ext.Col.of Verandah of S.No.355,G.F.
Approx. Width = 1.0mm, Approx.Length = 1.0m.
Distance from Left Ext.Col. =0m, Height from Floor =2.50m.

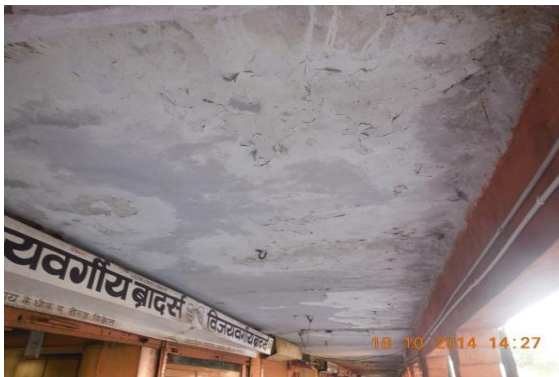
Photo 9

Dampness/Seepage on Roof of Verandah of S.No.355,
Ground Floor

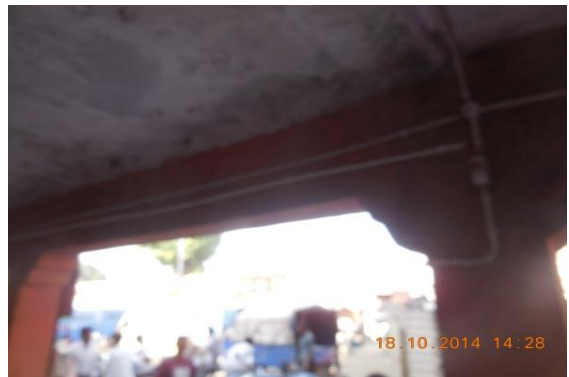
Photo 10

Dampness/Seepage on Ext.Beam of Verandah of S.No.355,
Ground Floor

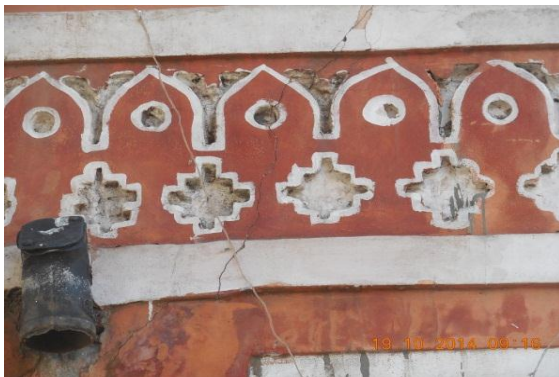
Photo 11

Peeling of Plaster on Outer L.Ext.Col.of Verandah of S.No.355,
Ground Floor

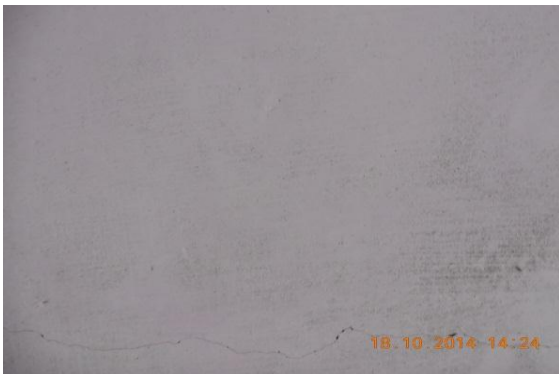
Photo 4
Plaster Crack on Roof of Verandah of S.No.353,
Ground Floor

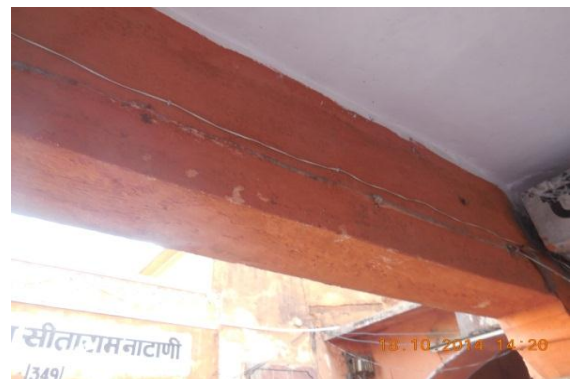
Photo 4
Dampness/Seepage on Left Ext.Beam of Verandah of S.No.350, Ground Floor

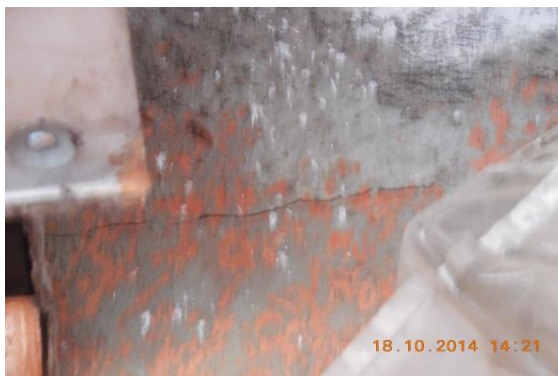
Photo 5
Plaster Crack on Right Int.Col. of Verandah of S.No.350, Ground Floor

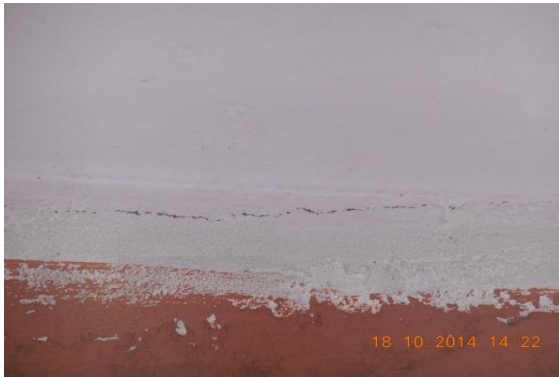
Photo 7
Plaster Crack on Ext.Beam of Verandah of S.No.350,
Ground Floor

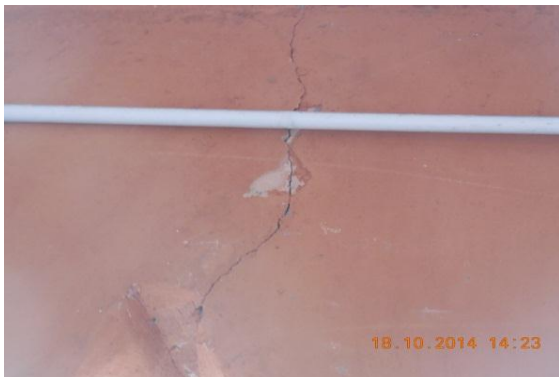
Photo 9
Inclined Crack on Left Ext.Col. of Verandah of S.No.351,GF
Approx. Width = 0.80mm, Approx.Length = 0.80m.
Distance from Right Ext.Col. = 0m, Height from Floor = 2.50m.

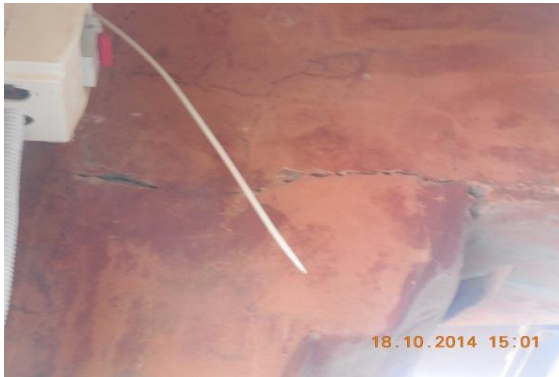
Photo 13

Horizontal Crack on R.Ext.Beam of Verandah of S.No.372,GF
Approx. Width =2.50mm, Approx.Length = 1.0m.
Distance from L.Ext.Col. = 0m, Height from Floor =2.50m.

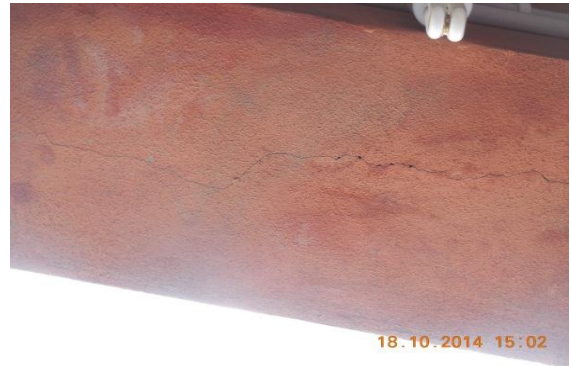
Photo 14

Horizontal Crack on Ext.Beam Roof of Verandah of S.No.372,GF
Approx. Width =0.30mm, Approx.Length = 1.20m.
Distance from L.Ext.Col. = 0.10m, Height from Floor =2.50m.

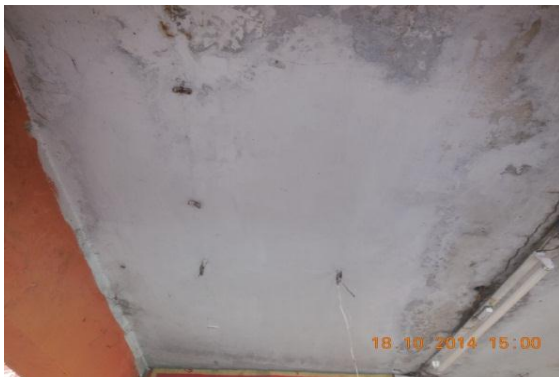
Photo 15

Dampness/Seepage on Roof of Verandah of S.No.372,
Ground Floor

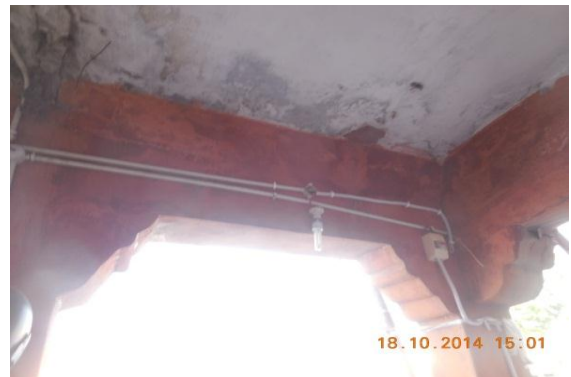
Photo 16

Dampness/Seepage on Ext.Beam of Verandah of S.No.372,
Ground Floor

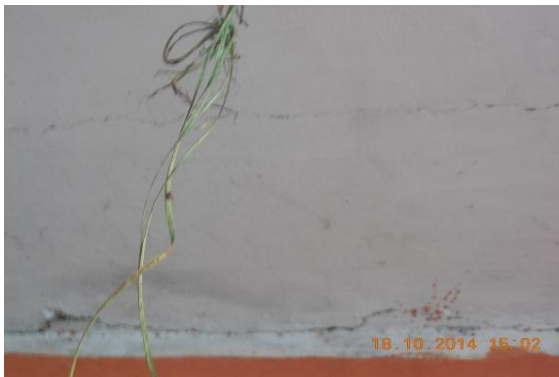
Photo 17

Horizontal Crack on Roof of Verandah of S.No.373,GF
Approx. Width =0.60mm, Approx.Length = 2.70m.
Distance from R.Ext.Col. = 0.20m, Height from Floor =2.80m.

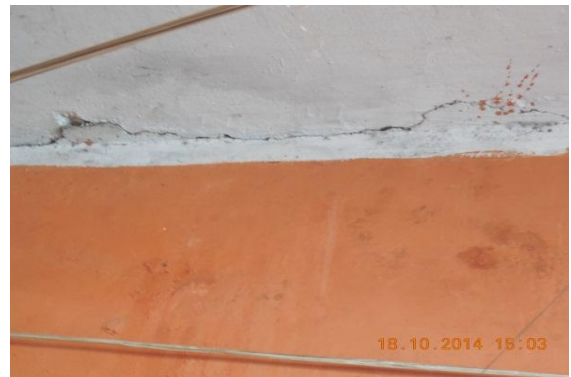
Photo 18

Horizontal Crack on Roof of Verandah of S.No.373,GF
Approx. Width =1.50mm, Approx.Length = 2.70m.
Distance from R.Ext.Col. = 0m, Height from Floor =2.80m.

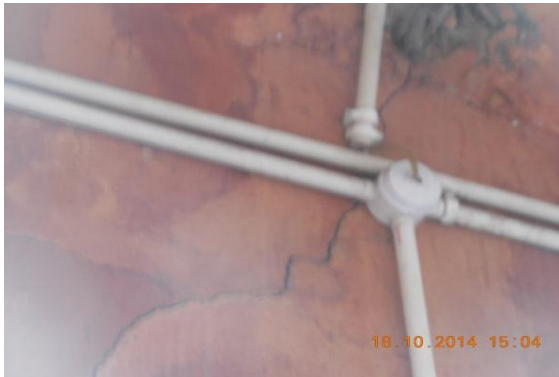
Photo 19A

Inclined Crack on Ext.Beam&L.Ext.Col. & Outerwall of Verandah of S.No.373,(GF),Approx. Width =2.50mm, Approx.Length = 2.0m.
Distance from L.Ext.Col. = 0m, Height from Floor =2.50m.

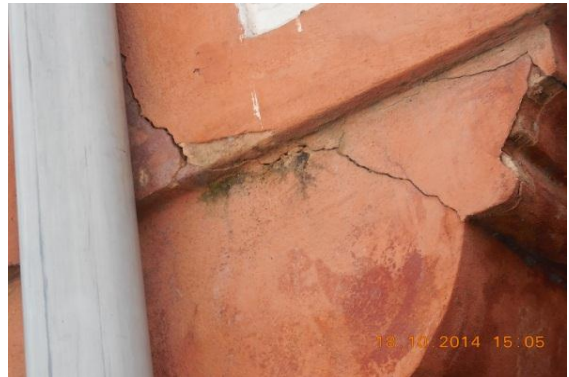
Photo 19B

Inclined Crack on Ext.Beam&L.Ext.Col. & Outerwall of Verandah of S.No.373,(GF),Approx. Width =2.50mm, Approx.Length = 2.0m.
Distance from L.Ext.Col. = 0m, Height from Floor =2.50m.

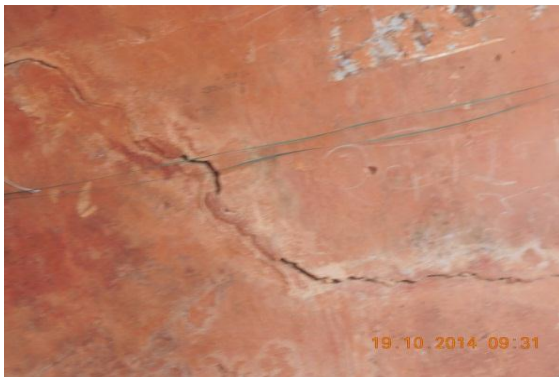
Photo 20A

Inclined Crack on Wall No.2 of Verandah of S.No.373,(GF),
Approx. Width =6.0mm, Approx.Length = 2.90m.
Distance from Wall No.4 = 0m, Height from Floor =0m.

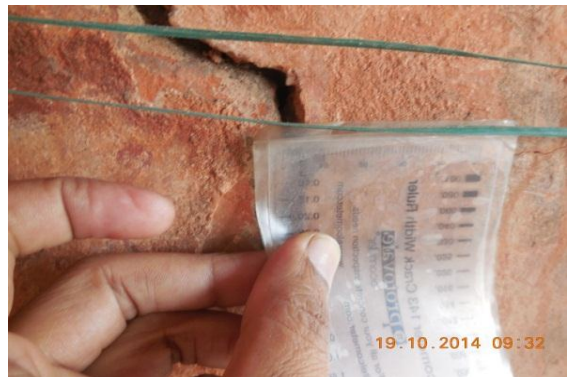
Photo 20B

Inclined Crack on Wall No.2 of Verandah of S.No.373,(GF),
Approx. Width =6.0mm, Approx.Length = 2.90m.
Distance from Wall No.4 = 0m, Height from Floor =0m.

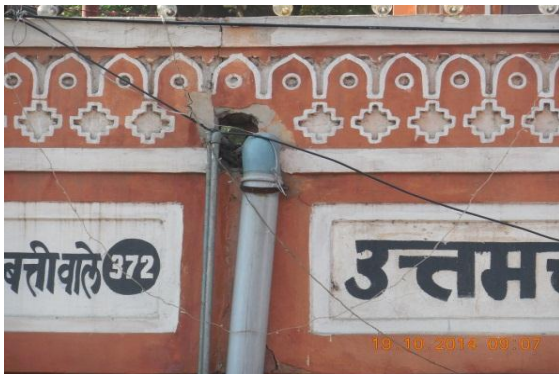
Photo 21

Inclined Crack on Outer L.Ext.Col. of Verandah of S.No.373,(GF),
Approx. Width =1.50mm, Approx.Length = 1.60m.
Distance from Left Ext.Col. = 0m, Height from Floor =2.0m.

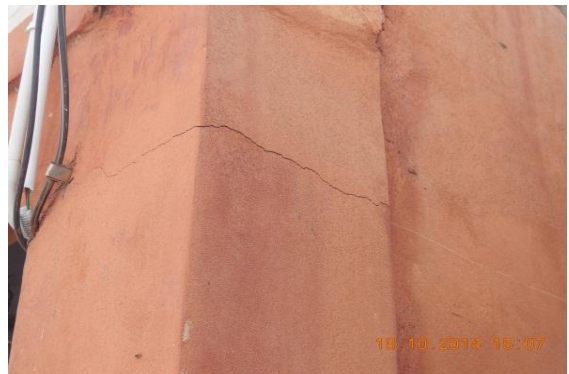
Photo 22

Horizontal Crack on Outer R.Ext.Col. of Verandah of S.No.373,(GF)
Approx. Width =1.0mm, Approx.Length = 0.70m.
Distance from Right Ext.Col. = 0m, Height from Floor =2.50m.

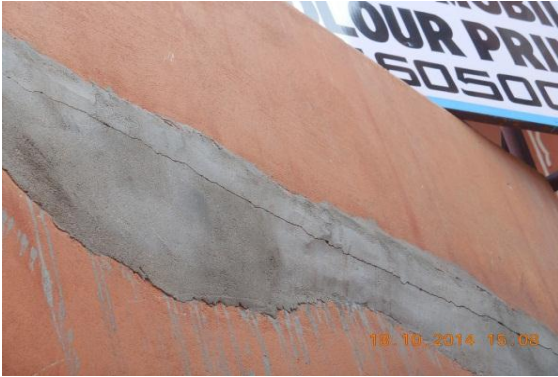
Photo 23

Horizontal Crack on Outer@Stairside of Verandah of S.No.373,GF
Approx. Width =1.0mm, Approx.Length = 3.0m.
Distance from Wall No.4 = 0m, Height from Floor =3.0m.

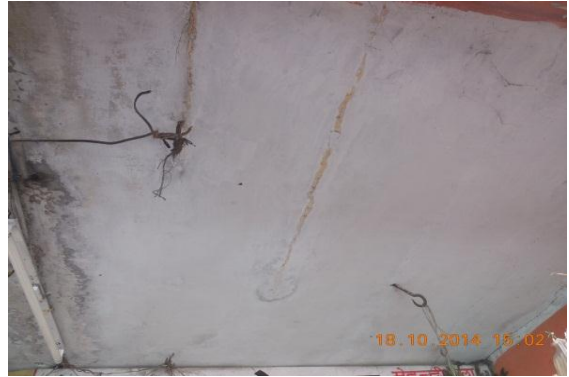
Photo 24

Dampness/Seepage on Roof of Verandah of S.No.373,
Ground Floor

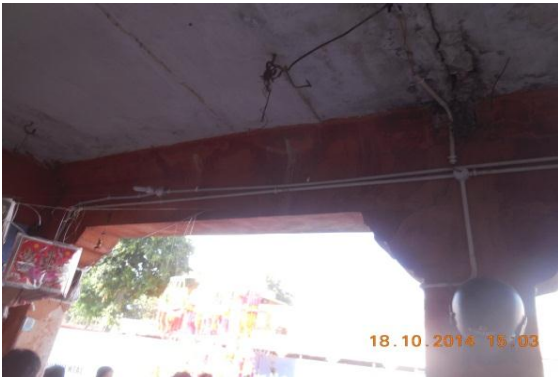
Photo 25

Dampness/Seepage on Ext.Beam of Verandah of S.No.373,
Ground Floor

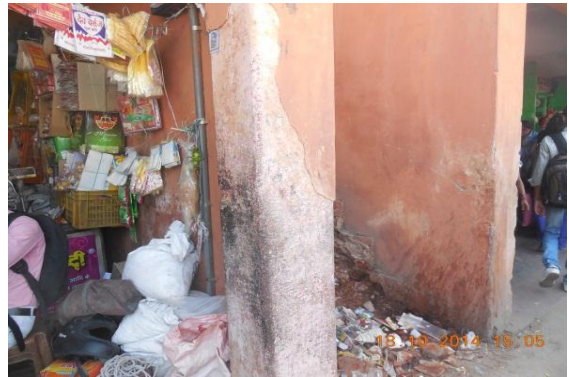
Photo 26

Peeling of Plaster on Right Ext.Col. of Verandah of S.No.373,
Ground Floor

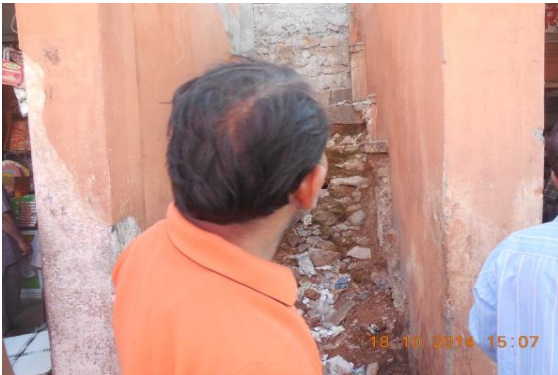
Photo 27

Damage on Stair Between S.No.373 & 374 of S.No.373,
Ground Floor

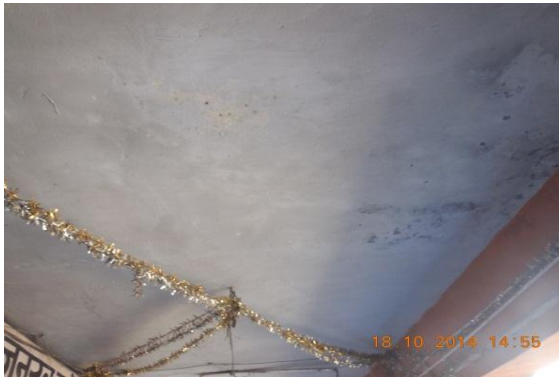
Photo 29

Inclined Crack on Wall No.1 of Verandah of S.No.374&374A, GF
Approx. Width = 5.0mm, Approx.Length = 1.50m.
Distance from Wall No.4. =0.60m, Height from Floor =0.70m.

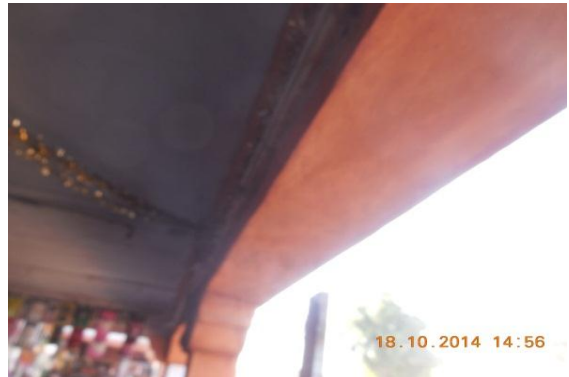
Photo 30

Plaster Removal on Int.Beam of Verandah of S.No.374,
Ground Floor

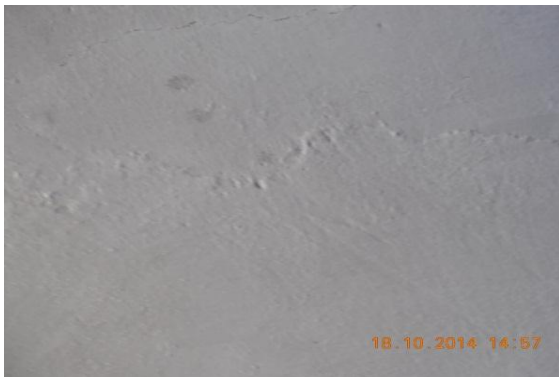
Photo 31

Dampness/ Seepage on Ext.Beam of Verandah of S.No.374,
Ground Floor

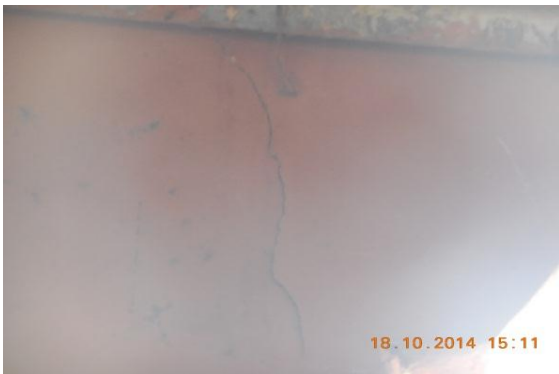
Photo 33A

Horizontal Crack on Roof of Verandah of S.No.375, GF
Approx. Width =2.50mm, Approx.Length = 2.50m.
Distance from Right Ext.Col. = 0m, Height from Floor =2.50m.

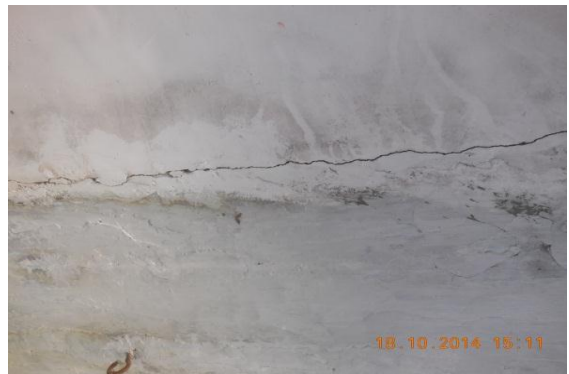
Photo 33B

Horizontal Crack on Roof of Verandah of S.No.375, GF
Approx. Width =2.50mm, Approx.Length = 2.50m.
Distance from Right Ext.Col. = 0m, Height from Floor =2.50m.

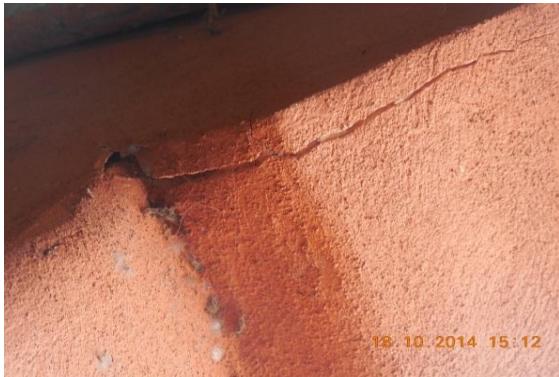
Photo 34

Plaster Removal on Right Ext.Col. of Verandah of S.No.375, Ground Floor

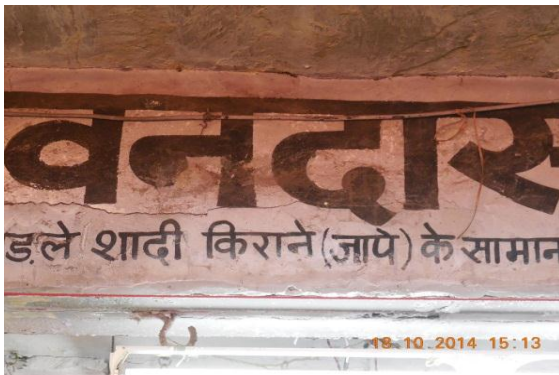
Photo 36

Horizontal Crack on Int.Beam of Verandah of S.No.376,GF
Approx. Width =5.0mm, Approx.Length = 2.30m.
Distance from Left Ext.Col. = 0m, Height from Floor =2.50m.

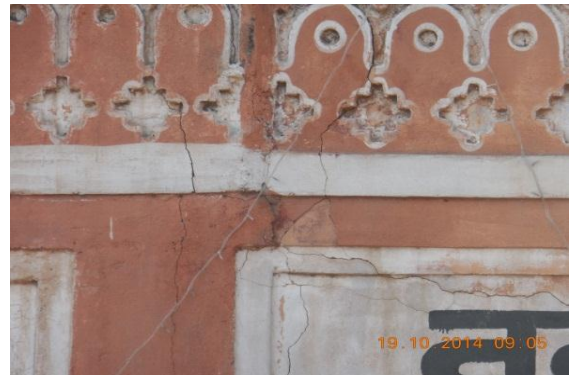
Photo 37

Inclined Crack on OuterExt.Beam &L.Col.of Verandah of S.No.376
Approx. Width =2.50mm, Approx.Length = 4.0m.
Distance from Left Ext.Col. = 0m, Height from Floor =2.10m.

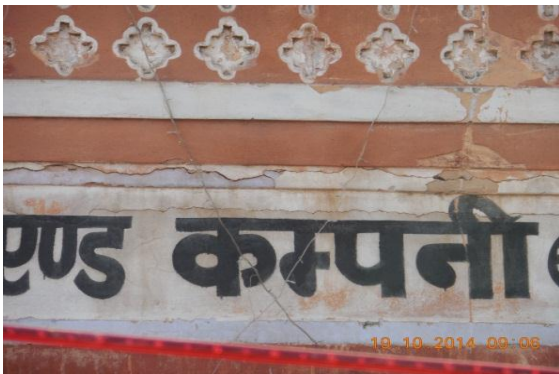
Photo 38

Horizontal Crack on Outer Ext.Beam of Verandah of S.No.376,,GF
Approx. Width =3.0mm, Approx.Length = 1.80m.
Distance from Right Ext.Col. = 0m, Height from Floor =2.30m.

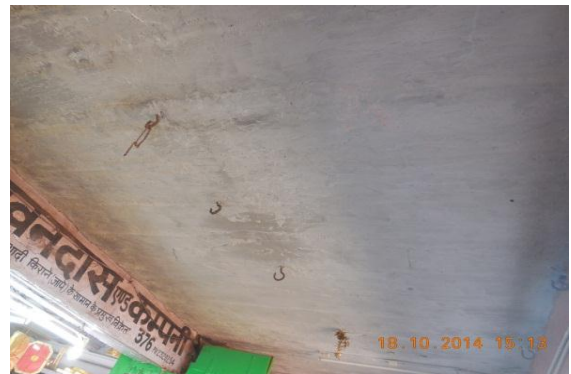
Photo 39

Dampness/ Seepage on Roof of Verandah of S.No.376, Ground Floor

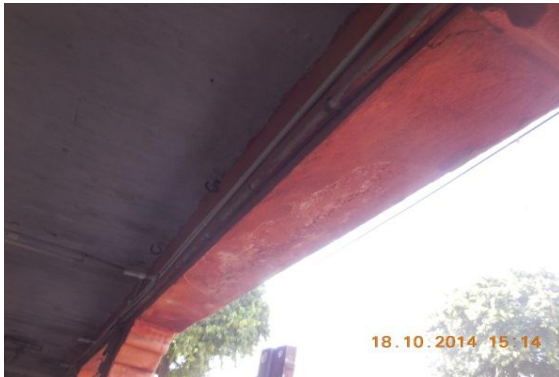
Photo 40

Dampness/ Seepage on Ext.Beam of Verandah of S.No.376, Ground Floor

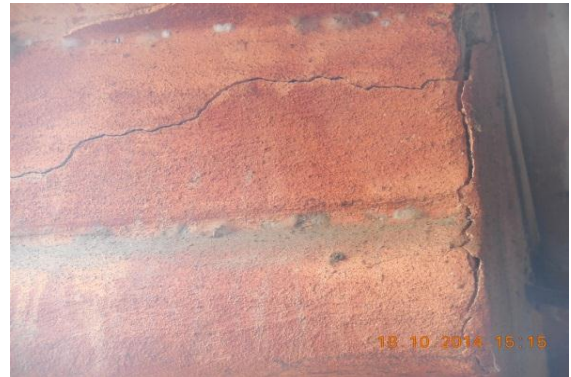
Photo 41A

Horizontal Crack on Left Ext.Col. of Verandah of S.No.377,,GF
Approx. Width =2.0mm, Approx.Length = 1.80m.
Distance from Left Ext.Col. = 0m, Height from Floor =2.50m.

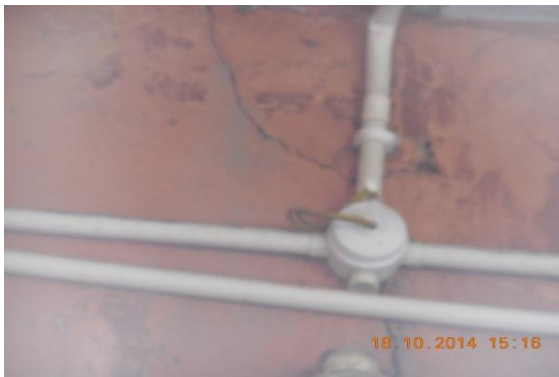
Photo 41B

Horizontal Crack on Left Ext.Col. of Verandah of S.No.377,,GF
Approx. Width =2.0mm, Approx.Length = 1.80m.
Distance from Left Ext.Col. = 0m, Height from Floor =2.50m.

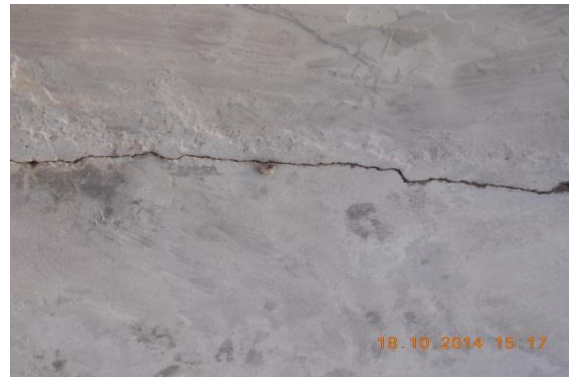
Photo 42A

Horizontal Crack on Roof of Verandah of S.No.377,,GF
Approx. Width =3.0mm, Approx.Length = 3.50m.
Distance from Right Ext.Col. = 0m, Height from Floor =2.80m.

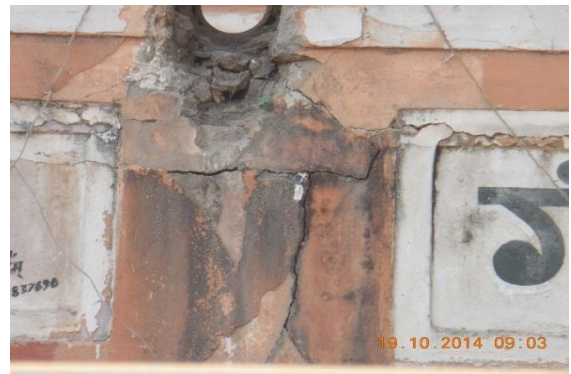
Photo 43

Inclined Crack on Outer Ext.L.Col.&Beam of Verandah of S.No.377
Approx. Width =2.50mm, Approx.Length = 3.0m.
Distance from Left Ext.Col. = 0m, Height from Floor =2.0m.

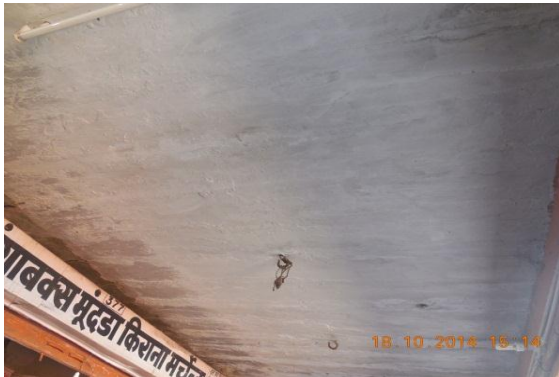
Photo 44

Dampness/ Seepage on Roof of Verandah of S.No.377,
Ground Floor

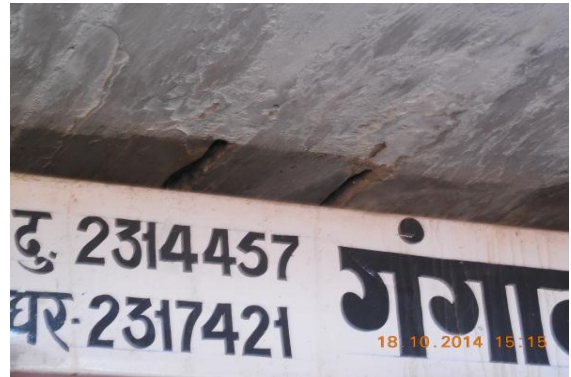
Photo 45

Stone Gap on Roof of Verandah of S.No.377,
Ground Floor

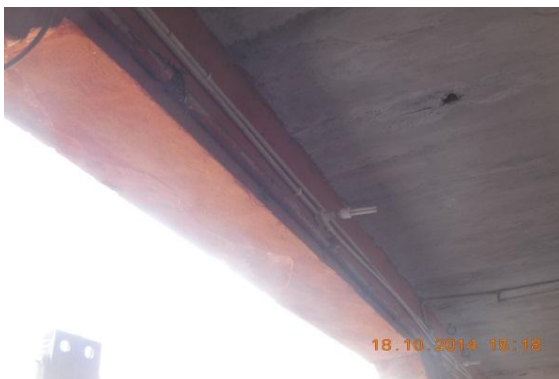
Photo 46

Dampness/ Seepage on Ext.Beam of Verandah of S.No.377,
Ground Floor

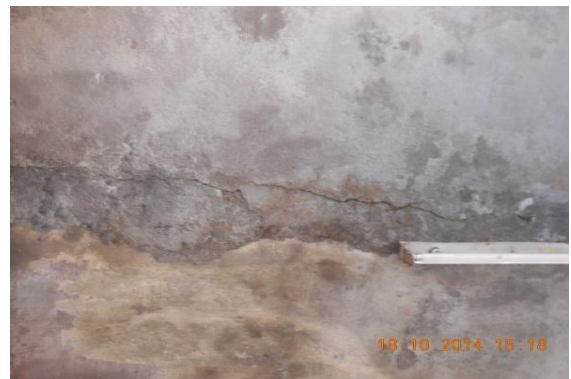
Photo 47

Horizontal Crack on Roof of Verandah of S.No.378,,GF
Approx. Width =2.0mm, Approx.Length = 2.50m.
Distance from Right Ext.Col. = 0m, Height from Floor =2.80m.

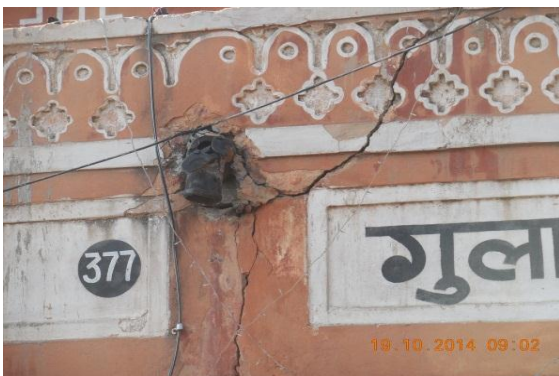
Photo 48

Inclined Crack on Outer L.Ext.Col of Verandah of S.No.378
Approx. Width =6.0mm, Approx.Length = 1.50m.
Distance from Left Ext.Col. = 0m, Height from Floor =2.20m.

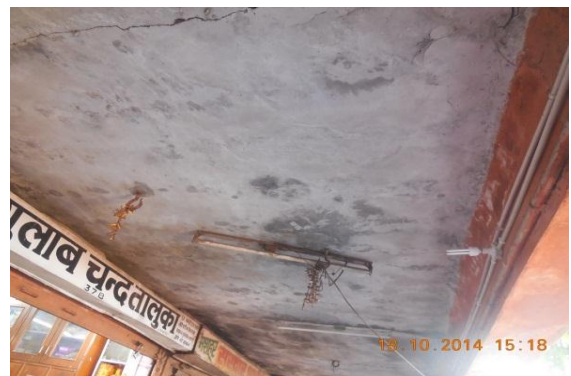
Photo 49

Dampness/ Seepage on Roof of Verandah of S.No.378,
Ground Floor

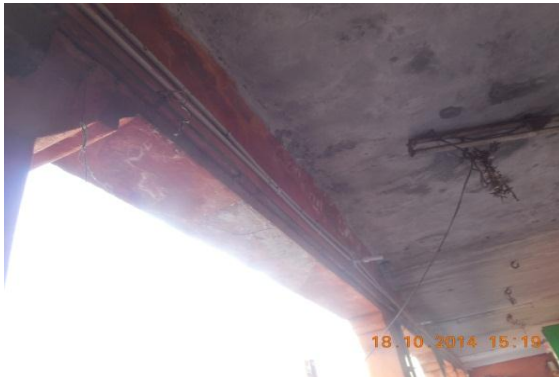
Photo 50

Dampness/ Seepage on Ext.Beam of Verandah of S.No.378, Ground Floor

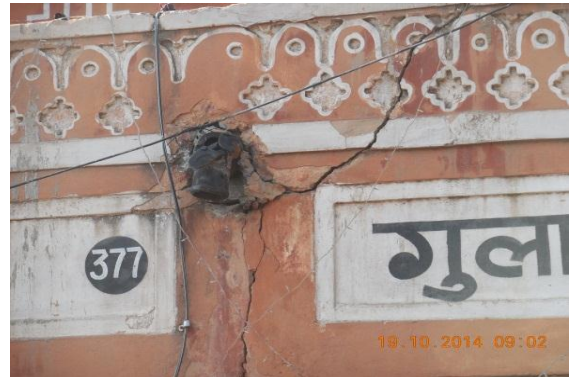
Photo 51

Plaster Removal on Outer L.Ext.Col of Verandah of S.No.378, Ground Floor

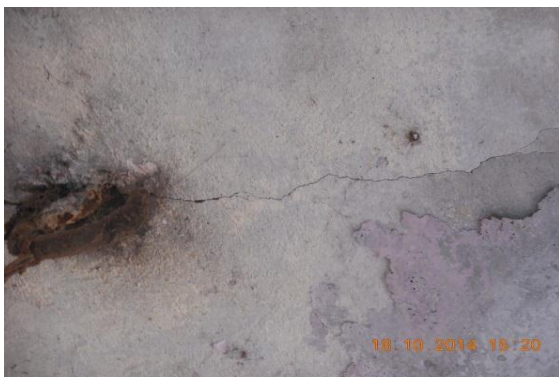
Photo 52

Horizontal Crack on Roof of Verandah of S.No.379, GF
Approx. Width = 0.35mm, Approx.Length = 2.50m.
Distance from Left Ext.Col. = 1.50m, Height from Floor = 2.80m.

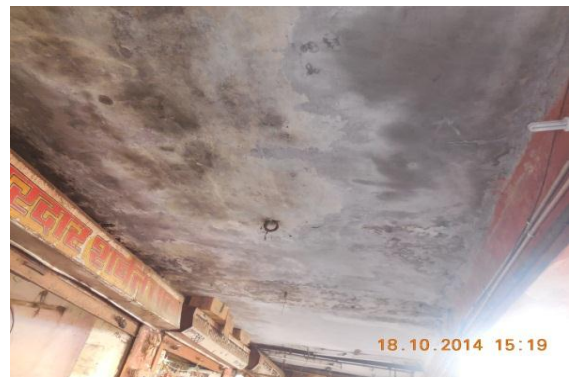
Photo 53

Dampness/ Seepage on Roof of Verandah of S.No.379, Ground Floor

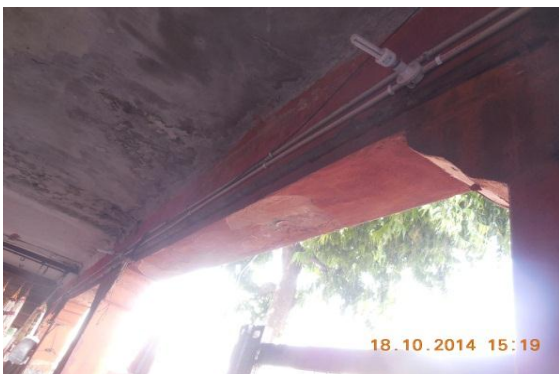
Photo 54

Dampness/ Seepage on Ext.Beam of Verandah of S.No.379, Ground Floor

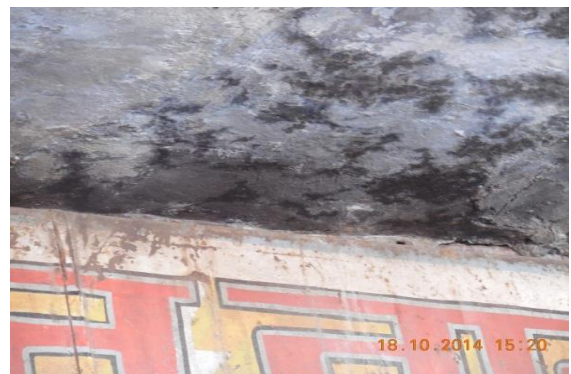
Photo 55

Plaster Removal on Int.Beam of Verandah of S.No.379, Ground Floor

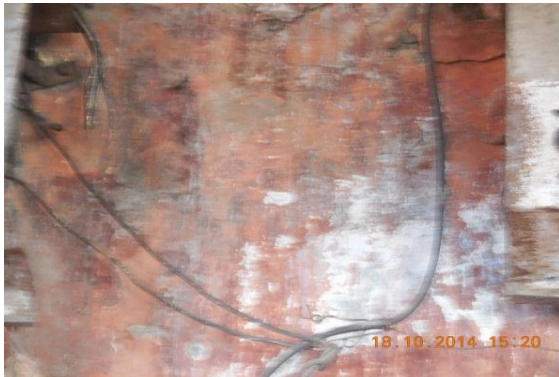
Photo 56

Plaster Removal on Right Int.Col. of Verandah of S.No.379, Ground Floor

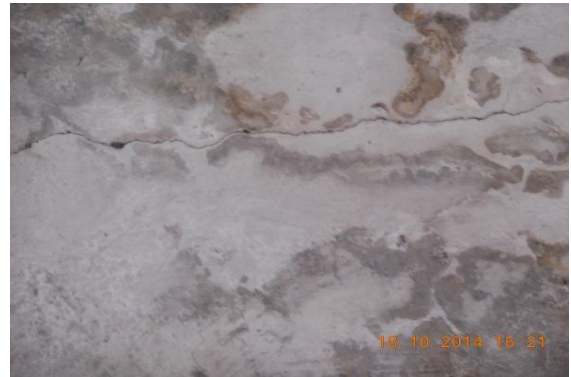
Photo 57

Horizontal Crack on Roof of Verandah of S.No.380,,GF
Approx. Width =1.0mm, Approx.Length = 2.50m.
Distance from Left Ext.Col. = 0m, Height from Floor =2.80m.

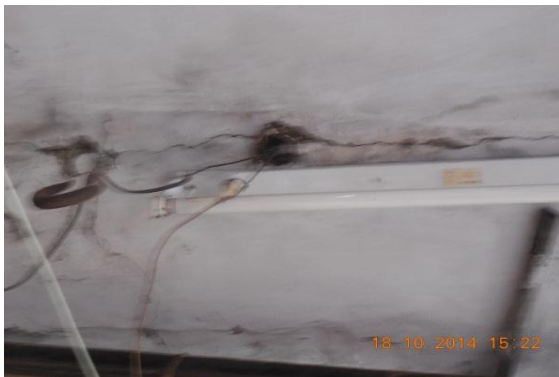
Photo 58

Horizontal Crack on Roof of Verandah of S.No.380,,GF
Approx. Width =1.50mm, Approx.Length = 2.50m.
Distance from Right Ext.Col. = 0m, Height from Floor =2.80m.

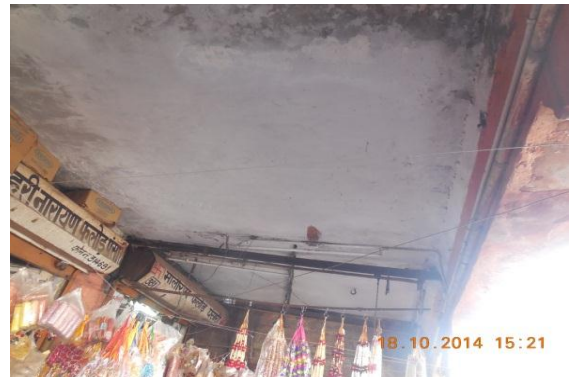
Photo 59

Dampness/ Seepage on Roof of Verandah of S.No.380, Ground Floor

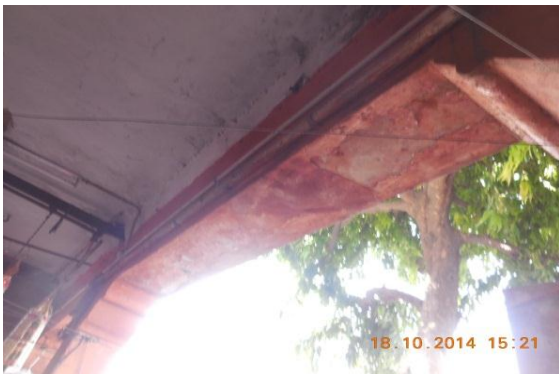
Photo 60

Dampness/ Seepage on Ext.Beam of Verandah of S.No.380, Ground Floor

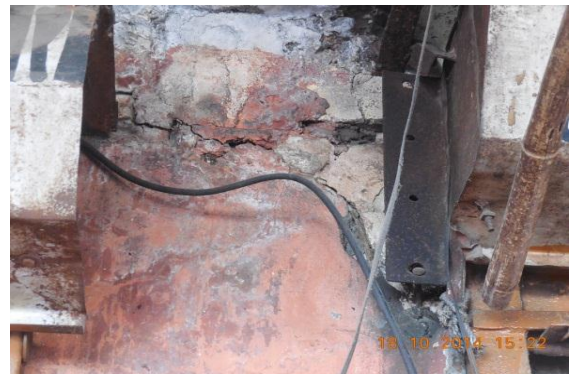
Photo 61

Plaster Removal on Right Int.Col. of Verandah of S.No.380, Ground Floor

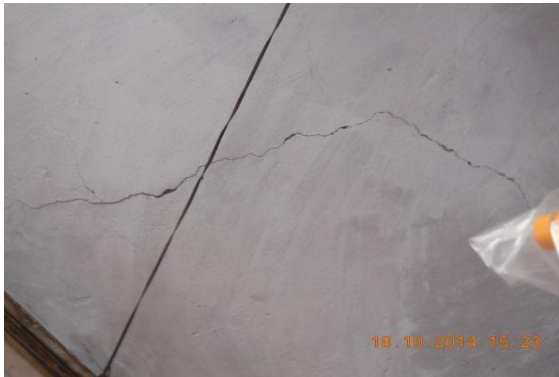
Photo 62

Inclined Crack on Roof of Verandah of S.No.381,,GF
Approx. Width =1.50mm, Approx.Length = 1.60m.
Distance from Left Ext.Col. = 1.80m, Height from Floor =2.80m.

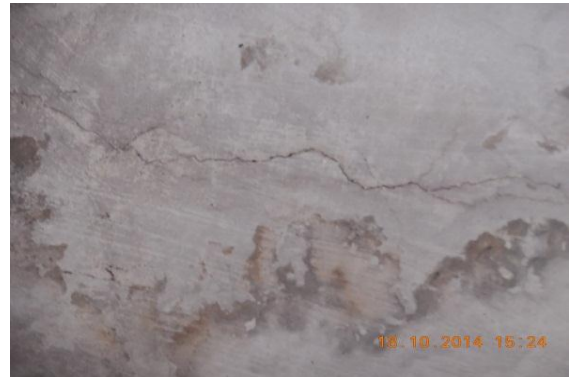
Photo 63

Horizontal Crack on Roof of Verandah of S.No.381,,GF
Approx. Width =0.60mm, Approx.Length = 2.50m.
Distance from Left Ext.Col. = 0m, Height from Floor =2.80m.

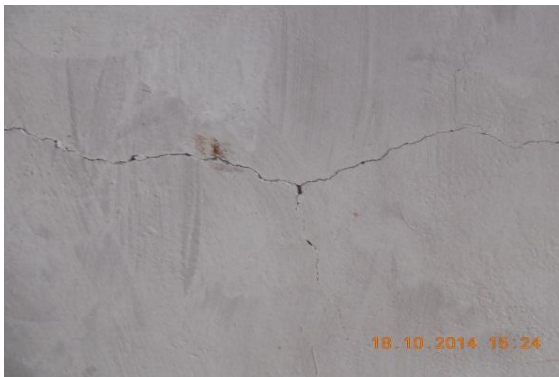
Photo 64

Horizontal Crack on Roof of Verandah of S.No.381,,GF
Approx. Width =0.60mm, Approx.Length = 2.0m.
Distance from Left Ext.Col. = 1.0m, Height from Floor =2.80m.

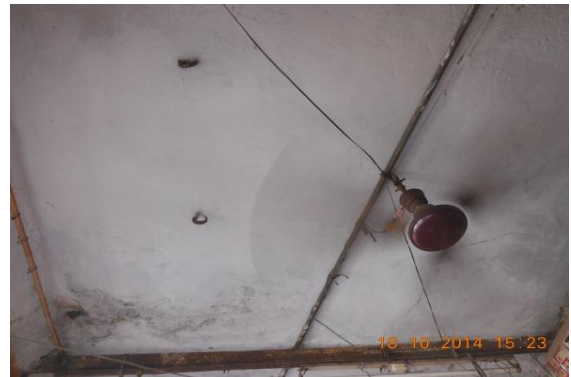
Photo 65

Dampness/ Seepage on Roof of Verandah of S.No.381,
Ground Floor

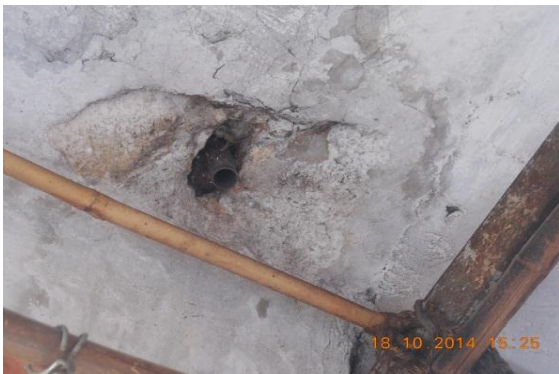
Photo 66

Plaster Removal on Roof of Verandah of S.No.381,
Ground Floor

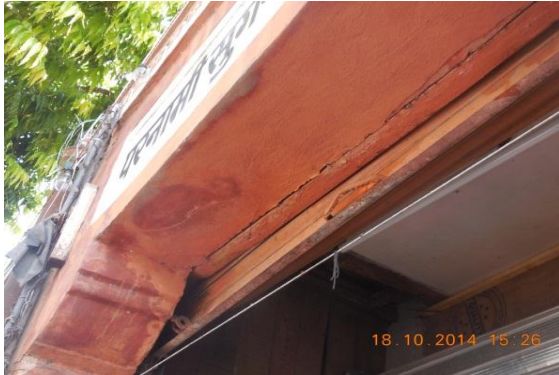
Photo 68

Dampness/ Seepage on Ext.Beam of Verandah of S.No.382,
Ground Floor

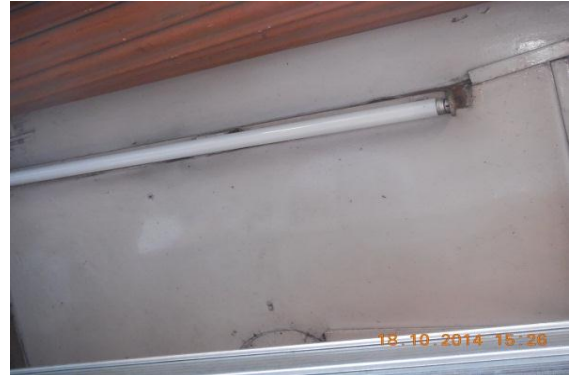
Photo 69

Covered with Wooden on Roof of Verandah of S.No.382,
Ground Floor

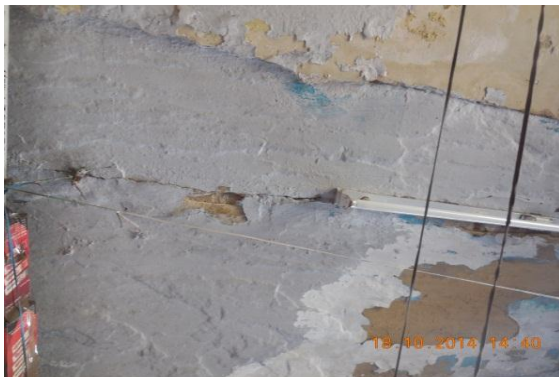
Photo 9
Horizontal Crack on Roof of Verandah of S.No.364A & 364B, GF
Approx. Width = 2.0mm, Approx.Length = 2.50m.
Distance from L.Ext.Col. = 0m, Height from Floor = 2.80m.

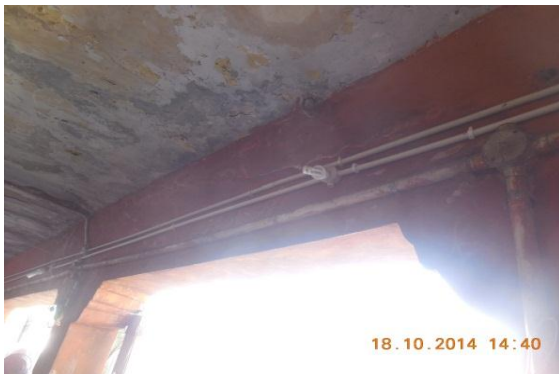
Photo 11
Dampness/Seepage on Ext.Beam of Verandah of
S.No.364A & 364B, Ground Floor

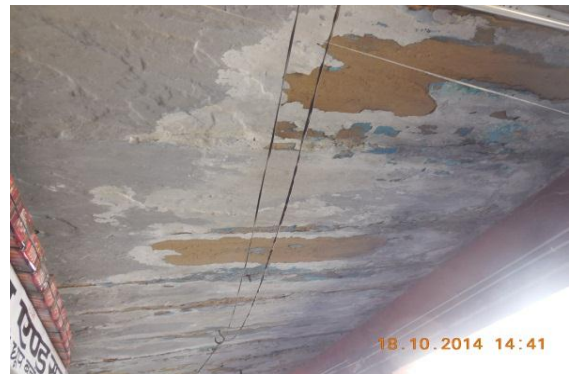
Photo 12
Dampness/Seepage on Roof of Verandah of S.No.365,
Ground Floor

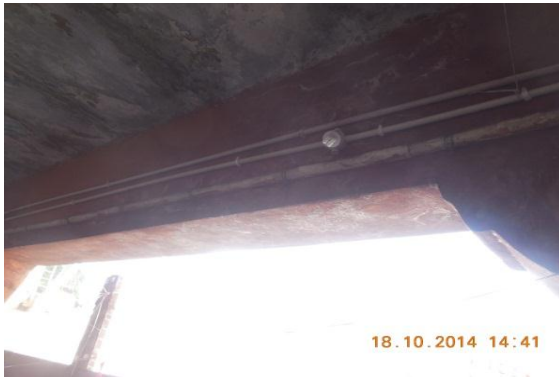
Photo 13
Dampness/Seepage on Ext.Beam of Verandah of S.No.365,
Ground Floor

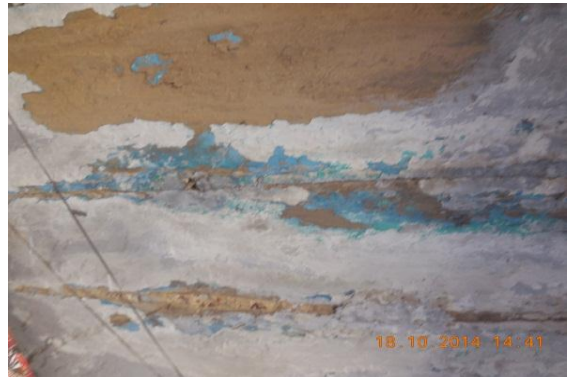
Photo 14
Stone Gap on Roof of Verandah of S.No.365,
Ground Floor

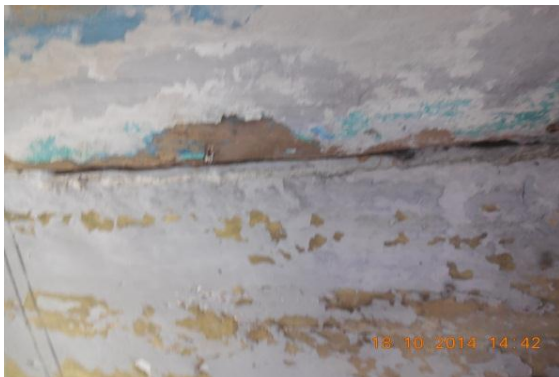
Photo 15
Joint Open on Roof of Verandah of S.No.365,
Ground Floor

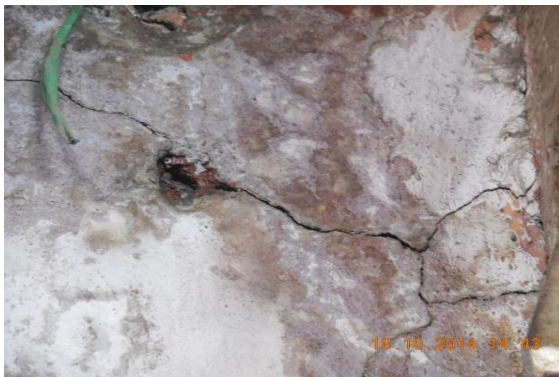
Photo 17
Plaster Crack on Int.Right Col.of Verandah of S.No.365,
Ground Floor

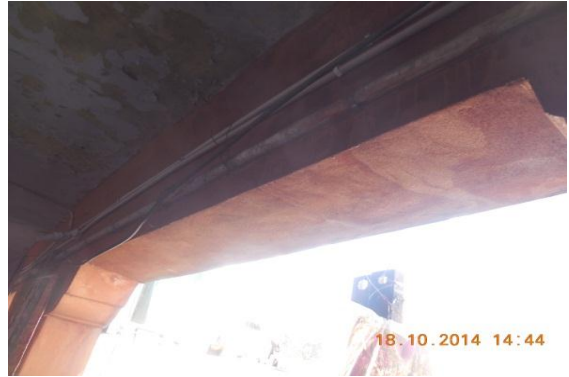
Photo 20
Dampness/Seepage on Ext.Beam of Verandah of S.No.366,
Ground Floor

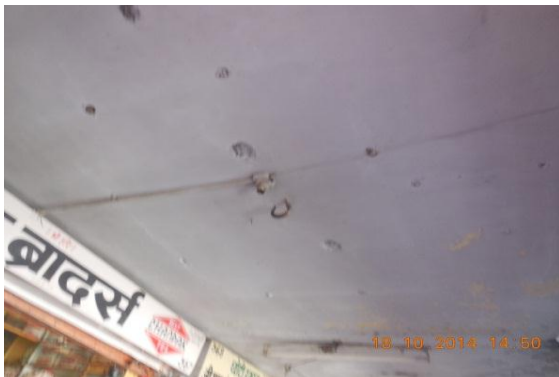
Photo 21
Dampness/Seepage on Roof of Verandah of S.No.367,
Ground Floor

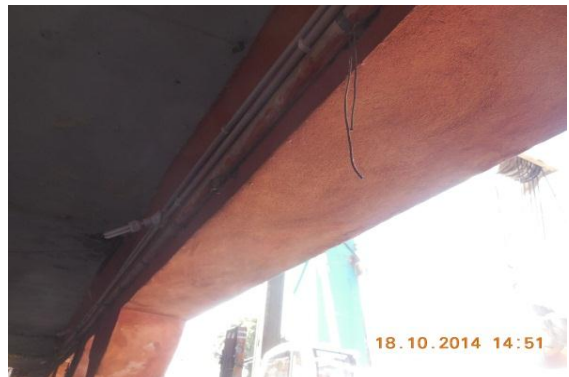
Photo 22
Dampness/Seepage on Ext.Beam of Verandah of S.No.367,
Ground Floor
