Pre - Condition Building Survey for Construction of Underground Stations from Chandpole to Bari Chouper and reversal line

Shop No.362-363
Choti Choper
Jaipur
Unique ID: CC-BC-DL-0008

Report Number: AIMIL/ESG/JMCEC/CC-BC-DL-0008/02/Verandah, Rev. 02, Dated: October, 2014

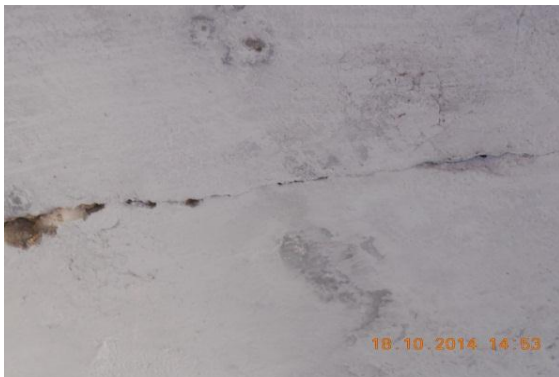
Photo 23
Horizontal Crack on Roof of Verandah of S.No.368,GF
Approx. Width =0.50mm, Approx.Length = 2.50m.
Distance from R.Ext.Col. = 0m, Height from Floor =2.80m.

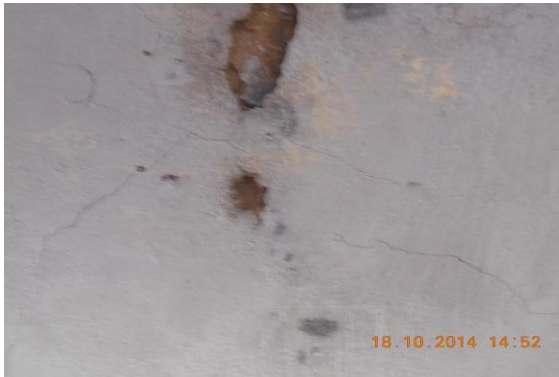
Photo 25
Plaster Removal on Roof of Verandah of S.No.368,
Ground Floor

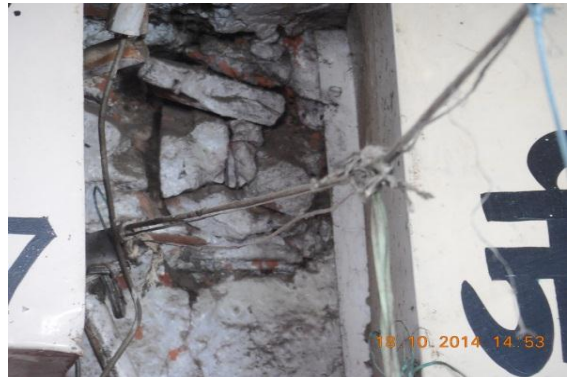
Photo 26
Plaster Removal on Left Int.Col. of Verandah of S.No.368,
Ground Floor

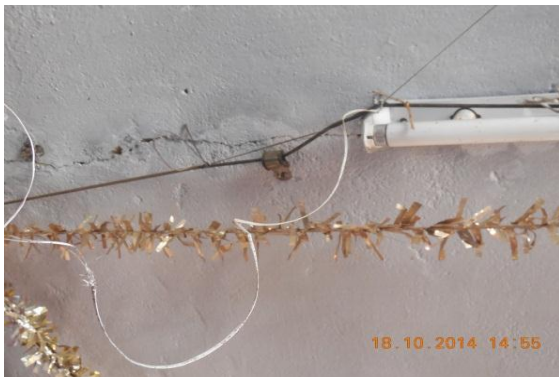
Photo 27
Horizontal Crack on Roof of Verandah of S.No.369,GF
Approx. Width = 0.80mm, Approx.Length = 2.50m.
Distance from R.Ext.Col. = 0m, Height from Floor = 2.80m.

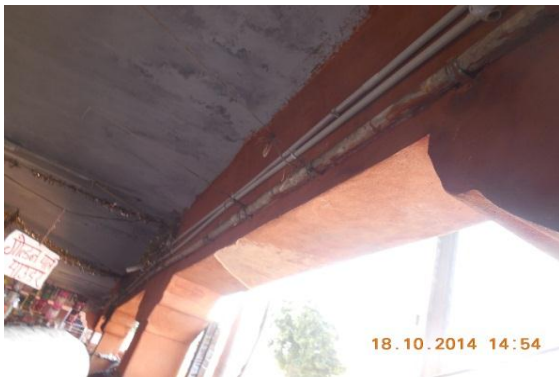
Photo 29
Dampness/Seepage on Ext.Beam of Verandah of S.No.369,
Ground Floor

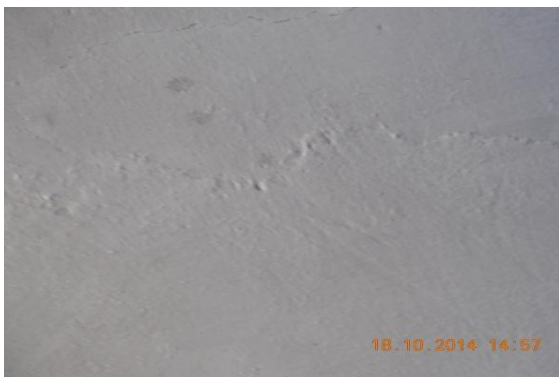
Photo 33

Plaster Crack on Roof of Verandah of S.No.370 & 370A,
Ground Floor

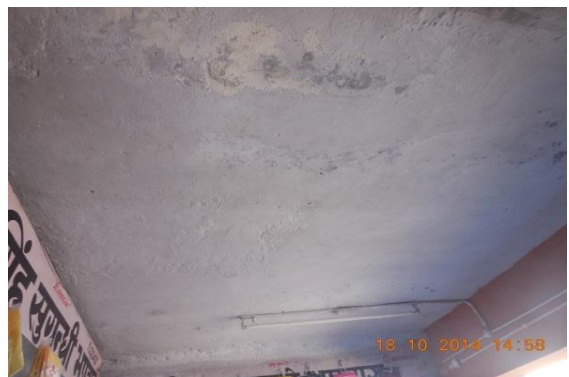
Photo 34

Dampness/ Seepage on Roof of Verandah of S.No.371,
Ground Floor

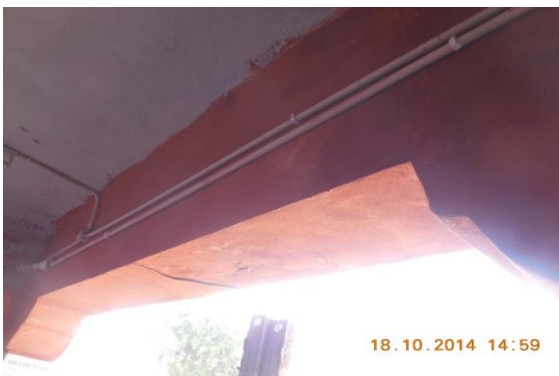
Photo 35

Dampness/ Seepage on Ext.Beam of Verandah of S.No.371,
Ground Floor

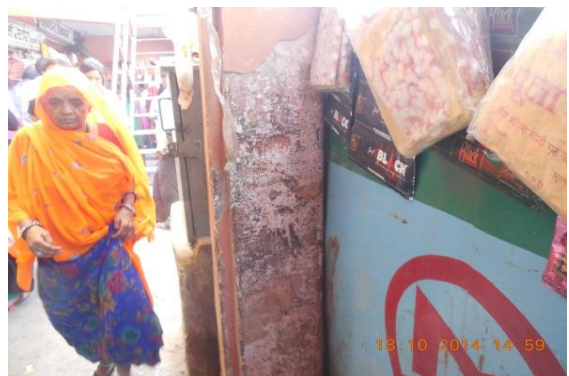
Photo 36

Peeling of Plaster on Right Ext.Col. of Verandah of S.No.371,
Ground Floor

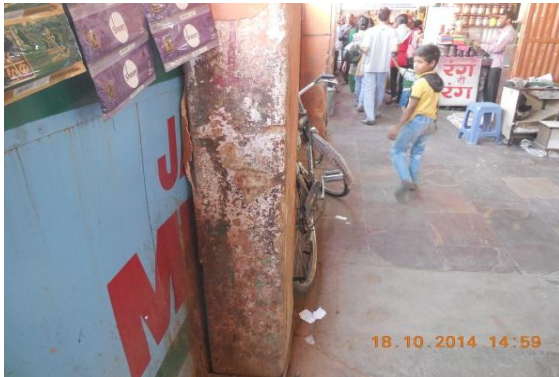
Photo 37

Peeling of Plaster on Left Ext.Col. of Verandah of S.No.371,
Ground Floor

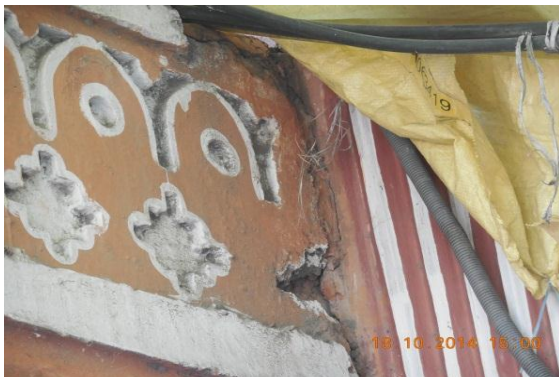
Photo 38A

Plaster Removal on Right Ext.Beam of Verandah of S.No.371,
Ground Floor
