Pre - Condition Building Survey for Construction of Underground Stations from Chandpole to Bari Chouper and reversal line

Shops
Choti Chopar
Jaipur
Unique ID: CC-BC-UP-0001

Report Number: AIMIL/ESG/JMCEC/CC-BC-UP-0001/03/Verandah, Rev. 02, Dated: October, 2014

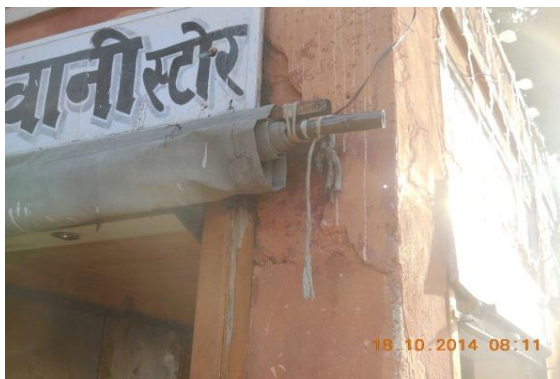
Photo 33
Plaster Removal on Right Ext. Col. of Verandah of S.No.792,
Ground Floor

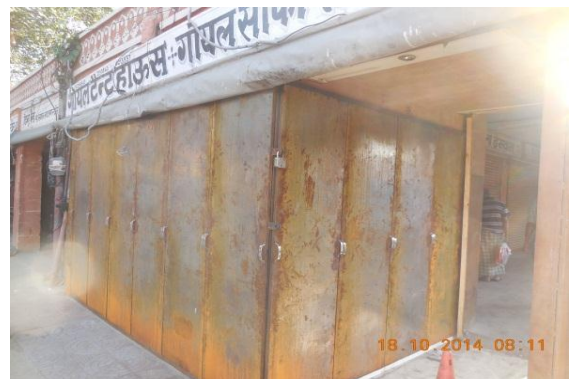
Photo 34
Covered with Metal, Verandah of S.No.792, Ground Floor

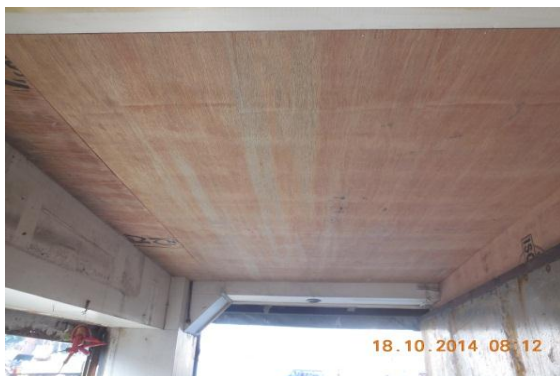
Photo 35
Covered with Wooden, Roof of Verandah of S.No.1,
Ground Floor

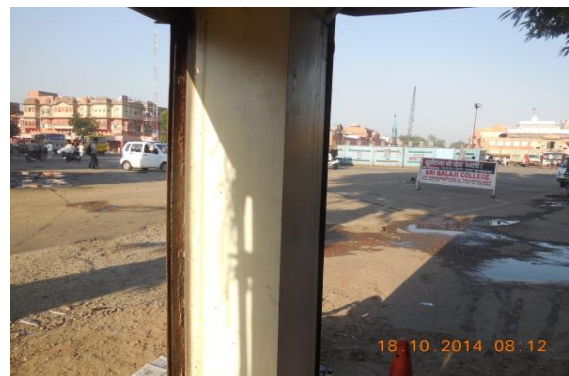
Photo 36
Covered with Wooden, Left Ext.Col. of Verandah of S.No.1,
Ground Floor

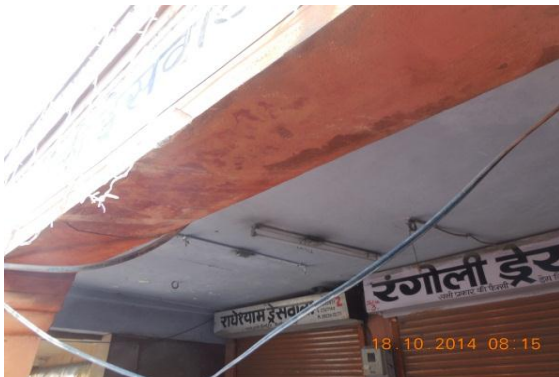
Photo 41

Dampness/Seepage on Ext.Beam of Varanda of S.No.3,
Ground Floor

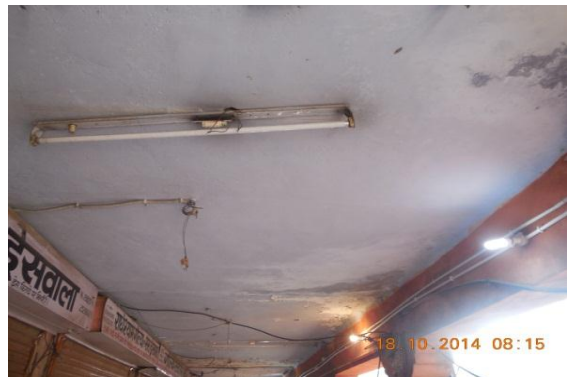
Photo 42

Dampness/Seepage on Roof of Varanda of S.No.3,
Ground Floor

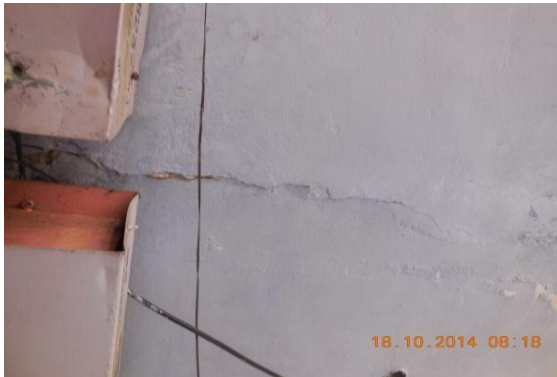
Photo 43

Horizontal Crack on Roof of Varanda of S.No.4,(G. Floor)
Approx. Width = 1.50mm, Approx.Length = 2.0m.
Distance from L.Int.Col. =0m, Height from Floor =2.80m.

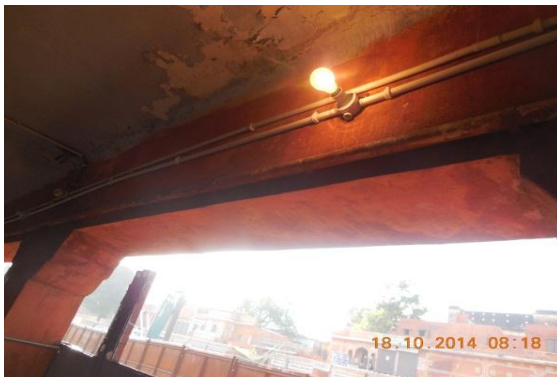
Photo 45

Dampness/Seepage on Ext.Beam of Varanda of S.No.4,
Ground Floor

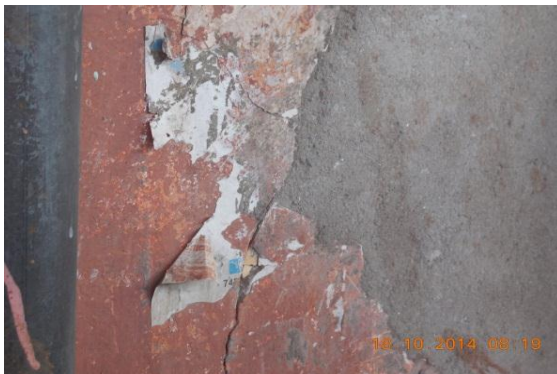
Photo 47A

Inclined Crack on Left Int.Col. of Verandah of S.No.5,(G.F.)
Approx. Width = 0.80mm, Approx.Length = 0.6m.
Distance from L.Int.Col. =0m, Height from Floor =0.30m.

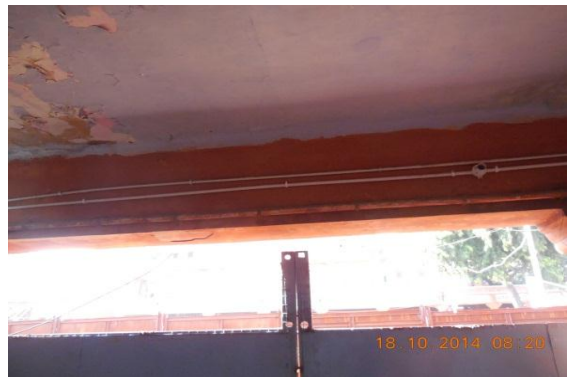
Photo 50

Dampness/Seepage on Ext.Beam of Varanda of S.No.5,
Ground Floor

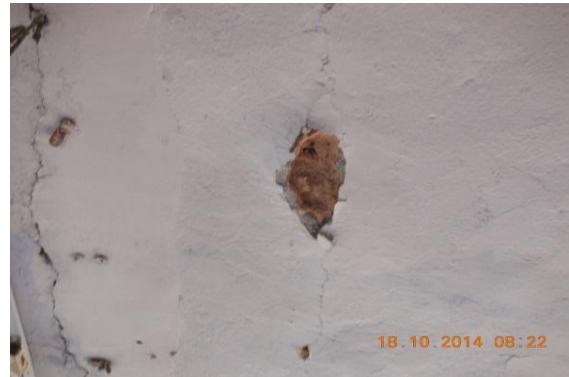
Photo 54

Plaster Removal on Roof of Varanda of S.No.6A & 6B,
Ground Floor

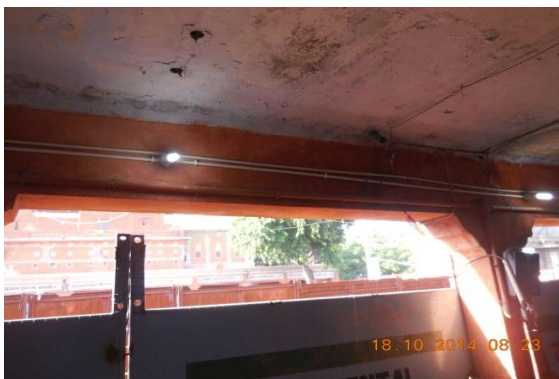
Photo 55

Dampness/Seepage on Ext.Beam of Varanda of S.No.6A & 6B,
Ground Floor

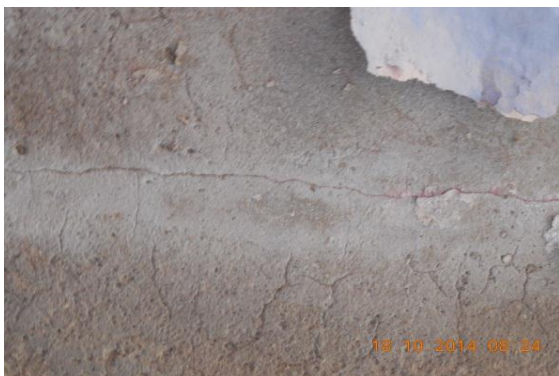
Photo 57

Horizontal Crack on Roof of Varanda of S.No.7,Ground Floor
Approx. Width = 0.50mm, Approx.Length = 2.80m.
Distance from R.Ext. Col. =0.80m, Height from Floor =2.8m.

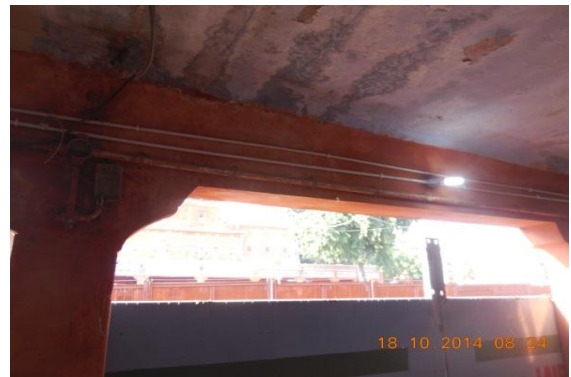
Photo 62

Dampness/Seepage on Ext.Beam of Verandah of S.No.7,
Ground Floor

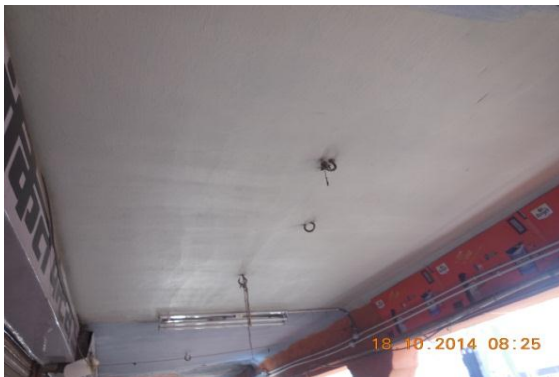
Photo 63

View of Roof of Verandah of S.No.8, Ground Floor

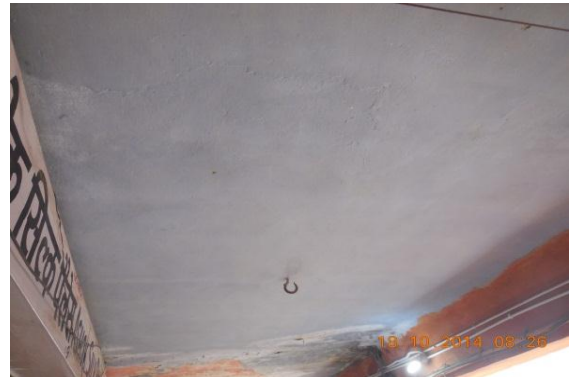
Photo 66

View of Roof of Verandah of S.No.9, Ground Floor

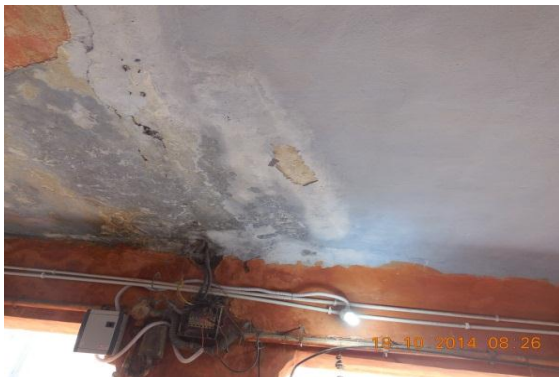
Photo 67

Dampness/Seepage on Roof of Verandah of S.No.9,
Ground Floor

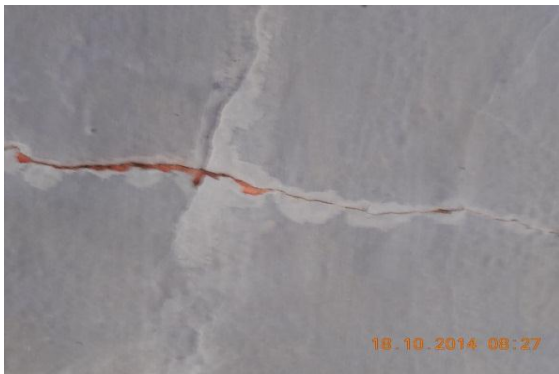
Photo 69

Horizontal Crack on Roof of Verandah of S.No.10,G.F.
Approx. Width = 0.50mm, Approx.Length = 0.50m.
Distance from L.Ext. Col. =1.50m, Height from Floor =2.80m.

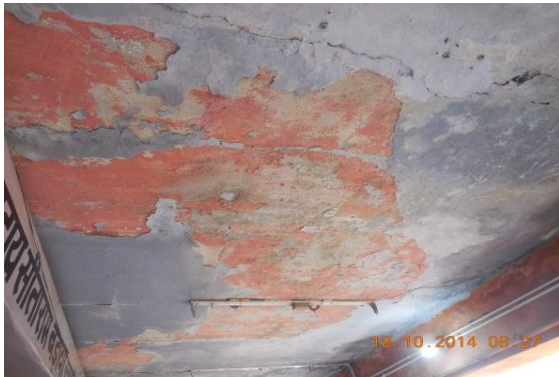
Photo 71

Dampness/Seepage on Roof of Verandah of S.No.10,
Ground Floor

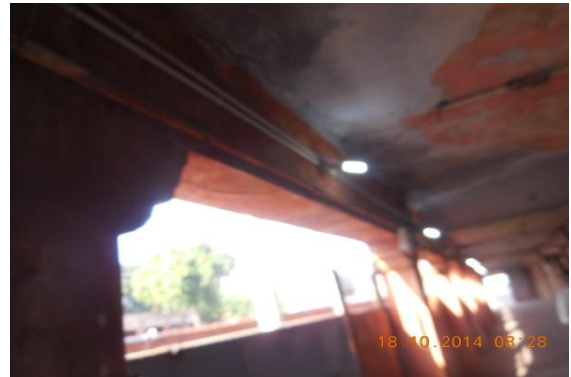
Photo 72

Dampness/Seepage on Ext.Beam of Verandah of S.No.10,
Ground Floor

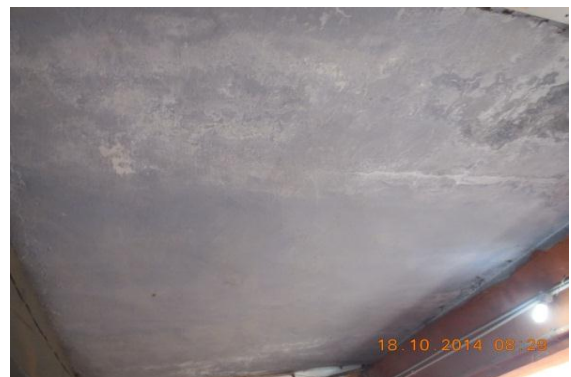
Photo 74

Dampness/Seepage on Roof of Verandah of S.No.11,
Ground Floor

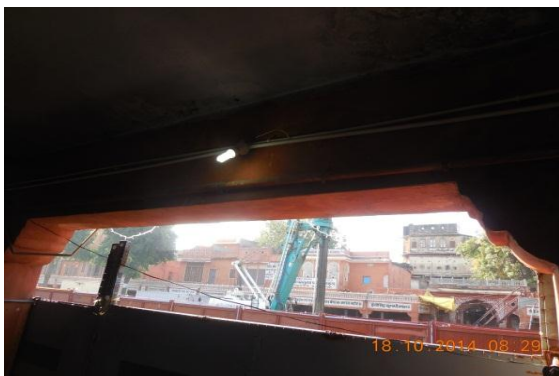
Photo 75

Dampness/Seepage on Ext.Beam of Verandah of S.No.11,
Ground Floor

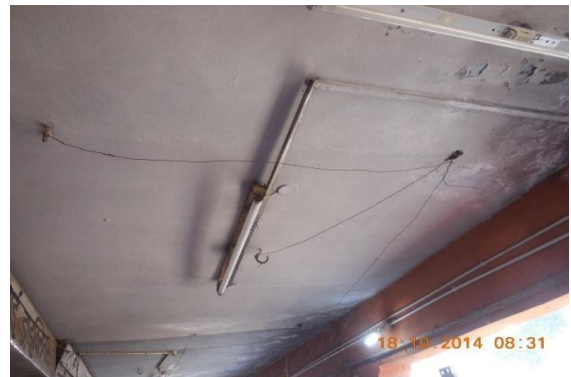
Photo 79

Dampness/Seepage on Roof of Verandah of S.No.13,
Ground Floor

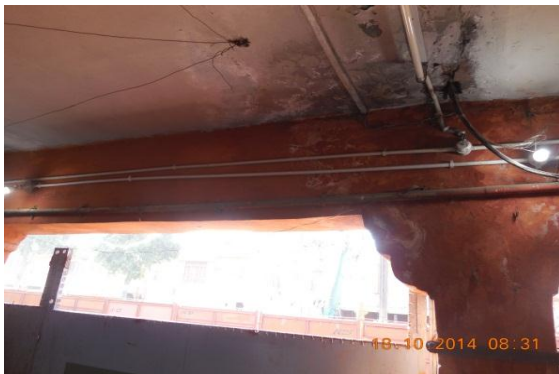
Photo 80

Dampness/Seepage on Ext.Beam of Verandah of S.No.13,
Ground Floor

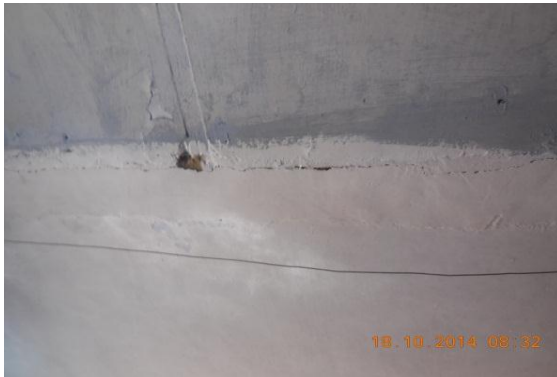
Photo 82

Horizontal Crack on Roof of Verandah of S.No.14A & 14B,G.F.
Approx. Width = 1.0mm, Approx.Length = 3.0m.
Distance from L.Ext. Col. =0m, Height from Floor =2.80m.

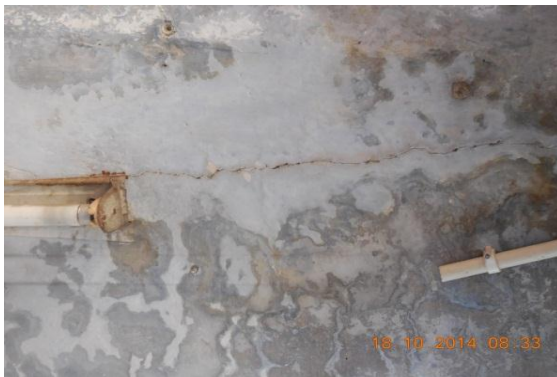
Photo 84

Horizontal Crack on Roof of Verandah of S.No.14A & 14B,G.F.
Approx. Width = 0.60mm, Approx.Length = 2.90m.
Distance from R.Ext. Col. =0m, Height from Floor =2.80m.

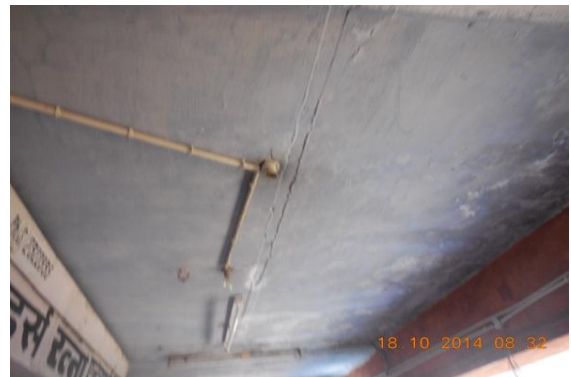
Photo 85

Dampness/Seepage on Roof of Verandah of S.No.14A & 14B,
Ground Floor

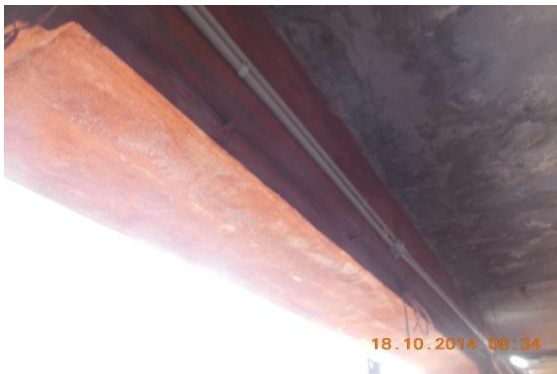
Photo 86

Dampness/Seepage on Ext.Beam of Verandah of S.No.14A & 14B,
Ground Floor

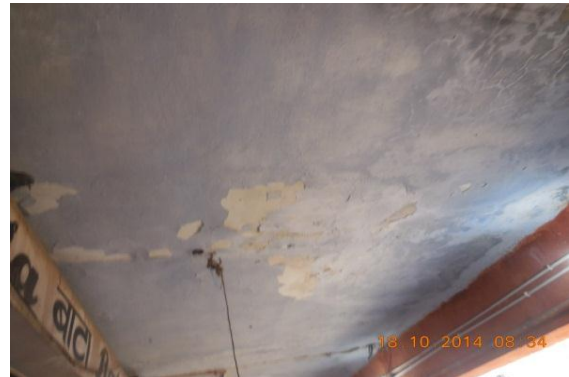
Photo 89

Dampness/Seepage on Roof of Verandah of S.No.15,
Ground Floor

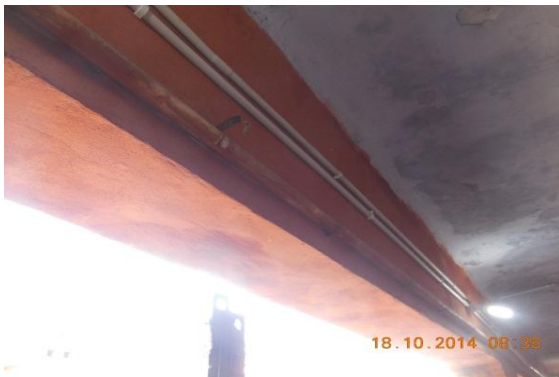
Photo 90

Dampness/Seepage on Ext.Beam of Verandah of S.No.15,
Ground Floor

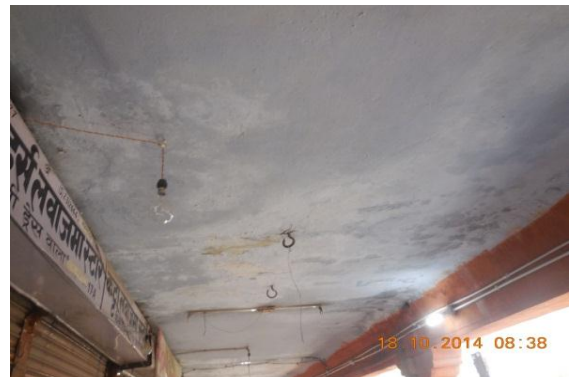
Photo 97

Dampness/Seepage on Roof of Verandah of S.No.17A & 17B, Ground Floor

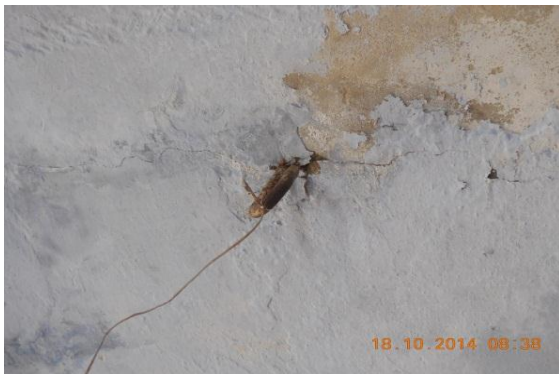
Photo 98

Plaster Crack on Roof of Verandah of S.No.17A&17B, Ground Floor

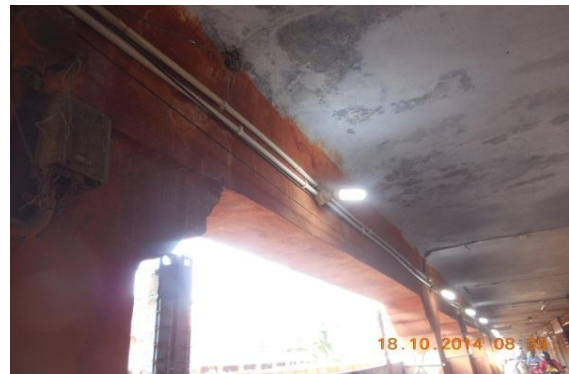
Photo 99

Dampness/Seepage on Ext.Beam of Verandah of S.No.17A&17B, Ground Floor

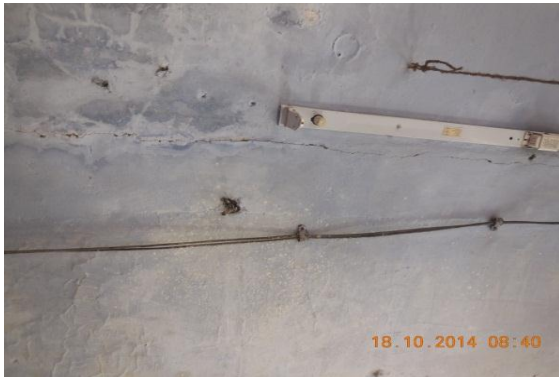
Photo 100

Horizontal Crack on Roof of Verandah of S.No.18,G.F.
Approx. Width = 0.50mm, Approx.Length = 2.90m.
Distance from R.Ext. Col. =0m, Height from Floor =2.80m.

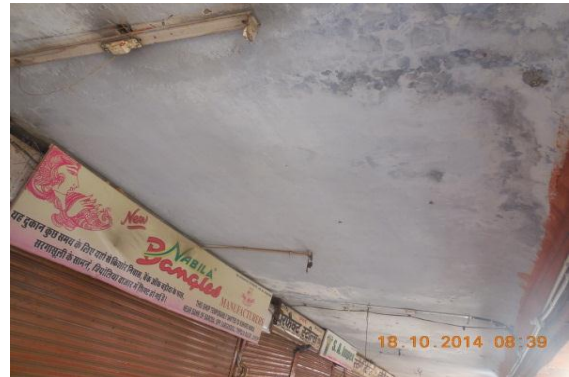
Photo 101

Dampness/Seepage on Roof of Verandah of S.No.18,
Ground Floor

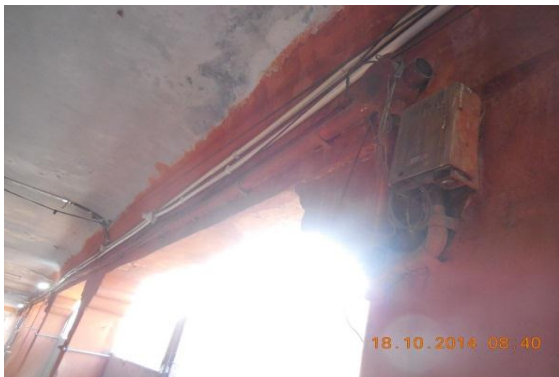
Photo 102

Dampness/Seepage on Ext.Beam of Verandah of S.No.18,
Ground Floor

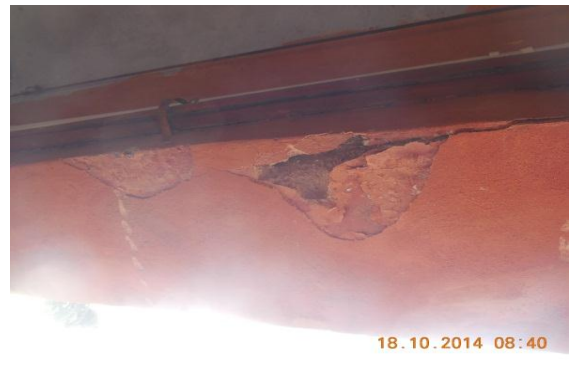
Photo 103

Plaster Removal on Roof of Verandah of S.No.18,
Ground Floor

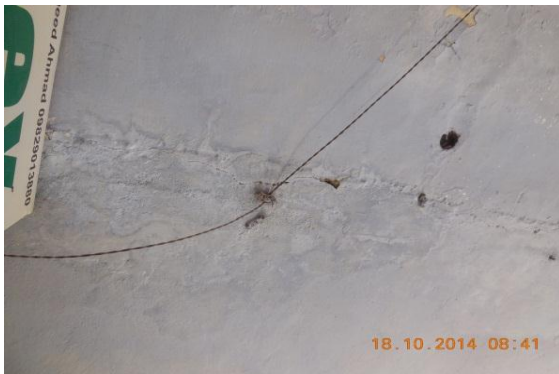
Photo 104

Horizontal Crack on Roof of Verandah of S.No.19A & 19B,G.F.
Approx. Width = 0.50mm, Approx.Length = 2.90m.
Distance from R.Ext. Col. =0m, Height from Floor =2.80m.

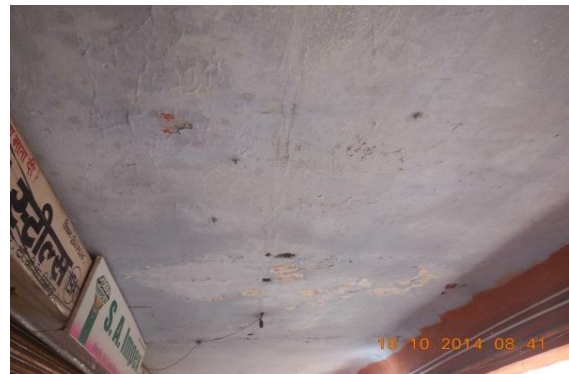
Photo 105

Dampness/Seepage on Roof of Verandah of S.No.19A & 19B,
Ground Floor

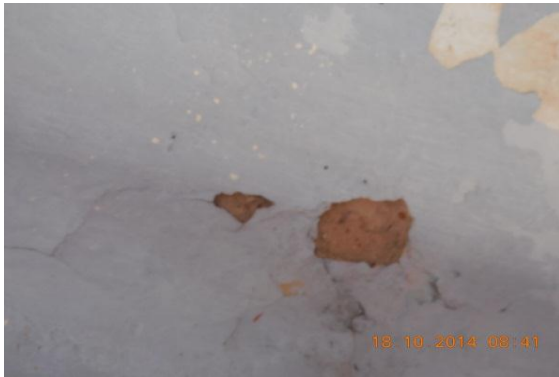
Photo 106

Plaster Removal on Roof of Verandah of S.No.19A & 19B,
Ground Floor

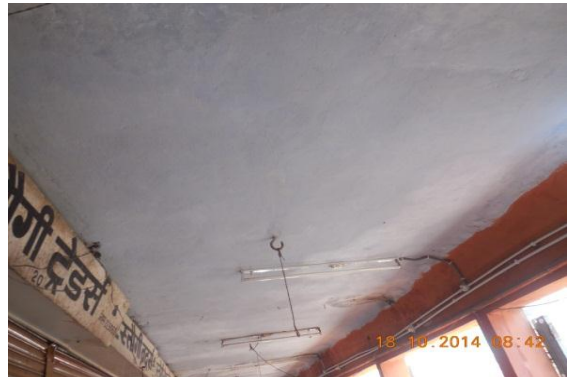
Photo 107

Dampness/Seepage on Roof of Verandah of S.No.20,
Ground Floor

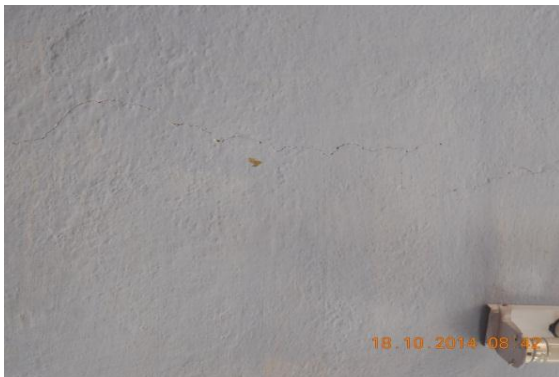
Photo 108

Plaster Crack on Roof of Verandah of S.No.20,
Ground Floor

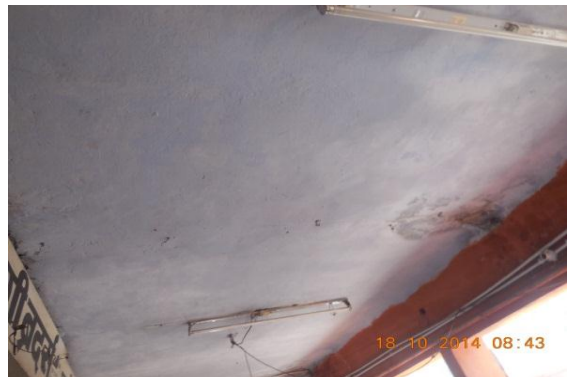
Photo 109

Dampness/Seepage on Roof of Verandah of S.No.21A,
Ground Floor

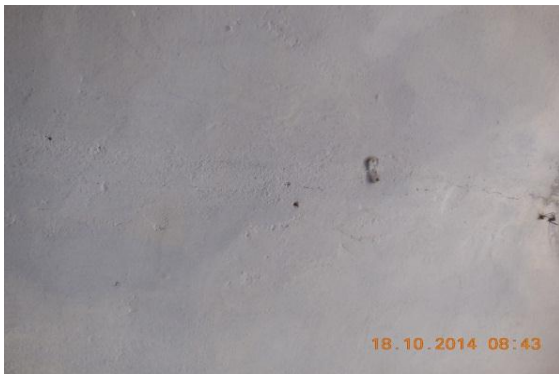
Photo 110

Plaster Crack on Roof of Verandah of S.No.21A,
Ground Floor

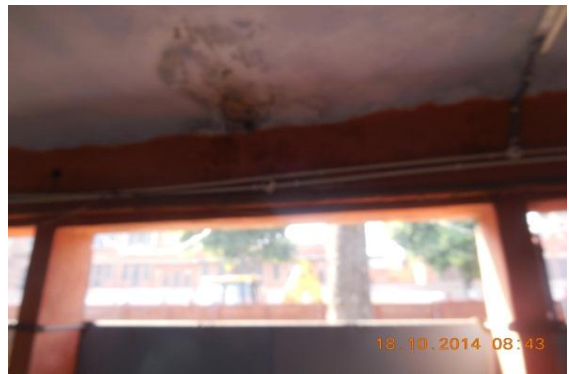
Photo 111

Dampness/Seepage on Ext. Beam of Verandah of S.No.21A,
Ground Floor

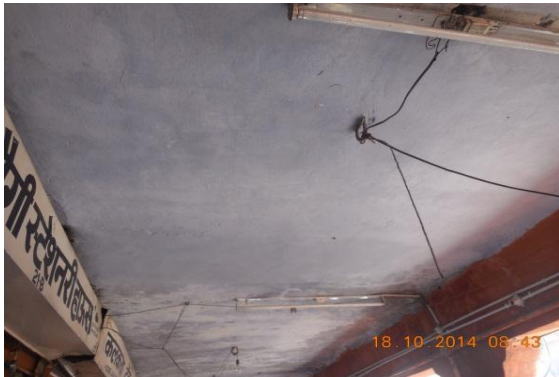
Photo 112
Dampness/Seepage on Roof of Verandah of S.No.21B,
Ground Floor

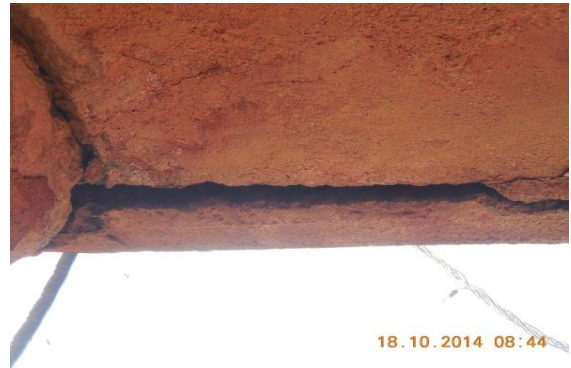
Photo 113
Plaster Removal on Ext.Beam of Verandah of S.No.21B,
Ground Floor

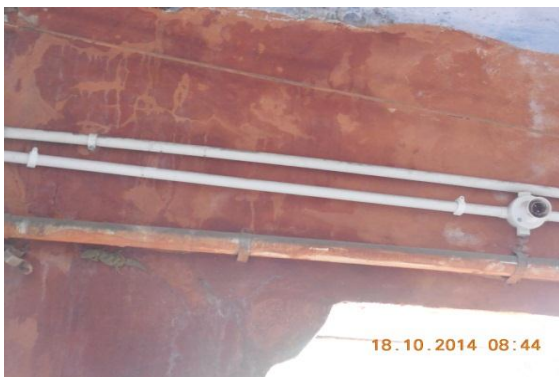
Photo 114
Dampness/Seepage on Ext.Beam & L.Ext.Col.of Verandah of S.No.21B,
Ground Floor

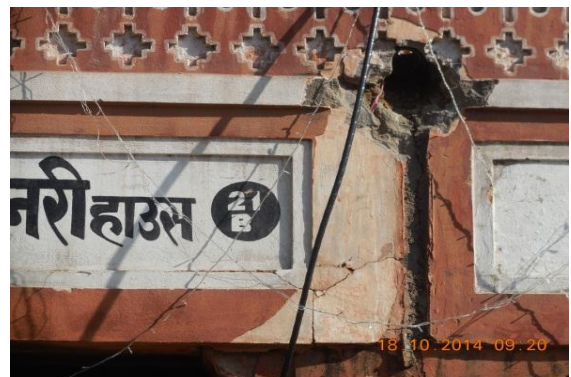
Photo 115
Plaster Removal on Outer Left Ext.Col. of Verandah of S.No.21B,
Ground Floor

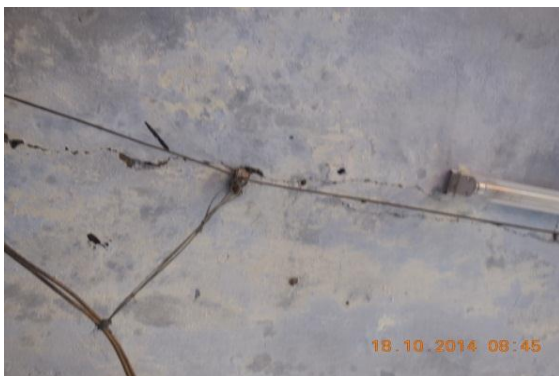
Photo 116A
Horizontal Crack on Roof & L.Ext.Col.of Verandah of S.No.22,G.F.
Approx. Width = 1.0mm, Approx.Length = 3.50m.
Distance from L.Ext. Col. =0m, Height from Floor =2.80m.

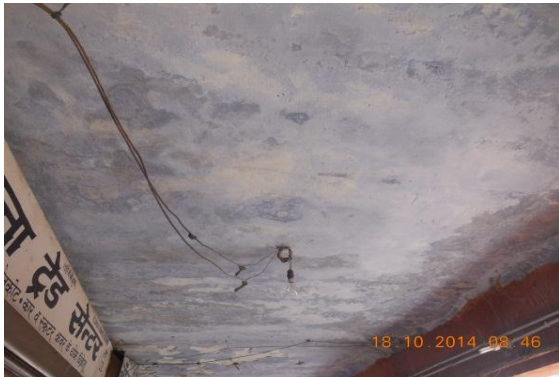
Photo 117

Dampness/Seepage on Roof of Verandah of S.No.22,
Ground Floor

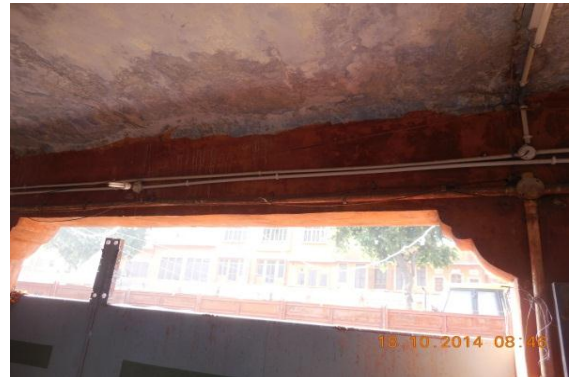
Photo 118

Dampness/Seepage on Ext.Beam of Verandah of S.No.22,
Ground Floor

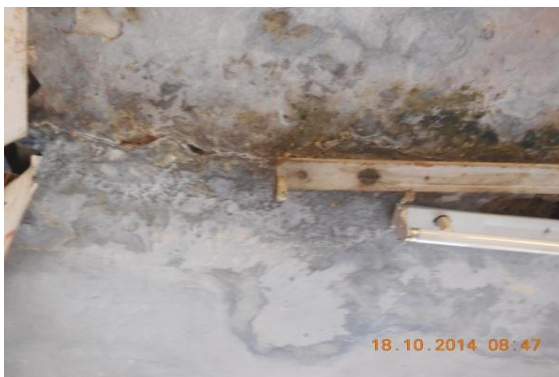
Photo 119

Horizontal Crack on Roof of Verandah of S.No.23,G.F.
Approx. Width = 1.0mm, Approx.Length = 3.0m.
Distance from R.Ext. Col. =0m, Height from Floor =2.80m.

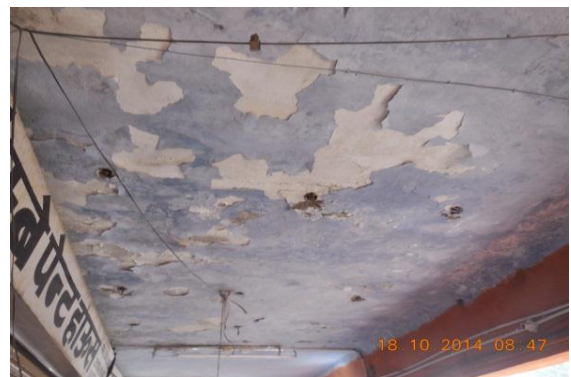
Photo 120

Dampness/Seepage on Roof of Verandah of S.No.23,
Ground Floor

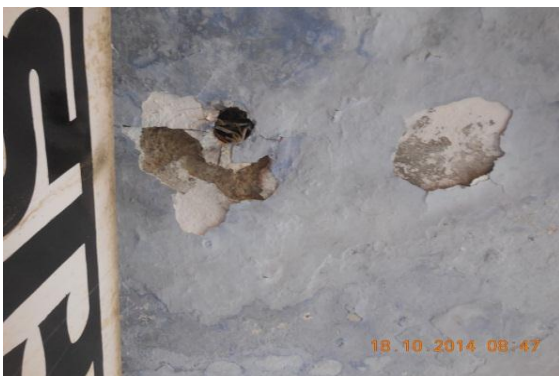
Photo 121

Plaster Removal on Roof of Verandah of S.No.23,
Ground Floor

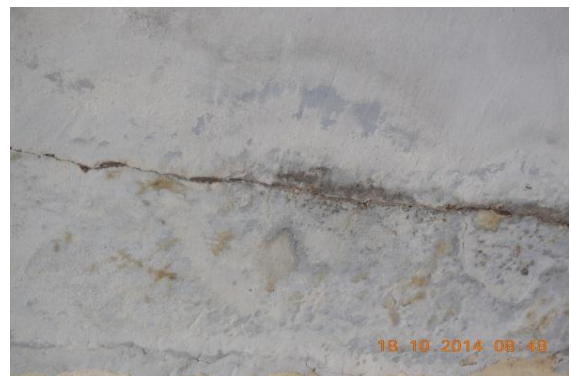
Photo 122

Horizontal Crack on Roof of Verandah of S.No.24,G.F.
Approx. Width = 2.50mm, Approx.Length = 3.0m.
Distance from R.Ext. Col. =0m, Height from Floor =2.80m.

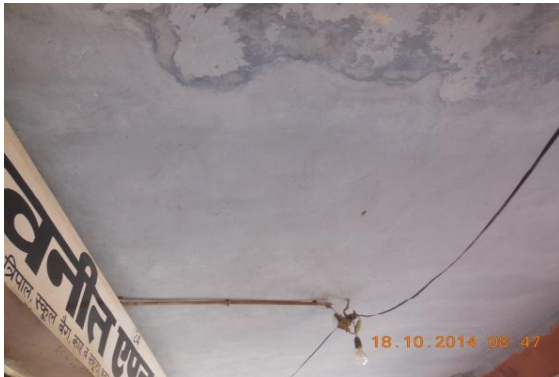
Photo 123
Dampness/Seepage on Roof of Verandah of S.No.24,
Ground Floor

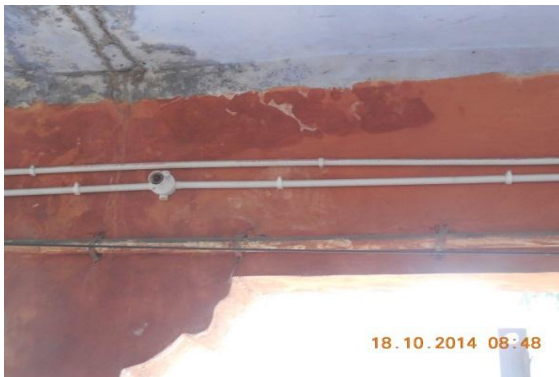
Photo 125
Dampness/Seepage on Ext. Beam of Verandah of S.No.24,
Ground Floor

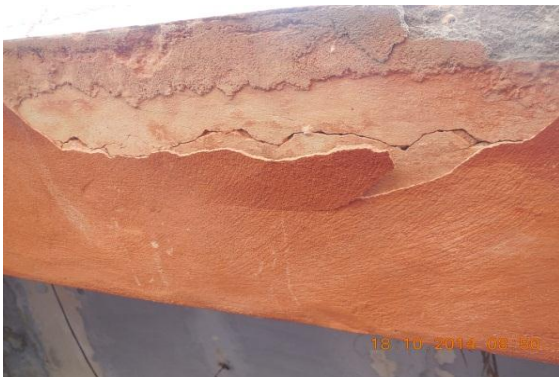
Photo 127
Horizontal Crack on Ext. Beam of Verandah of S.No.25, G.F.
Approx. Width = 1.0mm, Approx.Length = 0.60m.
Distance from L.Ext. Col. = 1.40m, Height from Floor = 2.30m.

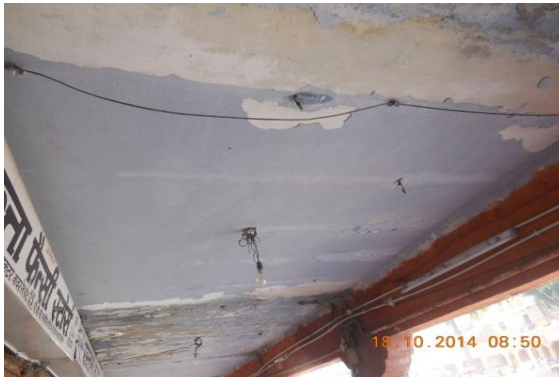
Photo 129
Dampness/Seepage on Roof of Verandah of S.No.25,
Ground Floor

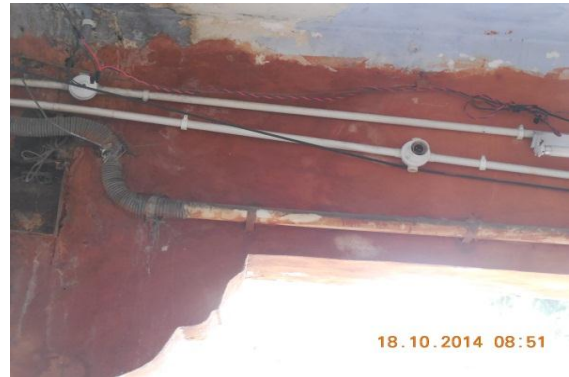
Photo 130
Dampness/Seepage on Ext.Beam of Verandah of S.No.25,
Ground Floor

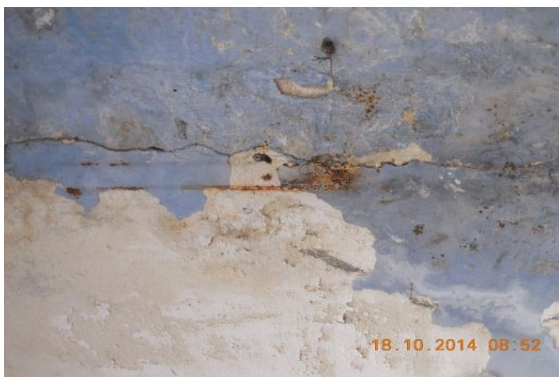
Photo 131
Horizontal Crack on Roof of Verandah of S.No.26, G.F.
Approx. Width = 1.0mm, Approx.Length = 2.90m.
Distance from L.Ext. Col. = 0m, Height from Floor = 2.80m.

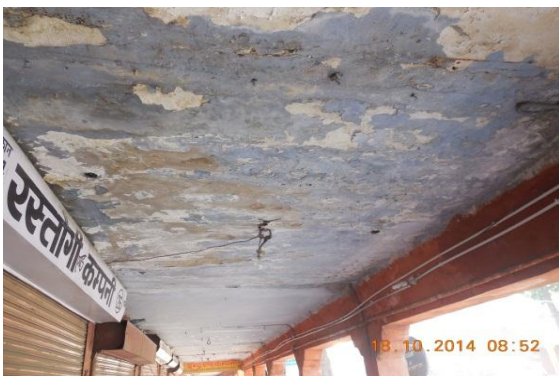
Photo 133
Dampness/Seepage on Roof of Verandah of S.No.26,
Ground Floor

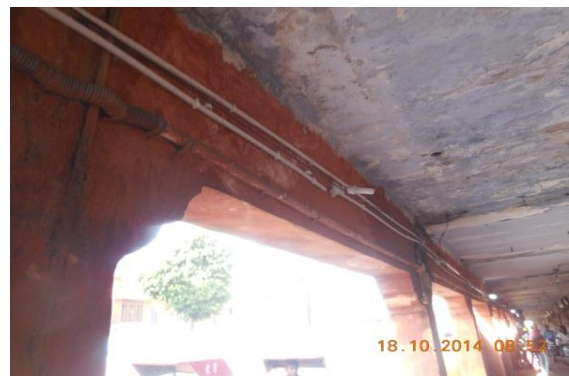
Photo 134
Dampness/Seepage on Ext.Beam of Verandah of S.No.26,
Ground Floor

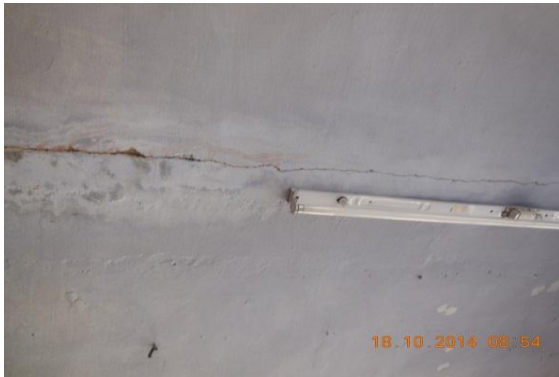
Photo 135

Horizontal Crack on Roof of Verandah of S.No.27, G.F.
Approx. Width = 1.50mm, Approx.Length = 2.90m.
Distance from R.Ext. Col. = 0m, Height from Floor = 2.80m.

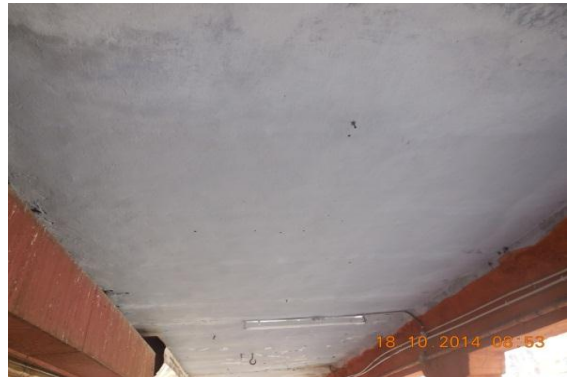
Photo 136

Dampness/Seepage on Roof of Verandah of S.No.27,
Ground Floor

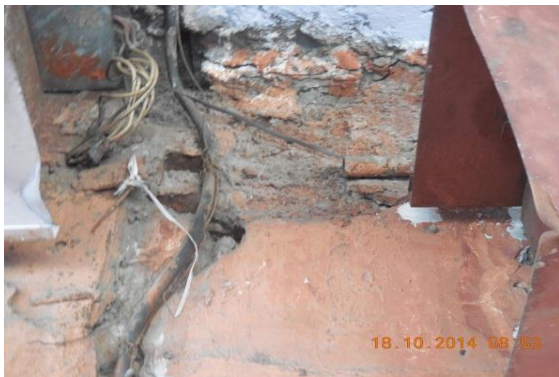
Photo 137

Plaster Removal on Left Int.Col. of Verandah of S.No.27,
Ground Floor

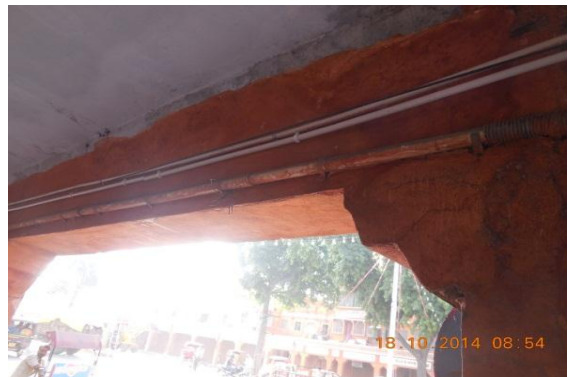
Photo 138

Dampness/Seepage on Ext.Beam of Verandah of S.No.27,
Ground Floor

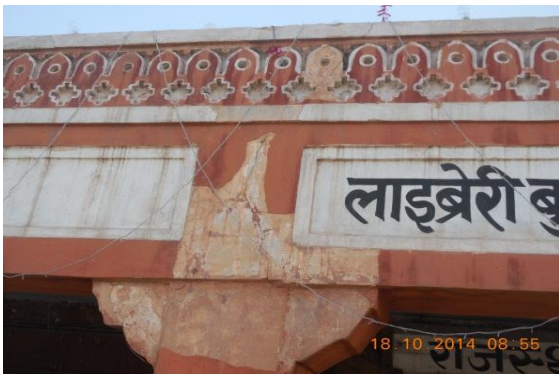
Photo 139

Inclined Crack on Outer Left Ext.Col. of Verandah of S.No.28, G.F.
Approx. Width = 1.50mm, Approx.Length = 2.90m.
Distance from L.Ext. Col. = 0m, Height from Floor = 2.50m.

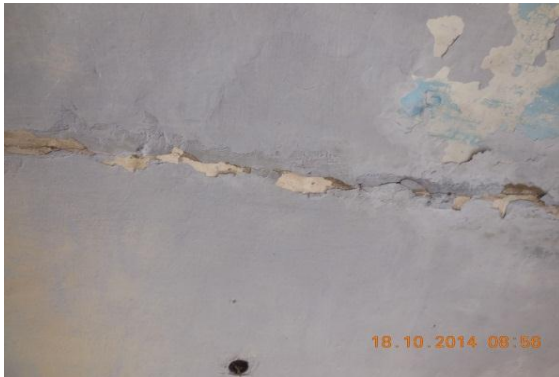
Photo 141A

Horizontal Crack on Roof & Ext.Beam of Verandah of S.No.28,G.F.
Approx. Width = 1.0mm, Approx.Length = 3.10m.
Distance from R.Ext. Col. =0m, Height from Floor =2.80m.

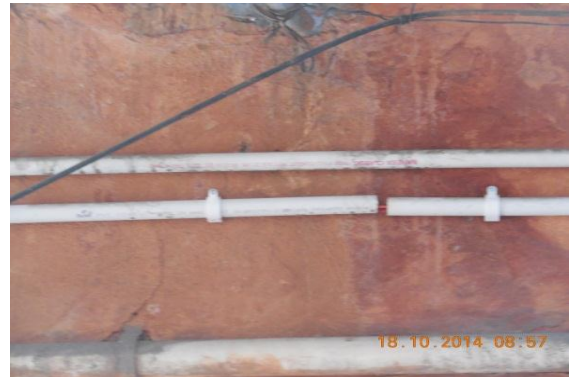
Photo 141B

Horizontal Crack on Roof & Ext.Beam of Verandah of S.No.28,G.F.
Approx. Width = 1.0mm, Approx.Length = 3.10m.
Distance from R.Ext. Col. =0m, Height from Floor =2.80m.

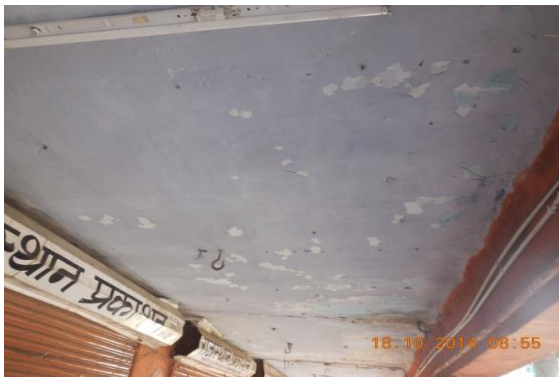
Photo 142

Dampness/Seepage on Roof of Verandah of S.No.28,
Ground Floor

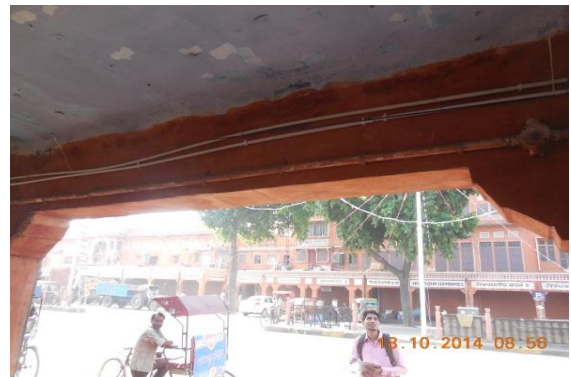
Photo 143

Dampness/Seepage on Ext.Beam of Verandah of S.No.28,
Ground Floor

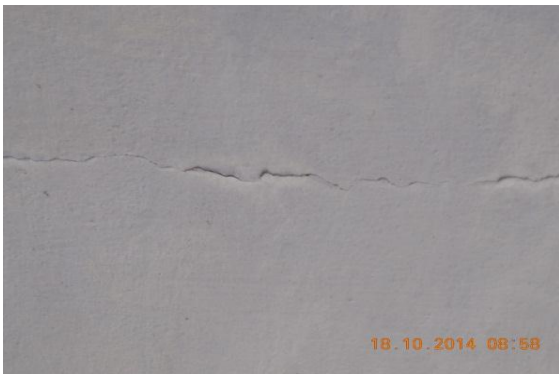
Photo 144

Horizontal Crack on Roof of Verandah of S.No.29,G.F.
Approx. Width = 0.25mm, Approx.Length = 2.90m.
Distance from L.Ext. Col. =1.0m, Height from Floor =2.80m.

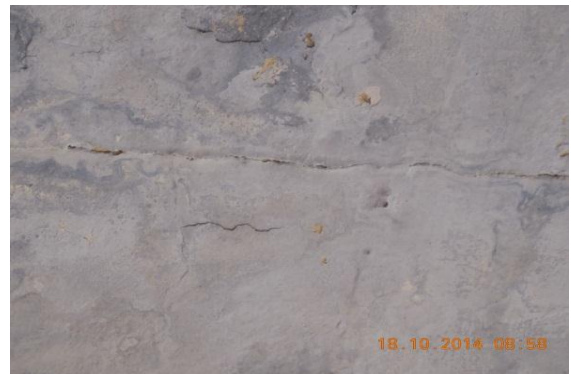
Photo 145

Horizontal Crack on Roof of Verandah of S.No.29,G.F.
Approx. Width = 0.50mm, Approx.Length = 2.90m.
Distance from R.Ext. Col. = 0.50m, Height from Floor =2.80m.

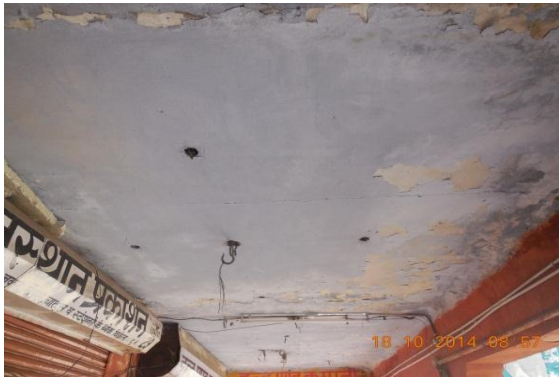
Photo 146

Dampness/Seepage on Roof of Verandah of S.No.29,
Ground Floor

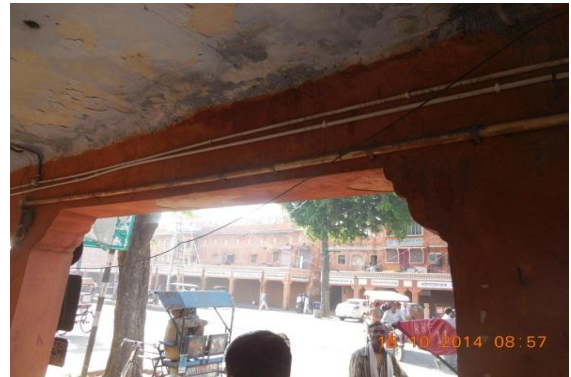
Photo 147

Dampness/Seepage on Ext.Beam of Verandah of S.No.29,
Ground Floor

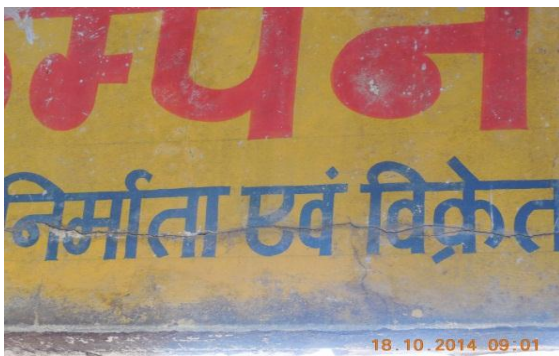
Photo 148

Horizontal Crack on Right Ext.Beam of Verandah of S.No.30,G.F.
Approx. Width = 1.50mm, Approx.Length = 1.60m.
Distance from R.Ext. Col. =0m, Height from Floor =2.50m.

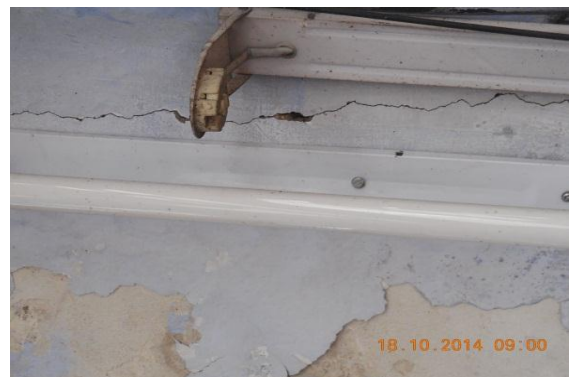
Photo 149

Horizontal Crack on Roof of Verandah of S.No.30,G.F.
Approx. Width = 1.0mm, Approx.Length = 2.90m.
Distance from L.Ext. Col. =0m, Height from Floor =2.80m.

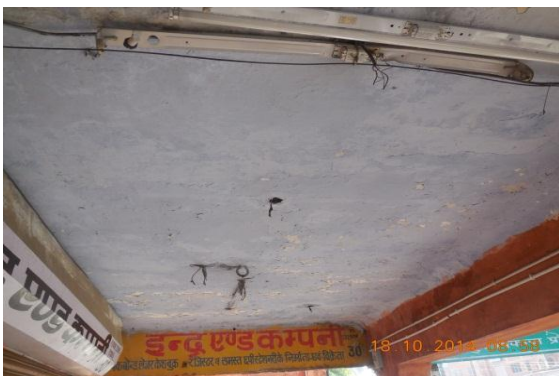
Photo 150

Dampness/Seepage on Roof of Verandah of S.No.30,
Ground Floor

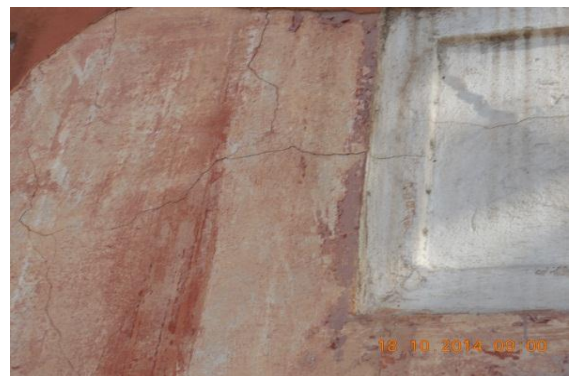
Photo 151

Plaster Crack on Left Ext.Col. of Verandah of S.No.30,
Ground Floor

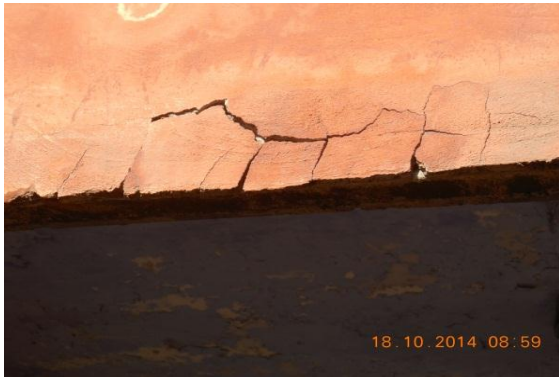
Photo 152

Plaster Removal on Outer R.Ext.Beam of Verandah of S.No.30,
Ground Floor

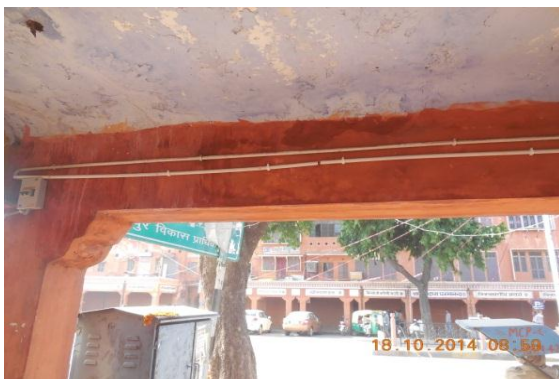
Photo 154

Dampness/Seepage on Ext.Beam of Verandah of S.No.30,
Ground Floor
